Library of Congress Cataloging-in-Publication Data
Kletz, Trevor A.

What went wrong? : case histories of process plant disasters and how they could have been avoided / Trevor Kletz. —5th ed.

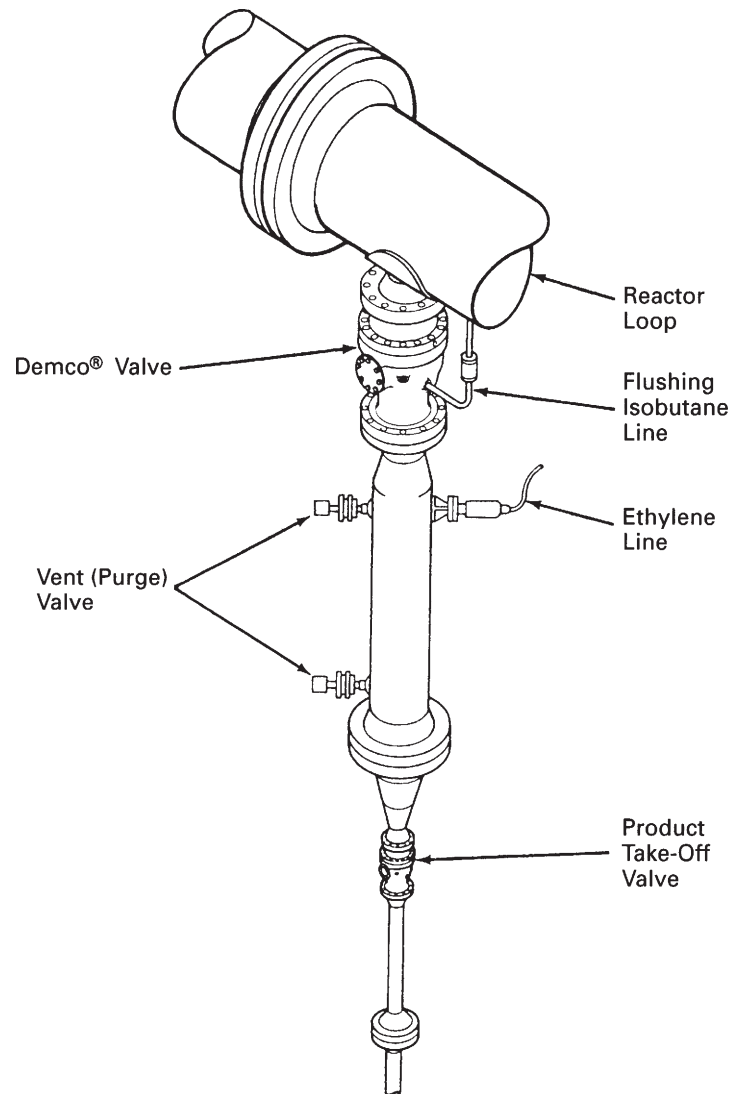
A similar but more serious incident occurred in a polyethylene plant in 1989. A take-off branch was dismantled to clear a choke. The 8-in. valve isolating it from the reactor loop (the Demco valve in Figure 1-2) was open, and hot ethylene under pressure came out and exploded, killing 23 people, injuring more than 130, and causing extensive damage. Debris was thrown 10 km (6 miles), and the subsequent fire caused two liquefied petroleum gas tanks to burst.

FIGURE 1-2 The take-off branch was dismantled with the Demco valve open. (Illustration courtesy of the U.S. Department of Labor.)

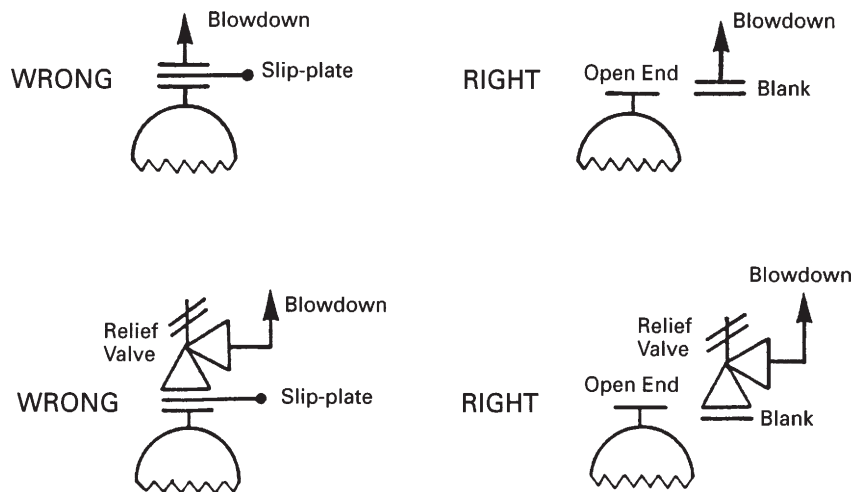
FIGURE 1-4 The right and wrong ways to isolate a vent line.

If a vent line has to be slip-plated because the line is too rigid to be moved, then the vents should be slip-plated last and de-slip-plated first. If all slip-plates inserted are listed on a register, they are less likely to be overlooked.

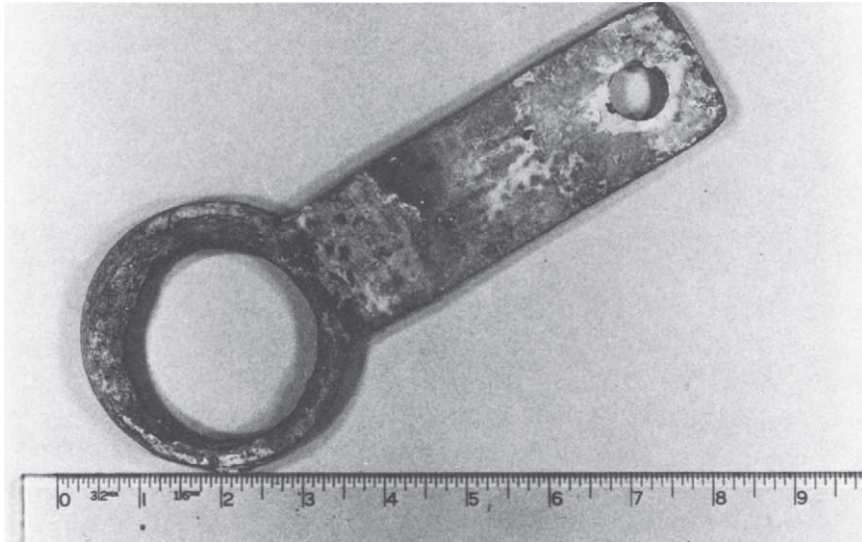
FIGURE 1-5 A slip-plate left in position for many months had corroded right through.

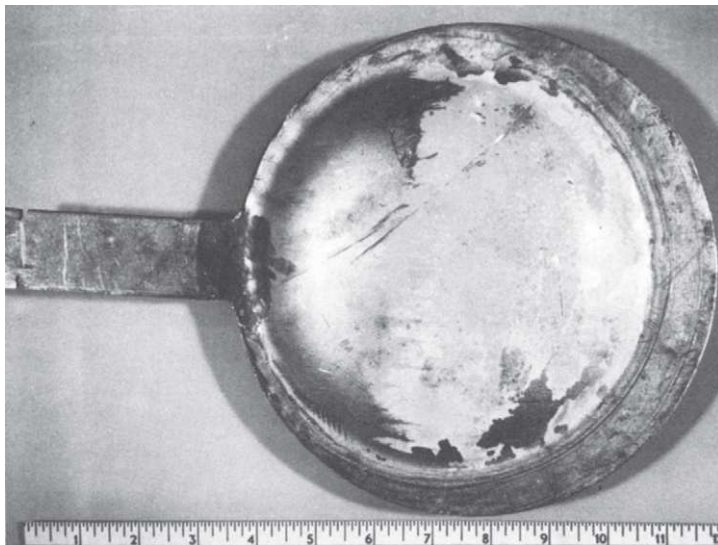
FIGURE 1-6 A slip-plate bowed by a gauge pressure of 470 psi (32 bar).

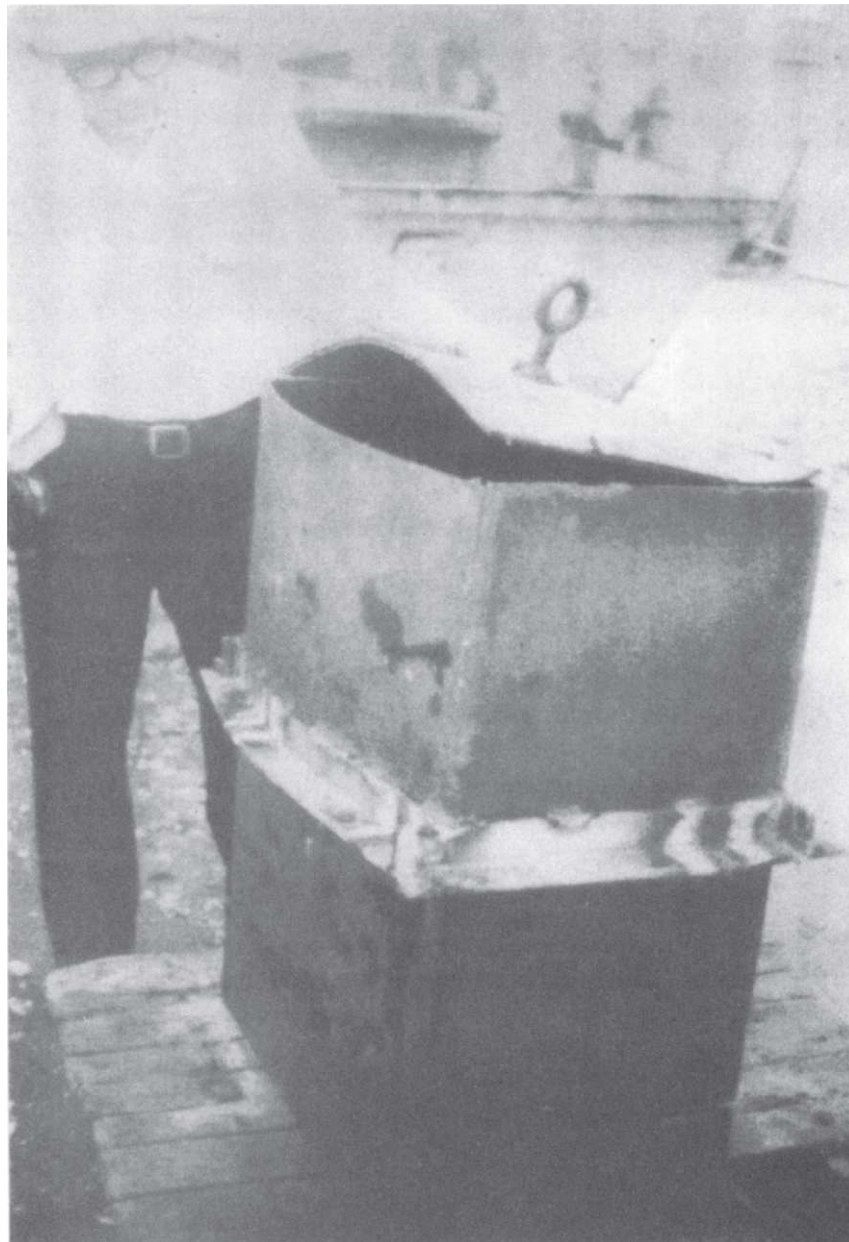
FIGURE 1-13 This steel box was quite incapable of containing a leak of steam at a gauge pressure of 300 psi (20 bar).

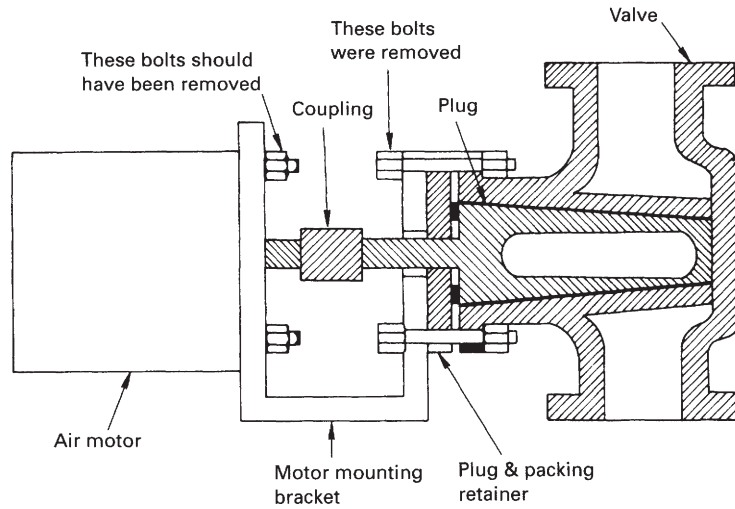
FIGURE 1-14 Wrong nuts undone to remove the valve actuator.

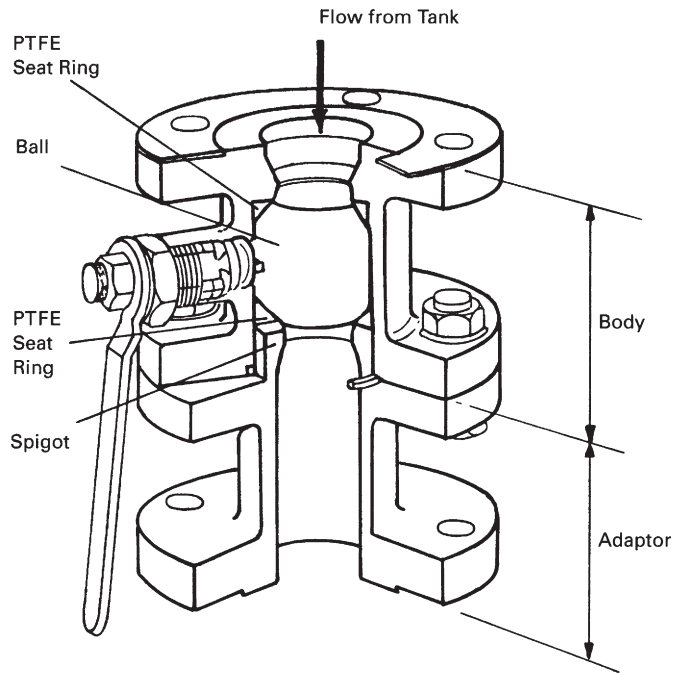
FIGURE 1-16 Valve dismantled in error.

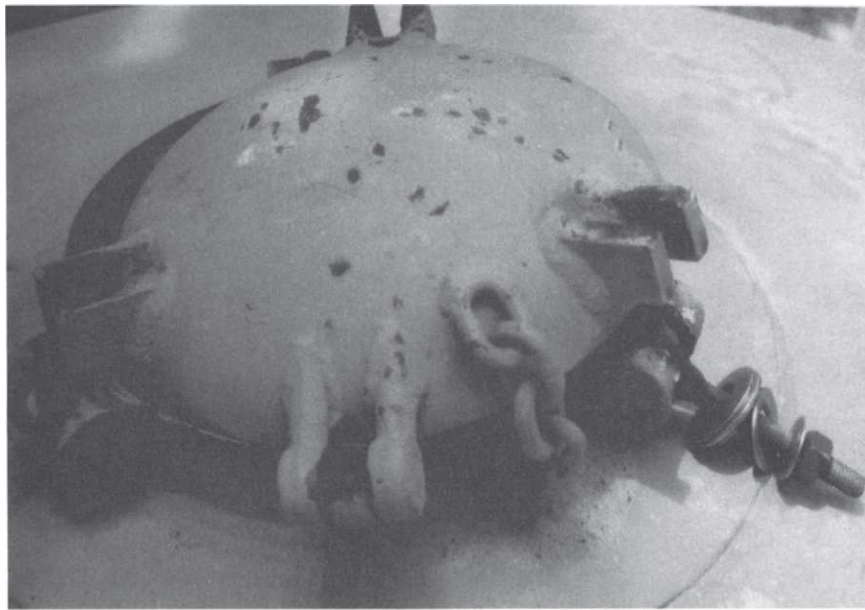
FIGURE 1-18 Instead of replacing the eyebolts, new studs were welded in place of the threaded portions. They were made brittle by the heat and failed in use. Fortunately, the chain prevented the lid from going into orbit.

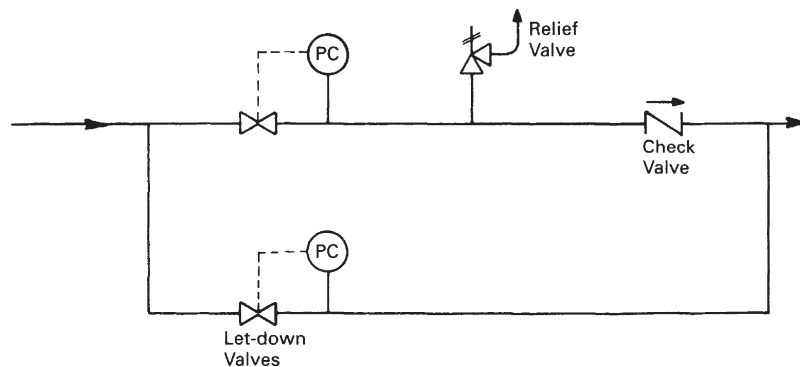
FIGURE 2-3 The second (*lower*) let-down valve was joined to the original line downstream of the check valve. When this let-down valve leaked, the downstream equipment was overpressured.

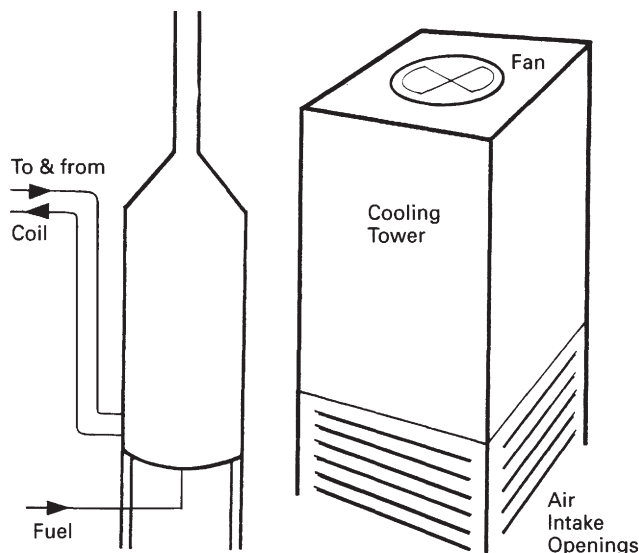
FIGURE 2-8 Gas entered the furnace when the cooling tower fan was switched off.

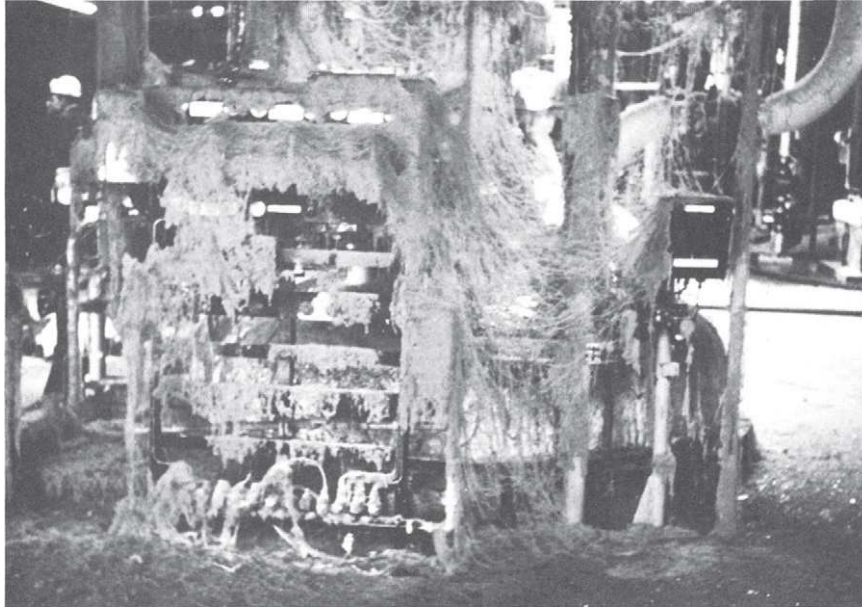
FIGURE 3-1b Because a rupture disc was fitted to the wrong side of a vacuum support, the flanges leaked, covering the reactor with “candy.”

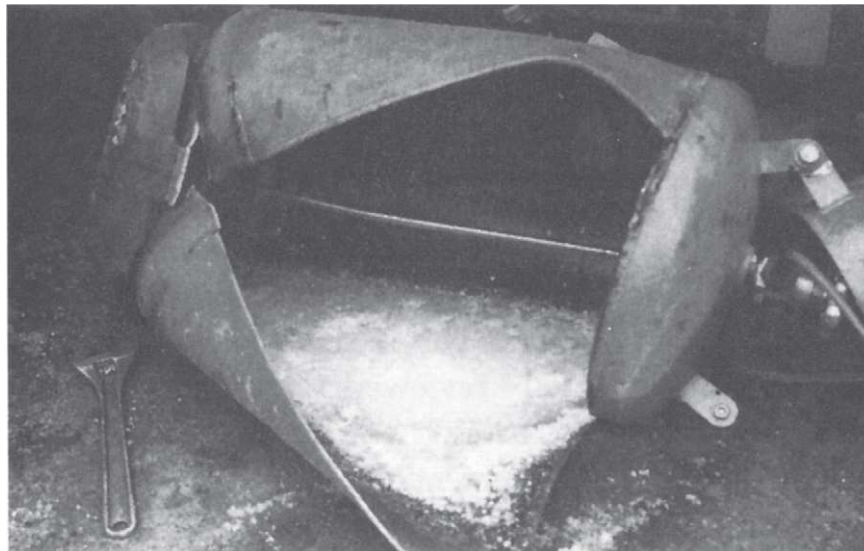
FIGURE 4-3 The result of pressurizing a cylinder to “two divisions” on a scale graduated in kg/cm^2 instead of psi. (Photo courtesy of the Institution of Chemical Engineers.)

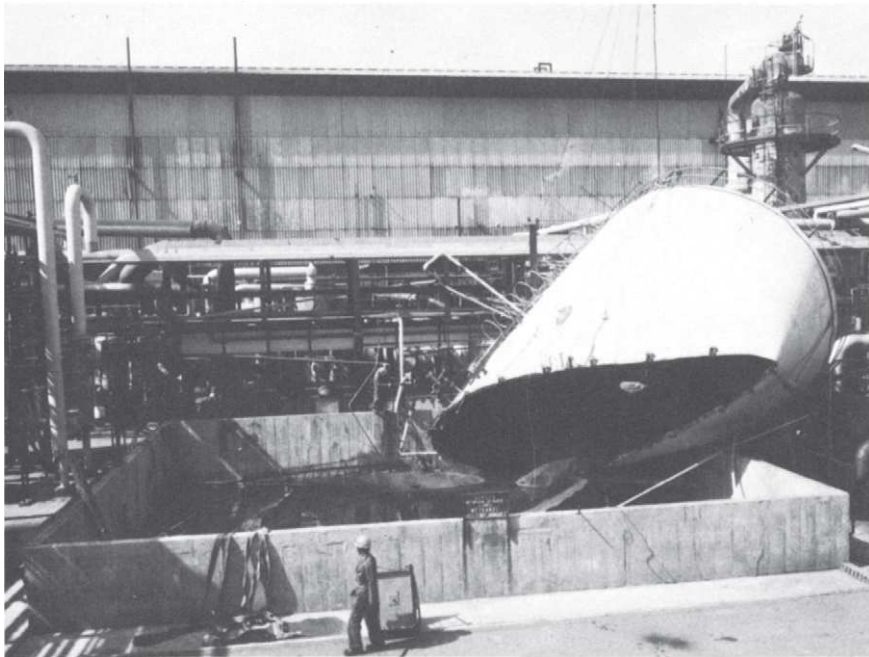
Tanks designed to fail at the roof/wall weld have failed at the base/wall weld because this weld was corroded or fatigued or because holding-down bolts were missing (Figure 5-1). Corrosion is most likely to occur in tanks containing a water layer or when spill absorbents have been placed

FIGURE 5-1 Corrosion and missing holding-down bolts caused this tank to fail at the base instead of the top.

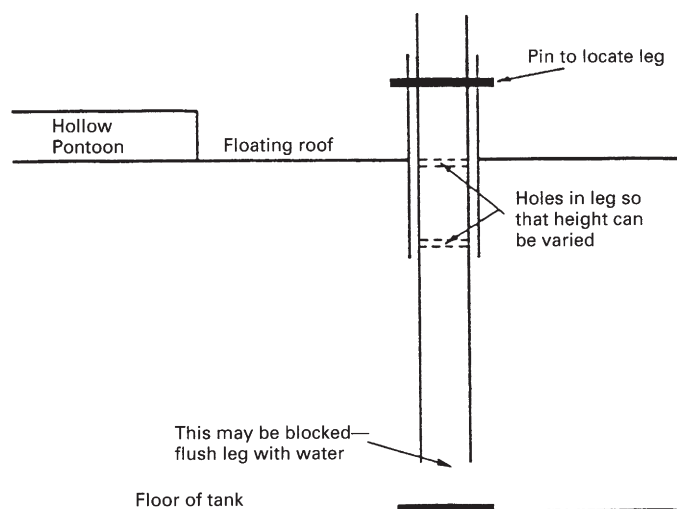
FIGURE 5-15 Oil trapped in the leg of a floating-roof tank caught fire during demolition.

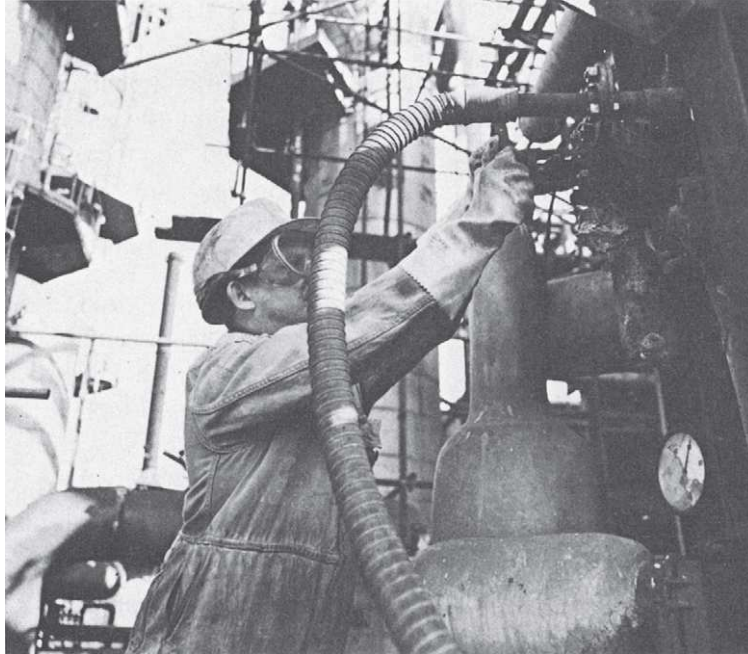
FIGURE 7-3 This hose burst, injuring the operator. It was the wrong type, was damaged, and was badly located.

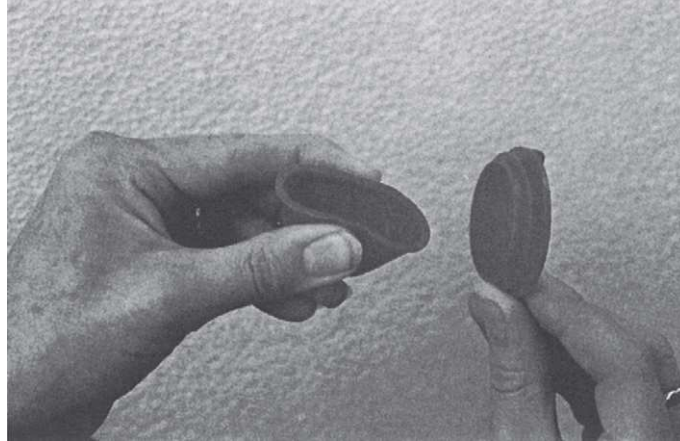
FIGURE 7-4 A soft plastic “top hat” plug (*left*) was fitted to the end of a railway carriage brake pipe to keep it clean. It was the same color as the end of the pipe and was not noticed and removed before the pipe was installed. The brakes failed, and the train overran. A more rigid plug with a larger lip (*right*) would have failed the brake test and would have been more visible. (*Photo courtesy of Roger Ford.*)

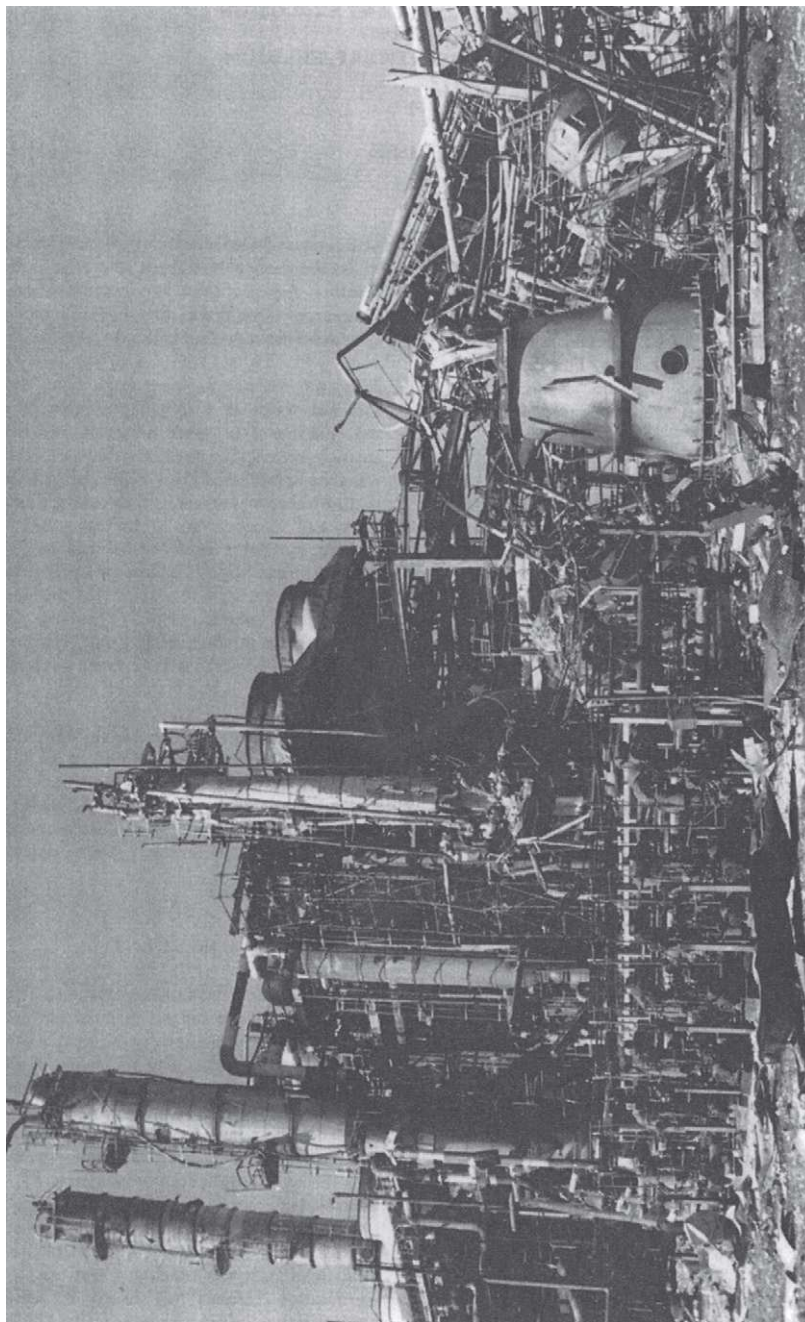
FIGURE 7-8 The ethylene oxide plant after the fire and explosion. (Photo courtesy of BP Chemicals Limited.)

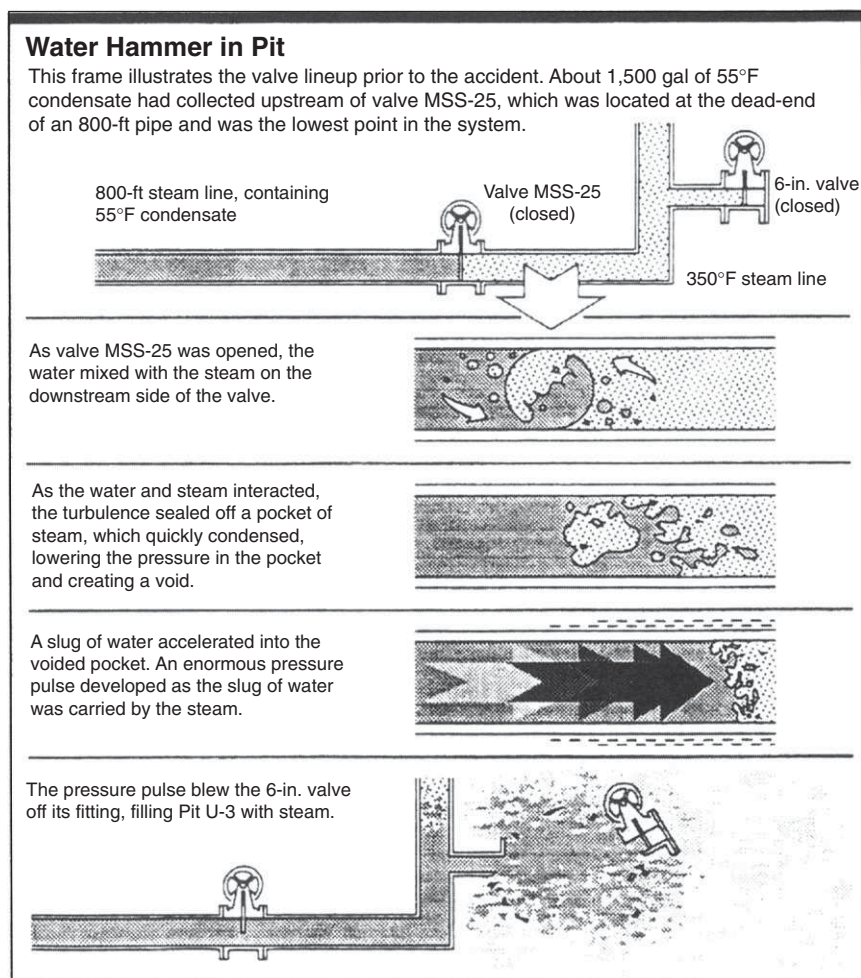
FIGURE 9-11 Condensate collected in a steam main. A valve was opened quickly. Sudden movement of the condensate fractured another valve. The figure explains how this occurred. (Reproduced by permission of the Office of Environment, Safety, and Health, U.S. Department of Energy.)

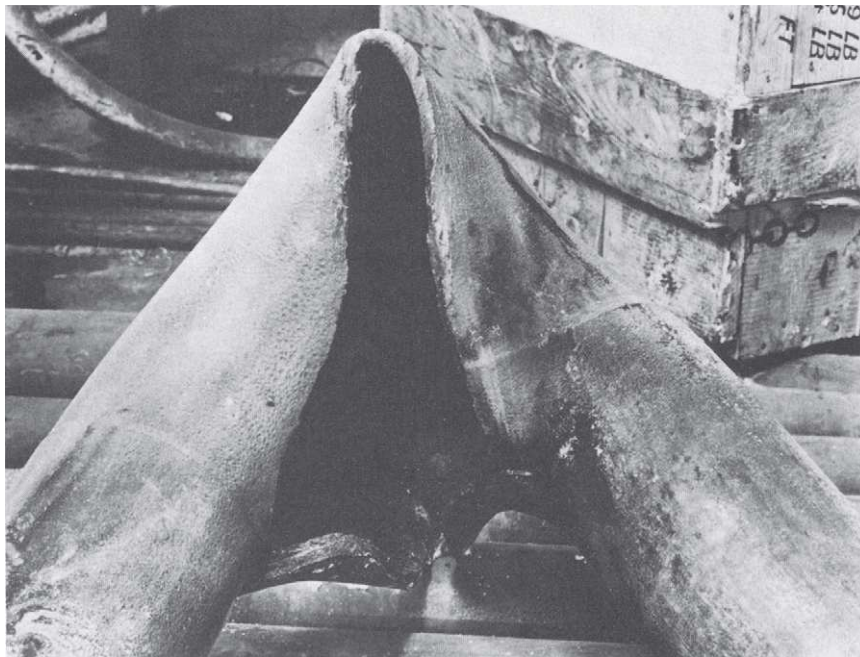
FIGURE 9-12 An old pipe was reused and failed by creep.

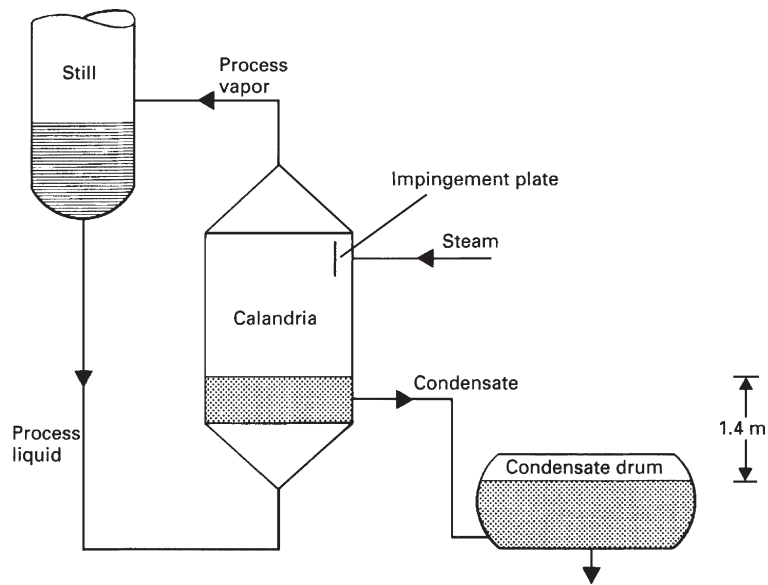
FIGURE 10-11 Condensate in the steam—the result of too few steam traps—knocked off the impingement plate and damaged the calandria tubes.

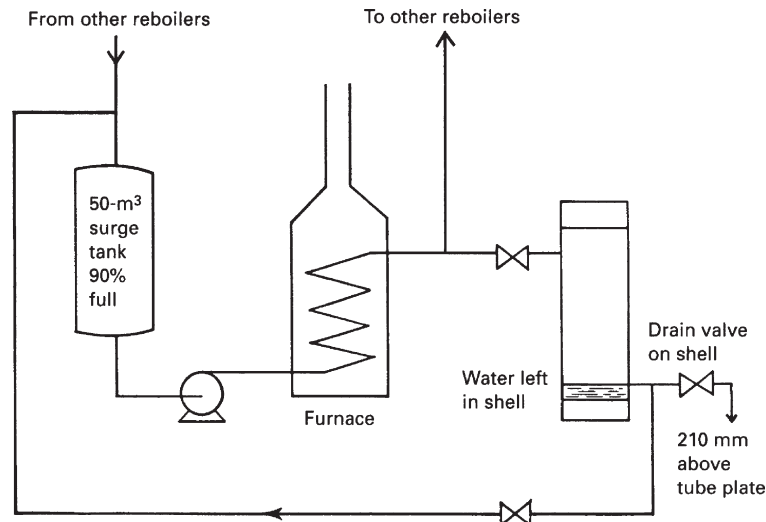
FIGURE 12-2 Water left in the heat exchanger was vaporized by hot oil.

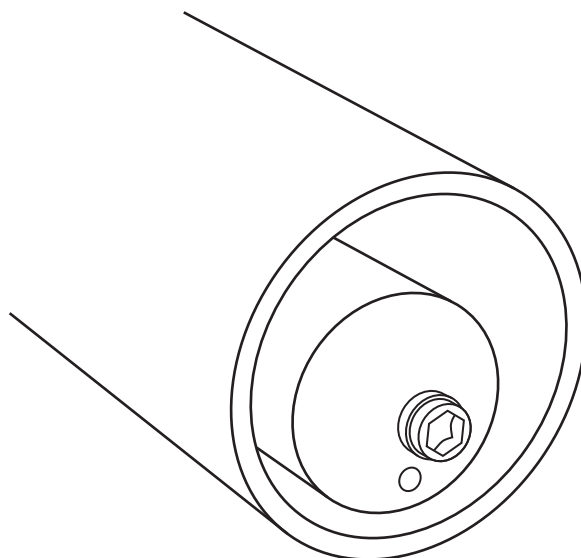
FIGURE 23-2 When a length of new pipe was cut open, a propane cylinder was found inside it. Fortunately, the cutting tool just missed it.

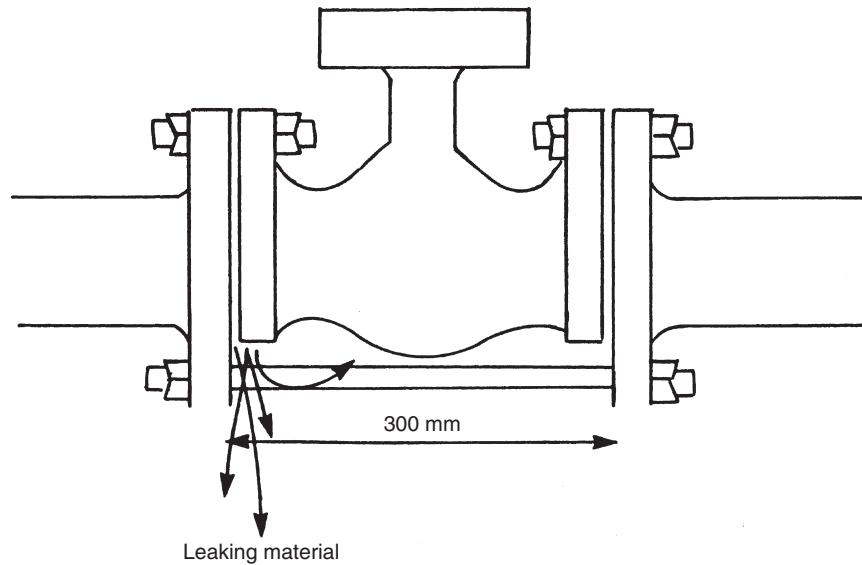
FIGURE 25-2 When this valve was insulated to save heat, the long bolts expanded and the flanges leaked.

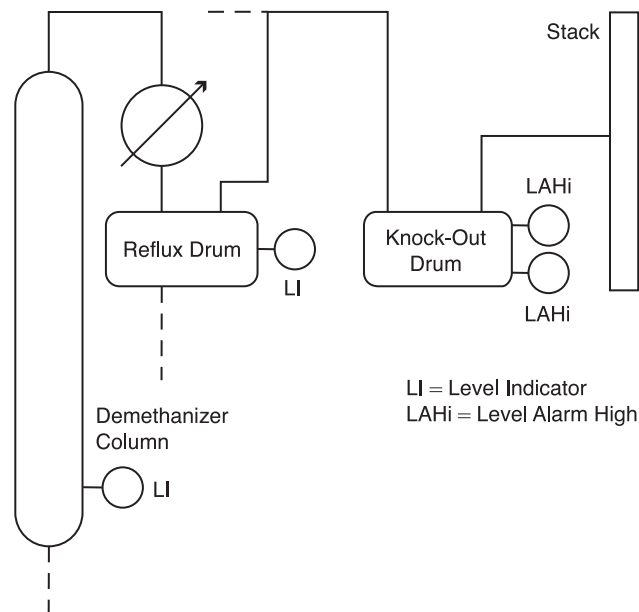
FIGURE 26-1 The level indicator on the column and the level alarms on the knock-out drum were out of order. The column filled with liquid, which overflowed into the drums and then into the stack.

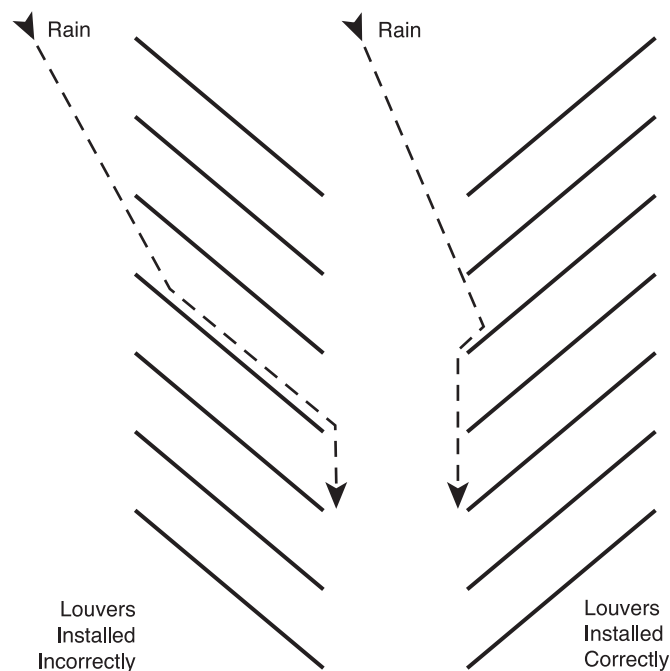
FIGURE 27-5 The louvers were installed so that they directed spray and rainwater through them.

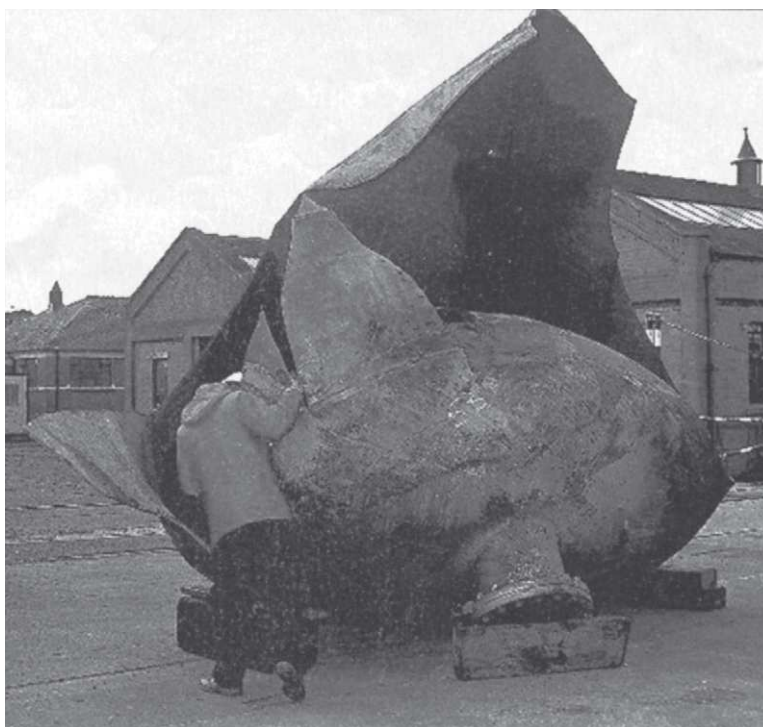
FIGURE 28-1 The result of an absorber failure. From reference 18. (Reprinted with the permission of Gulf Professional Publishing.)

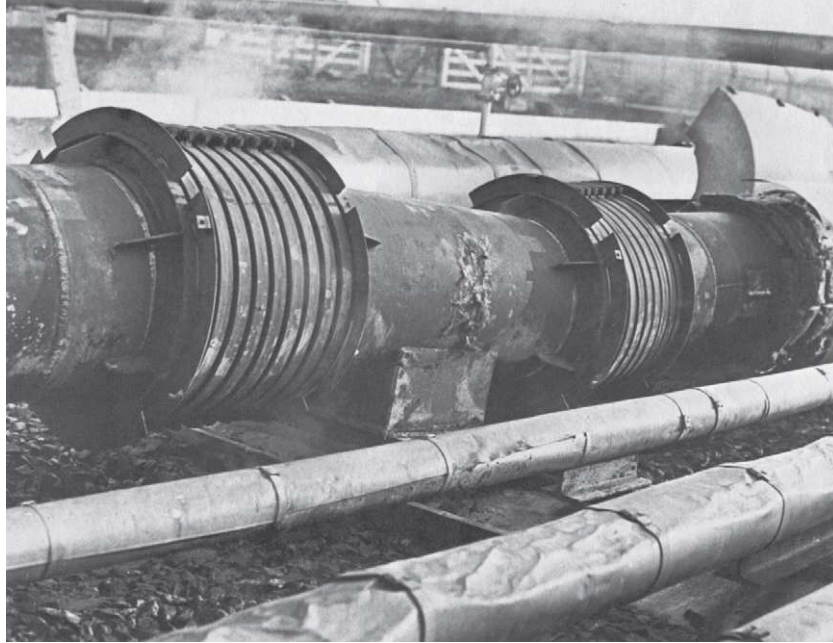
FIGURE 28-2 This low-pressure steam main was not scheduled for regular inspection and the damage was undetected for months, perhaps years.

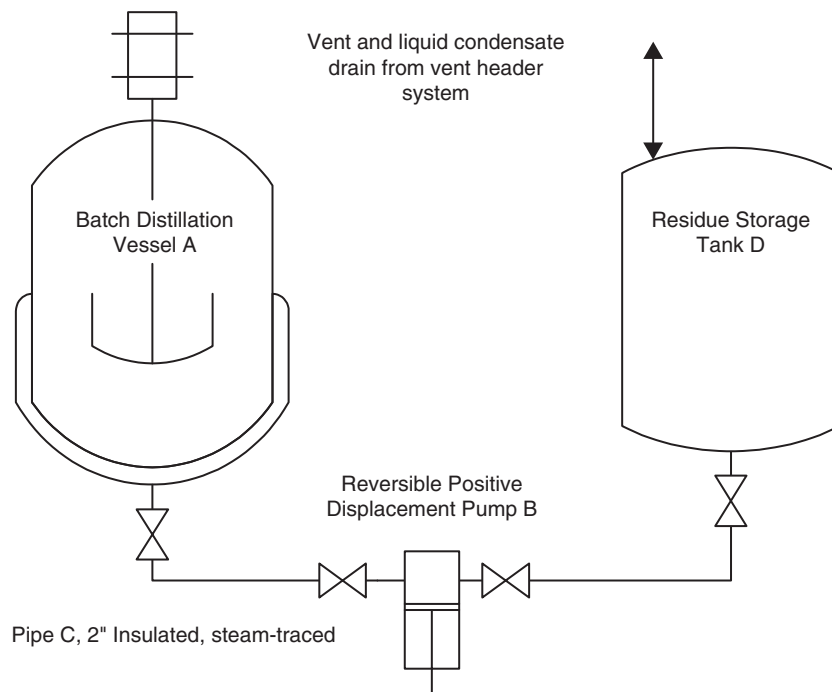
FIGURE 30-1 Some of the residue moved from D to A and left in pipe C decomposed and ruptured the pipe. From reference 9. (Reprinted with the permission of the American Institute of Chemical Engineers.)

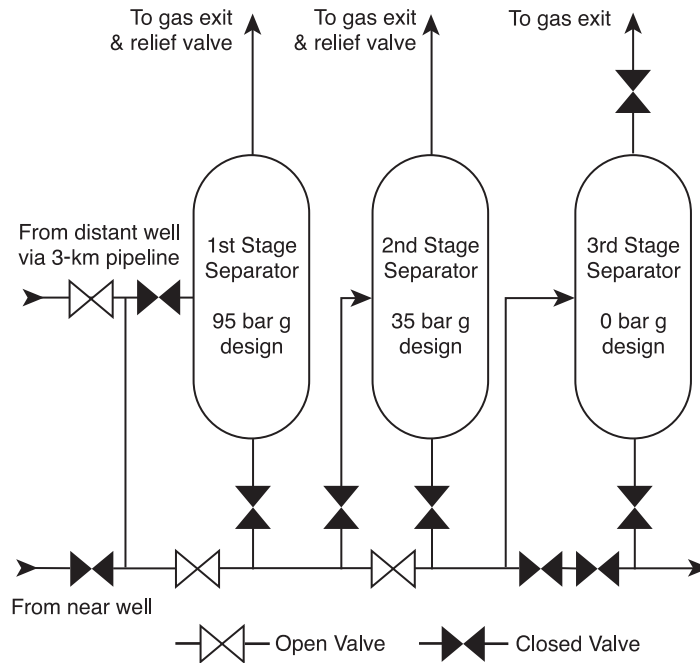
FIGURE 36-1 The third separator was overpressured and ruptured when its bypass valves were closed in error.
