Innovations in Bridge Engineering Technology

Edited by Khaled M. Mahmoud

Khaled M. Mahmoud
Bridge Technology Consulting
New York City, USA

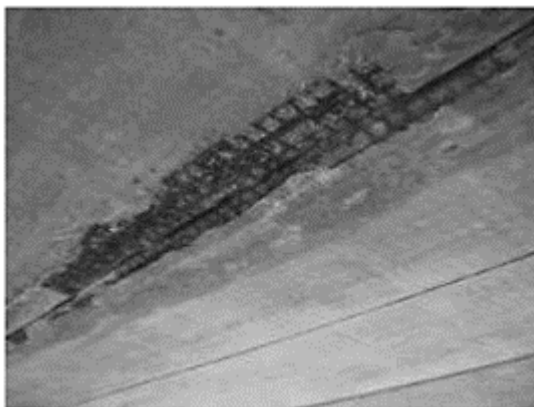
Figure 19. Cracks in slab.

Bridge slabs, on some location, had significant cracks and water leaked through (Fig 17 and 18). The most deteriorated parts of superstructure were those placed under expansion joints because of the failure of waterproofing property of rubber. Rubber parts were not replaced during their service life. It was concluded that prefabricated concrete bridges shown on Figures 2 to 9 are in rather good conditions after almost thirty years only local damages were recorded.

Damages showed in Figures 19–22 happened in only 25 to 30 years in service. Steel reinforcement corrosion were so severe that about 60 percent of reinforcement missed or has been broken, either in girders or in piers. Concrete covers were delaminated completely in some areas and they

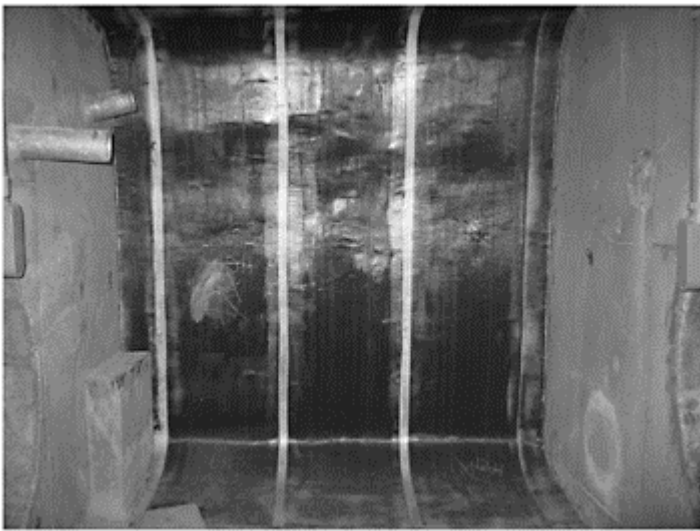
Figure 12. CFRP reinforcement of pier table web. Note 2-inch wide inspection strips between panels.

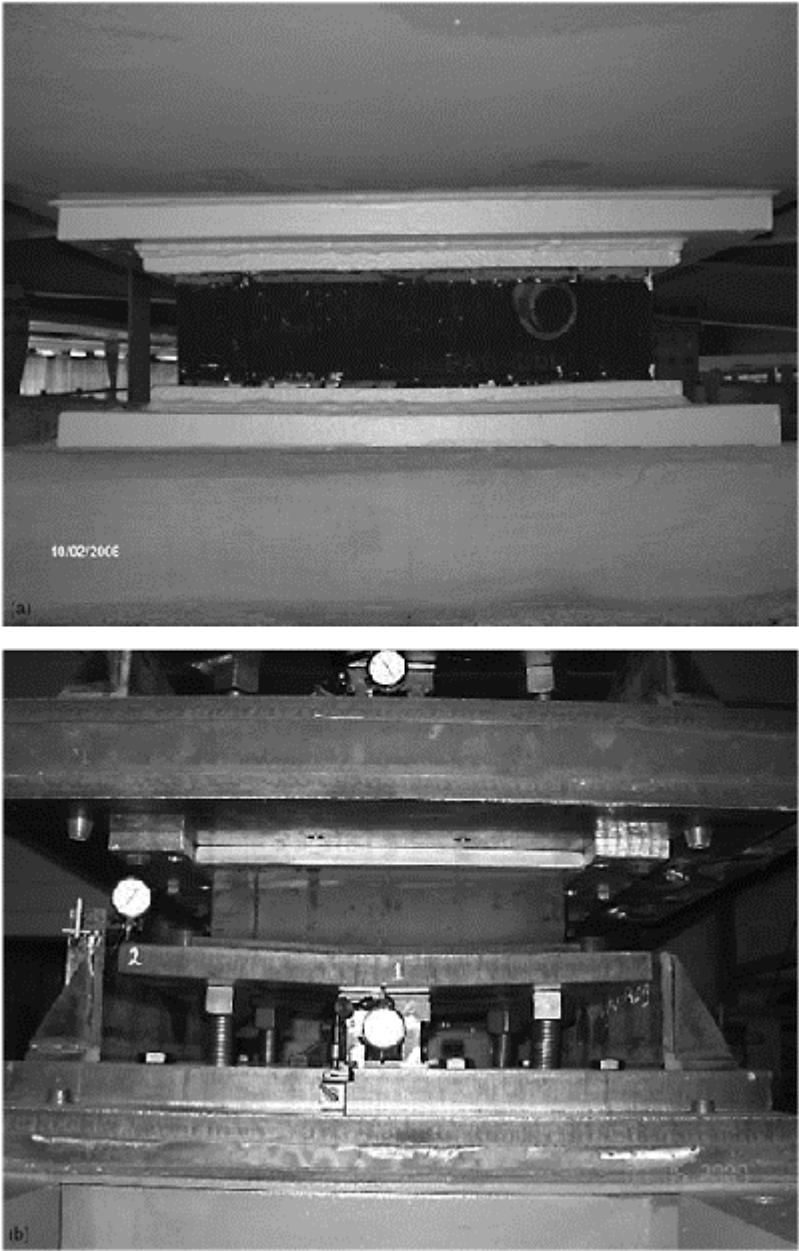
Figure 2. (a) Deformed isolators in the structure. (b) Deformed isolators in the structure.

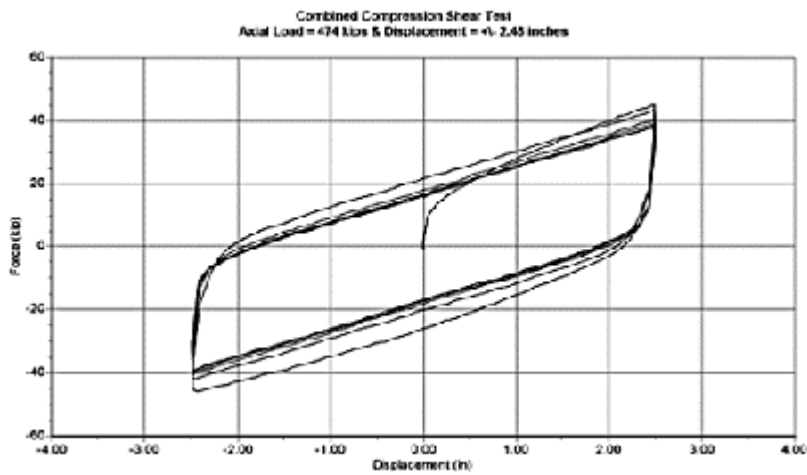
Figure 3. 5-cycle shear test prior to deformation of masonry plate (Test B).

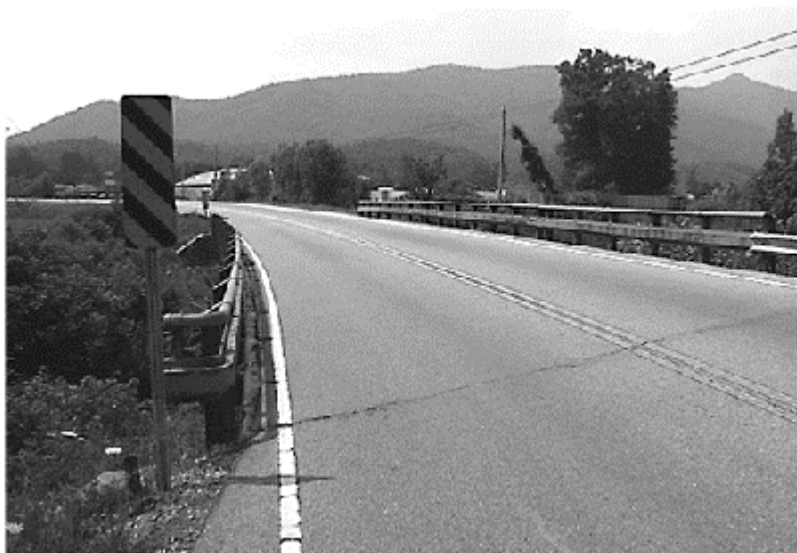
Figure 1. Above bridge before rehabilitation.

The first step of the project involved a field inspection to assess the bridge's condition so that a plan could be devised that would best meet TDOT's goals. The guardrails approaching the bridge were substandard as were the original barrier rails which also had areas of collision damage and missing sections. The original concrete deck had been overlaid with multiple layers of asphalt throughout the years. Prior to rehabilitation the total asphalt thickness on the bridge was 203 mm (8"), which made the riding surface near the top of the original curbs (Fig. 1).

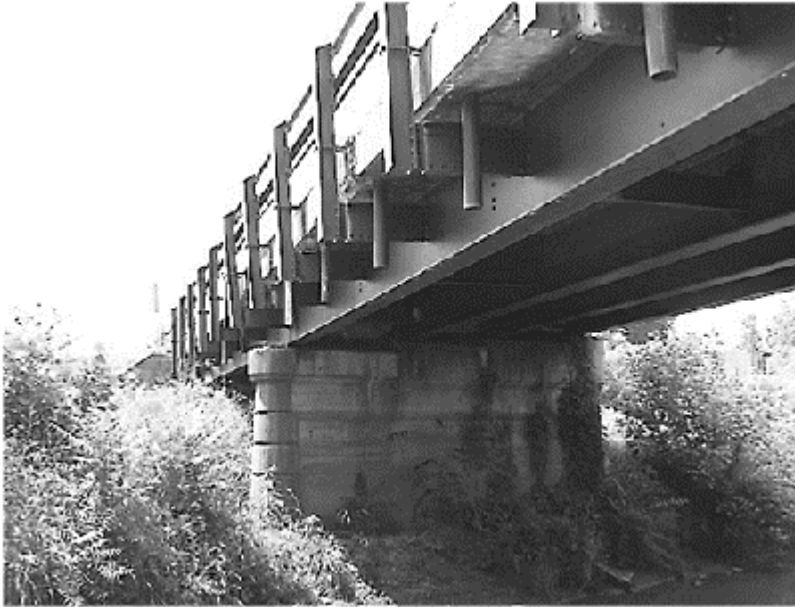
Figure 2. Below bridge before rehabilitation.

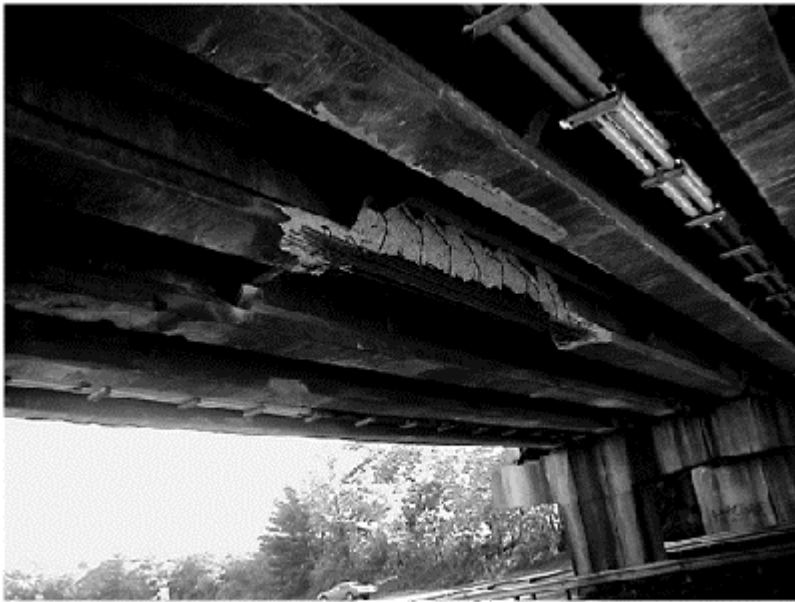
Figure 1. Exposed prestressing strands of damaged interior girder of Creek Road Bridge.

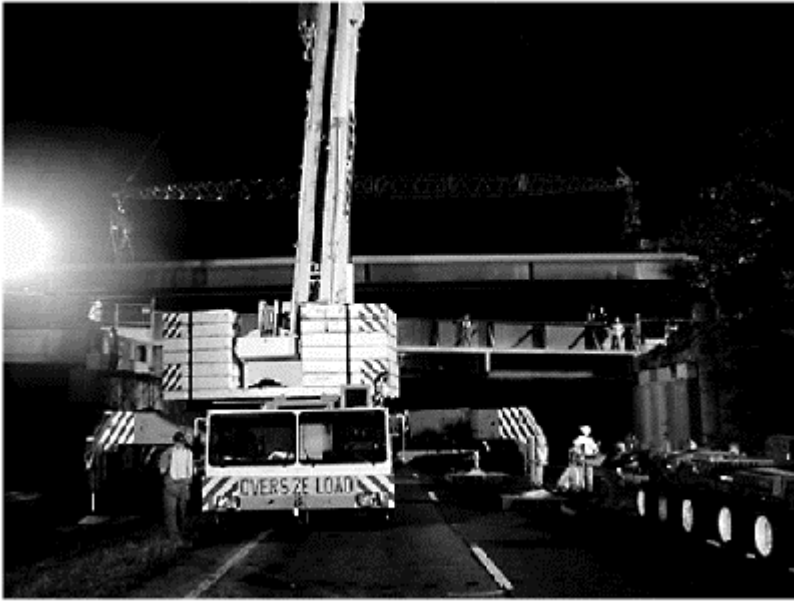
Figure 2. Night time erection of deck panels over I-295.

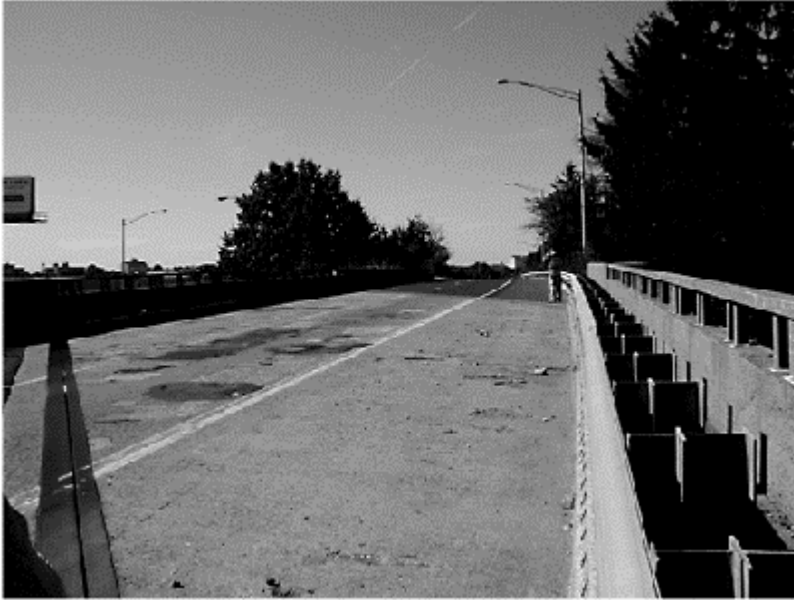
Figure 4. Deteriorated decks of the Route 1 Bridge over the Olden Avenue Connector.

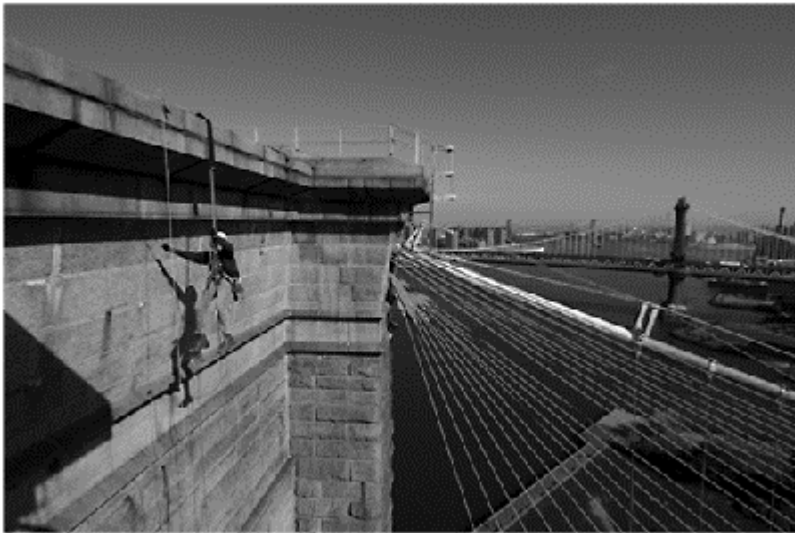
Figure 7. Inspector sounding mortar on Brooklyn Tower.

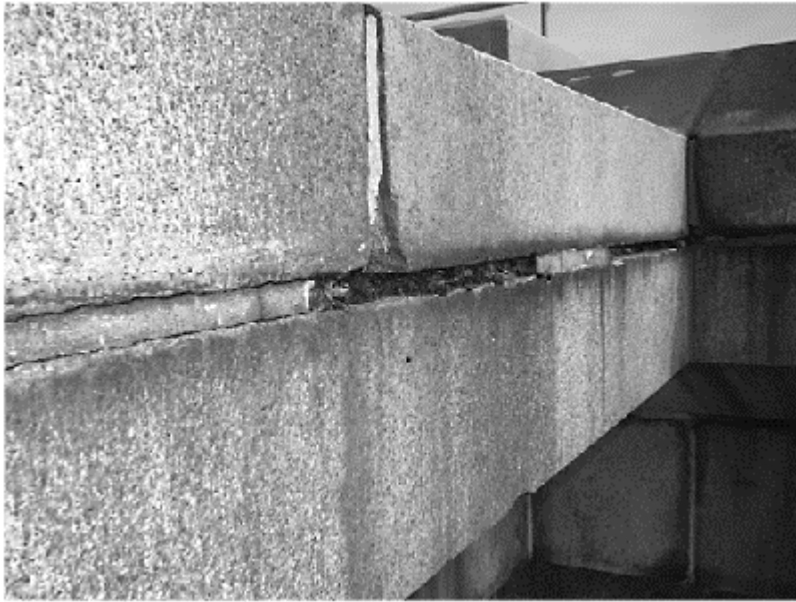
Figure 8. Mortar joint deterioration on Manhattan Tower.

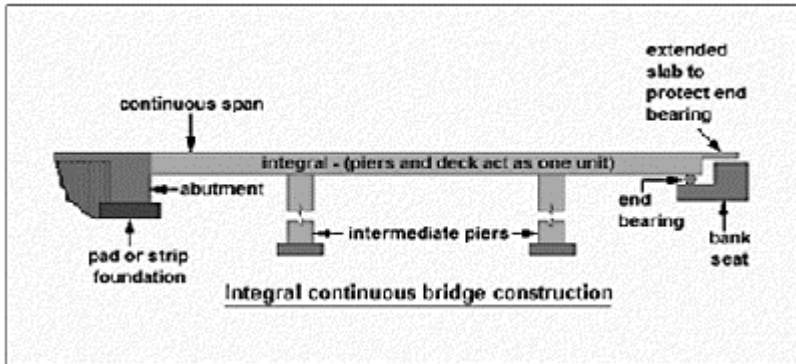
Figure 6. Integral flyover scheme.

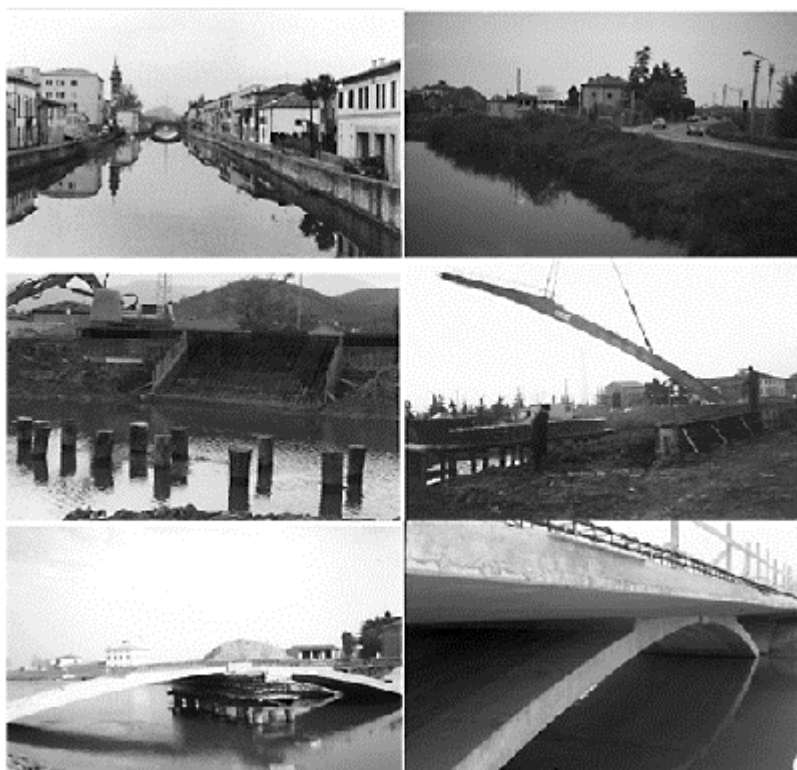
Figure 9. Building phases of the bridge.
