Village Handpump Technology: Research and Evaluation
in Asia, Publication IDRC-204e

edited by Donald Sharp and Michael Graham

Village Handpump Technology

Research and Evaluation in Asia

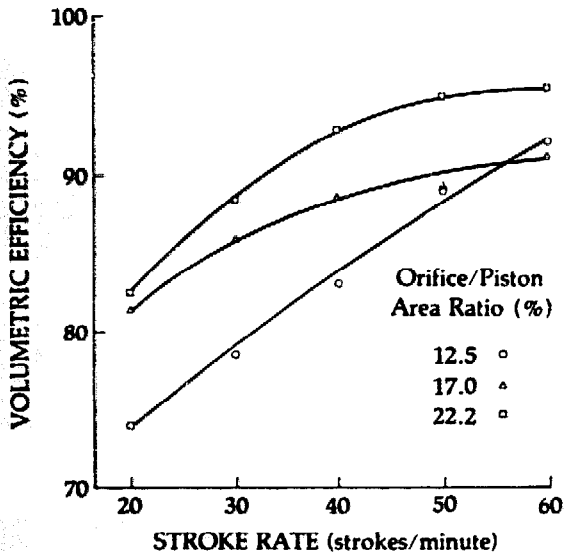
Fig. 3. Influence of orifice/piston area ratio on volumetric efficiency of Waterloo pumps having 6-inch (15-cm) stroke length. (Water head, 15 feet (4.57 m); piston diameter, 3 inches (7.5 cm); valve gap, 0.25 inch (0.6 cm).)

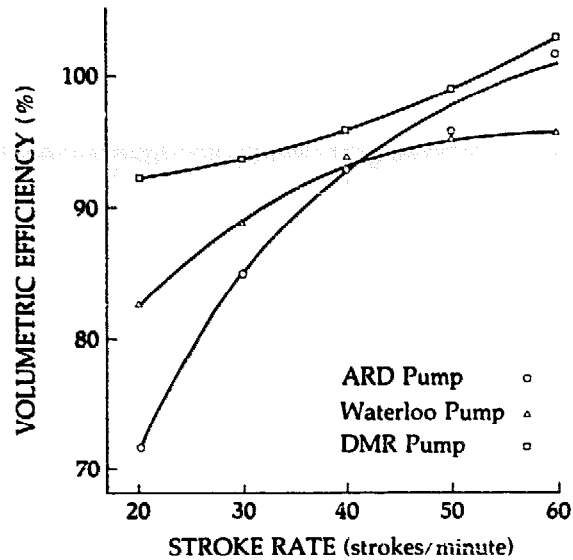
Fig. 4. Comparison of volumetric efficiencies for different pumps having 6-inch (15-cm) stroke length.

The performance of DMR and ARD handpumps under laboratory conditions was also plotted. At low speeds of piston movement, the volumetric efficiency of ARD handpumps was lower than that of DMR handpumps. At higher speeds of piston movement, however, the volumetric efficiency of ARD handpumps improved significantly. At very high piston speeds, the volumetric efficiency of the DMR handpumps exceeded 100%. This can be explained by the fact that, when the pump is operated at very high speed, extra water from the riser pipe is pumped up.

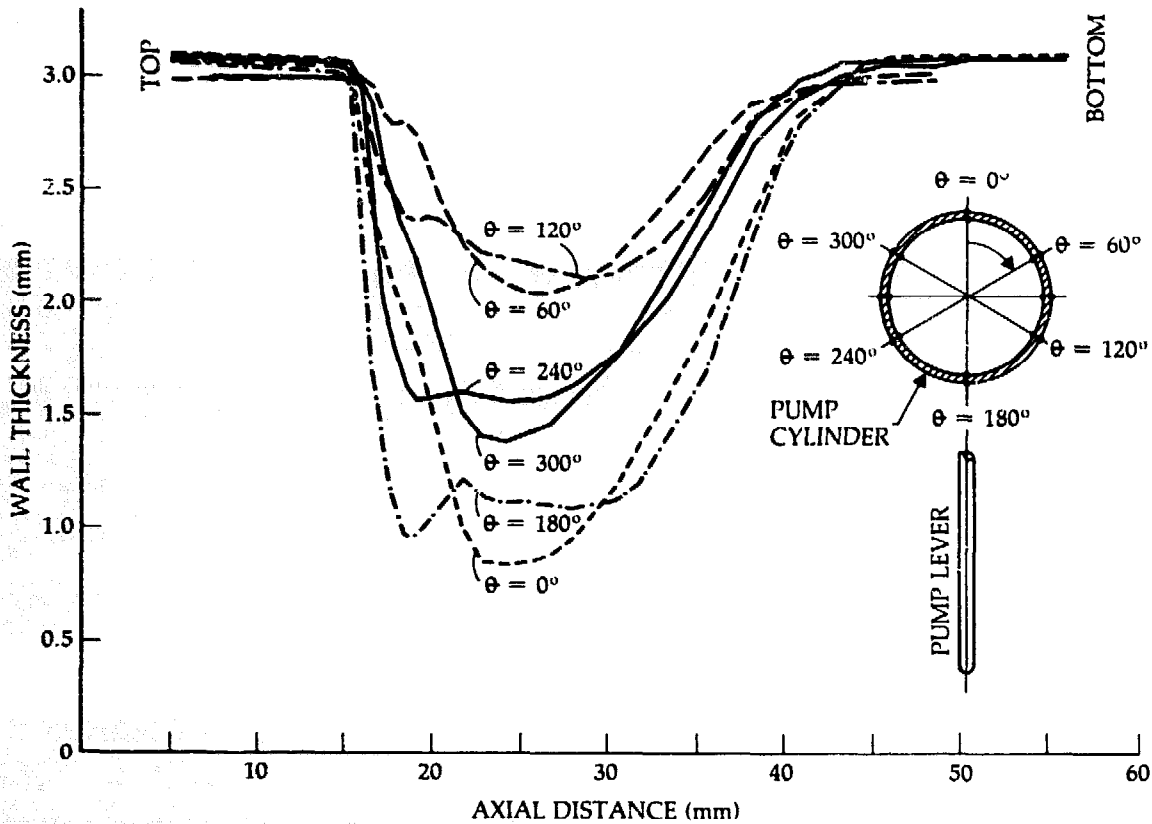
Fig. 11. Variation of wall thickness of pump cylinder with axial distance for pump NS 0105.
