Library of Congress Cataloging-in-Publication Data
Kletz, Trevor A.

What went wrong? : case histories of process plant disasters and how they could have been avoided / Trevor Kletz. —5th ed.

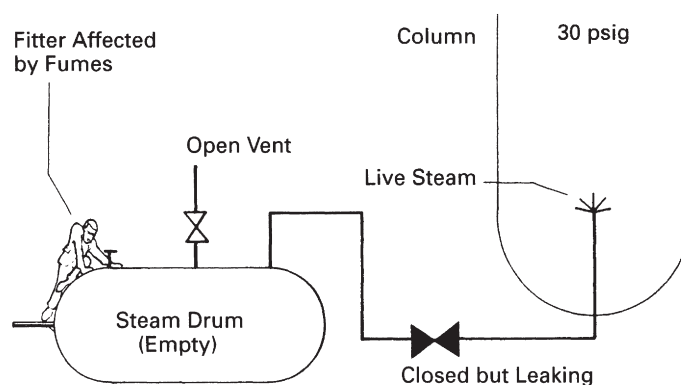
FIGURE 1-3 Contamination of a steam drum by process materials.

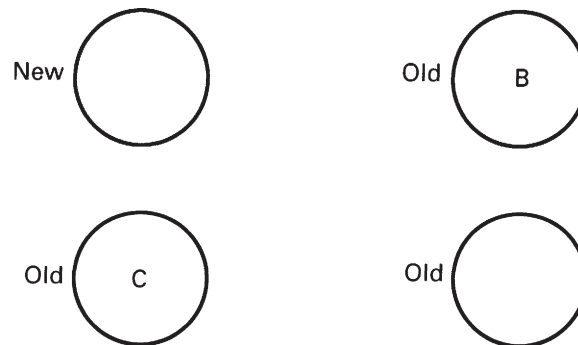
FIGURE 1-8 Which is crystallizer A?

- (b) There were four crystallizers in a plant, three old ones and one just installed. A man was asked to repair A. When he went onto the structure, he saw that two were labeled B and C but the other two were not labeled. He assumed that A was the old unlabeled crystallizer and started work on it. Actually, A was the new crystallizer. The original three were called B, C, and D. Crystallizer A was reserved for a possible future addition for which space was left (Figure 1-8).

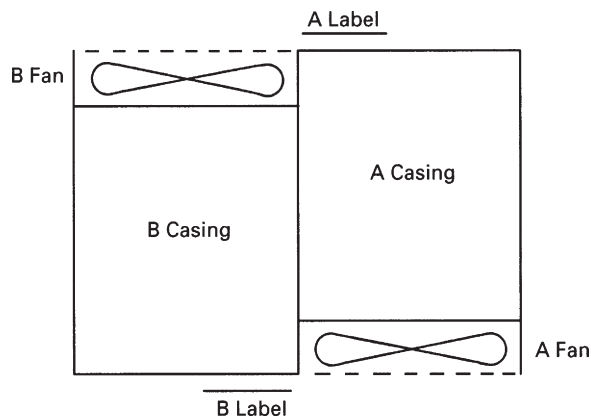
- (c) The labels on two air coolers were arranged as shown in Figure 1-9. The B label was on the side of the B cooler farthest away from the B fan and near the A fan. Not unreasonably, workers who were asked to overhaul the B fan assumed it was the one next to the B label and overhauled it. The power had not been isolated. But fortunately, the overhaul was nearly complete before someone started the fan.

FIGURE 1-9 Which is the A fan?

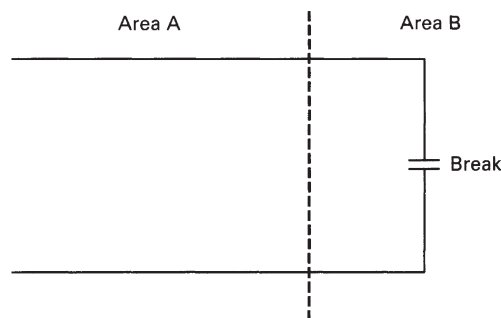
Suppose a pipeline belonging to area A passes through area B and that this pipeline has to be broken in area B (Figure 1-10).

FIGURE 1-10 Who should authorize the pipeline break?

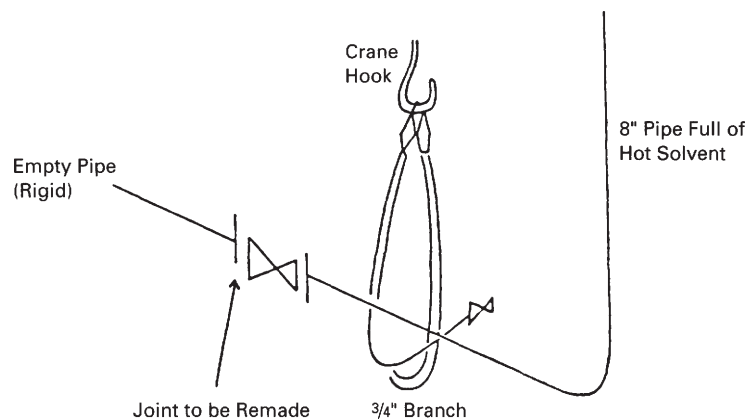
A joint on an 8-in. line containing a hot solvent had to be remade. The two sides were $\frac{3}{4}$ -in. out of line. There was a crane in the plant at the time, so it was decided to use it to lift one of the lines slightly. The lifting strap pulled against a $\frac{3}{4}$ -in. branch and broke it off (Figure 1-11).

FIGURE 1-11 A branch broke when a crane was used to move a live line.

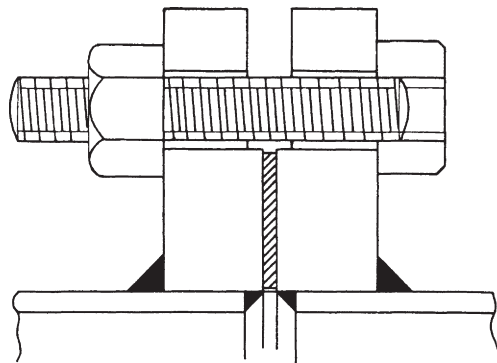
more protruded on one side than on the other. On some flanges, one of the nuts was secured by only two or three threads (Figure 1-12).

FIGURE 1-12 Nuts fitted incorrectly to studs.

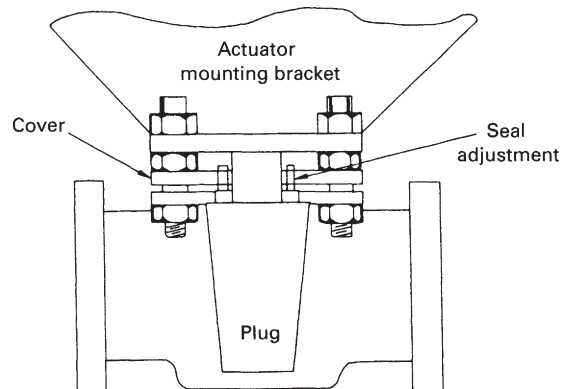
FIGURE 1-15 Another example of wrong nuts undone to remove the valve actuator.

- (a)** Several spillages have occurred from power-operated valves while the actuators were being removed because the bolts holding the valve bonnets in position were removed in error. Figures 1-14 and 1-15 show how two such incidents occurred. The second system is particularly vulnerable because in trying to unscrew the nuts that hold the actuator mounting bracket in place, the stud may unscrew out of the lower nuts. This incident could be classified as due to poor design [10].

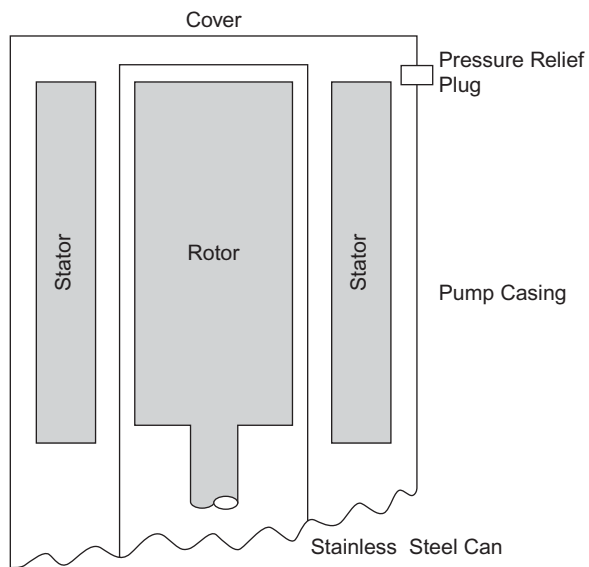
The fixed part of the electric motor—the stator—is not immersed in the process liquid and is separated from the rotor by a stainless steel can (Figure 1-17).

FIGURE 1-17 Canned pumps.

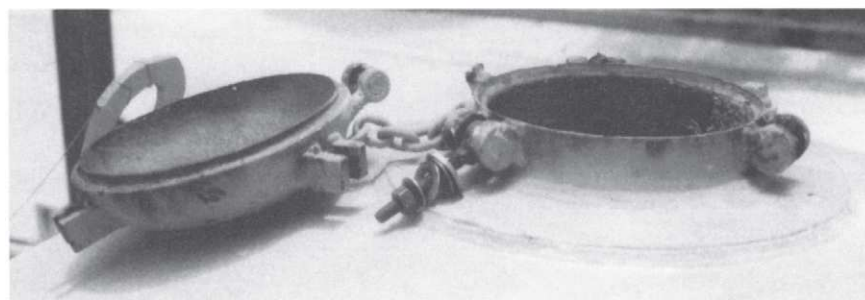
- (a) A pressure vessel was fitted with a quick-opening lid, with a 10-in. diameter, secured by four eyebolts (Figure 1-18). They had to be replaced, as the threads were corroded. Instead of replacing the whole eyebolt, a well-meaning person decided to save time by simply cutting the eyes off the bolts and welding new studs onto them. As soon as the vessel was pressurized (with compressed air), the new studs, which had been made brittle by the welding, failed, and the lid flew off. Fortunately, a short length of chain restrained it, and it did not

FIGURE 1-18 Instead of replacing the eyebolts, new studs were welded in place of the threaded portions. They were made brittle by the heat and failed in use. Fortunately, the chain prevented the lid from going into orbit.

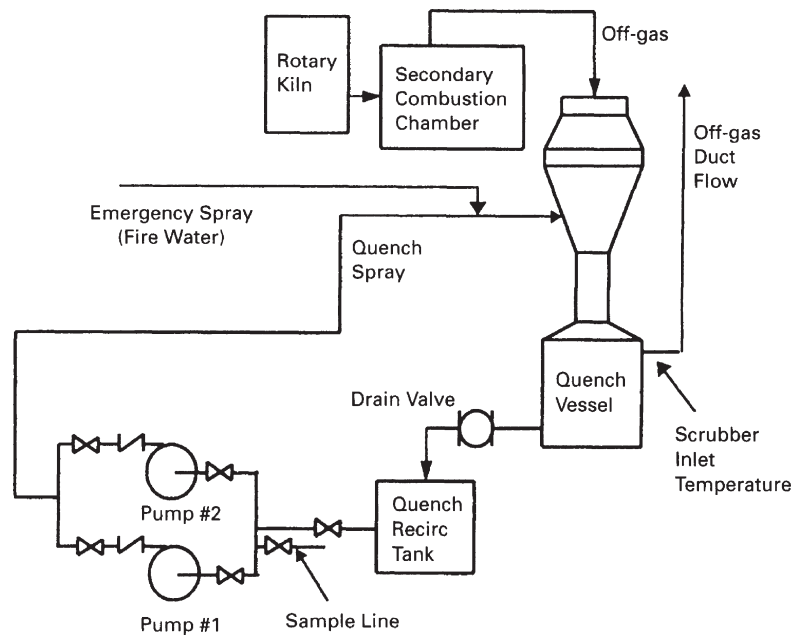
A sample point on the suction line of two water pumps became choked, and a maintenance worker was asked to clear it. He was not told how to do so—craftspeople dislike people from other departments telling them how to do their jobs—but the operators assumed he would use water under pressure or a rod. Instead he used compressed air at a gauge pressure of 115 psi (8 bar), and a pocket of air caused the pumps to lose suction (Figure 1-19).

The results were not serious. The pumps supplied water to cool the hot gases leaving an incinerator; when the water flow stopped, a high-temperature trip shut down the burner. The incinerator was new, it was still undergoing tests, and the job had not been done before. The water was recycled, and ash in it probably caused the choke [40].

FIGURE 1-19 Simplified drawing of incinerator quench recirculation system. (Illustration courtesy of the U.S. Department of Energy.)

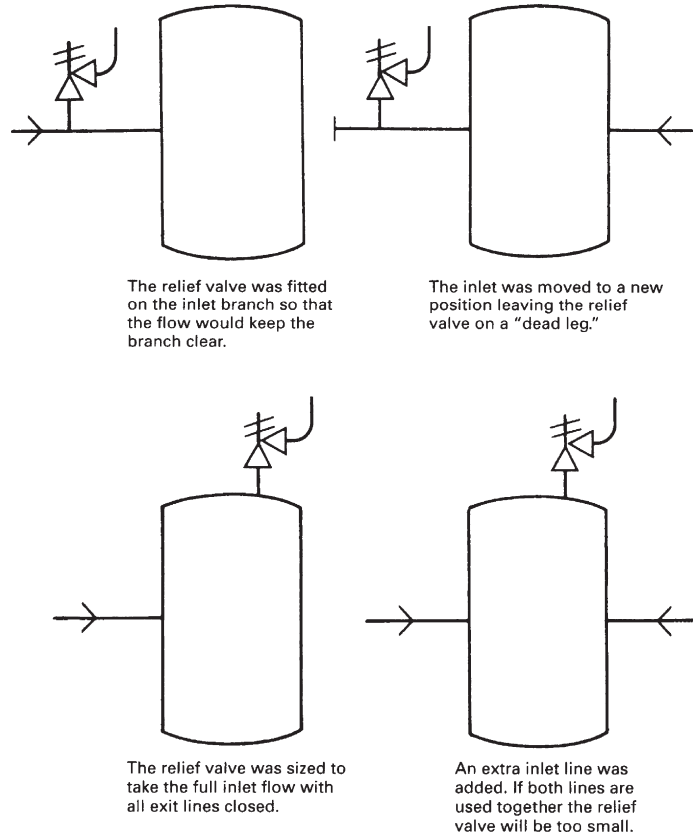
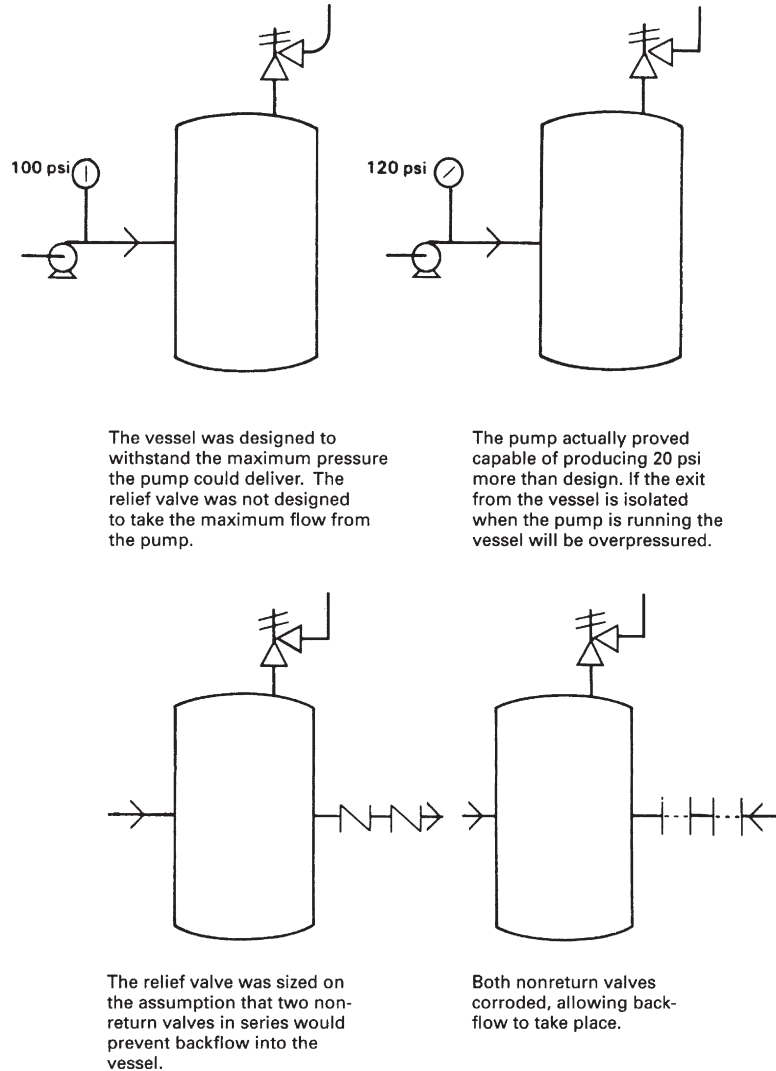
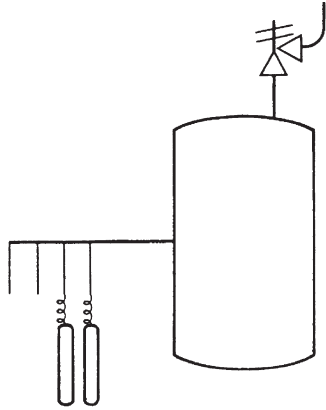
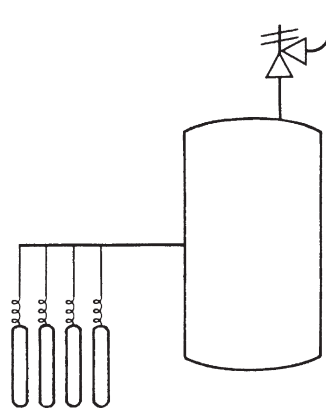
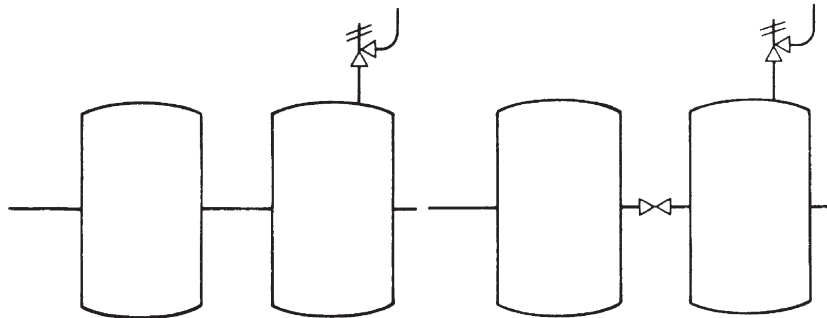
At one plant, a repeat relief and blowdown review was carried out one year after startup. The startup team had been well aware of the need to look for the consequences of modifications and had tried to do so as modifications were made. Nevertheless, the repeat relief and blowdown review brought to light 12 instances in which the assumptions of the original review were no longer true and additional or larger relief valves, or changes in the position of a relief valve, were necessary. Figure 2-1 shows some examples.

FIGURE 2-1 Some of the modifications made to the relief system in a plant during its first year on line.

The relief valve was sized on the assumption that only two gas cylinders would be used at a time, though connections were provided for four cylinders.

Inevitably, four cylinders were connected up and sometimes used.

A single relief valve was designed to protect two vessels, which were connected together by a line without any valve or other restriction between them.

An extra isolation valve was fitted between the two vessels, thus making it possible to isolate the first vessel from its relief valve.

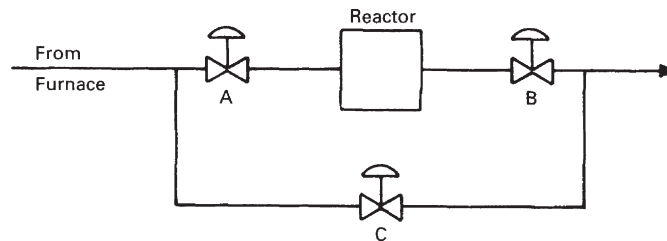
- (b) A reactor was fitted with a bypass (Figure 2-2a). The remotely operated valves A, B, and C were interlocked so that C had to be open before A or B could be closed. It was found that the valves leaked, so hand-operated isolation valves (a, b, and c) were installed in series with them (Figure 2-2b).

FIGURE 2-2a Original reactor bypass.

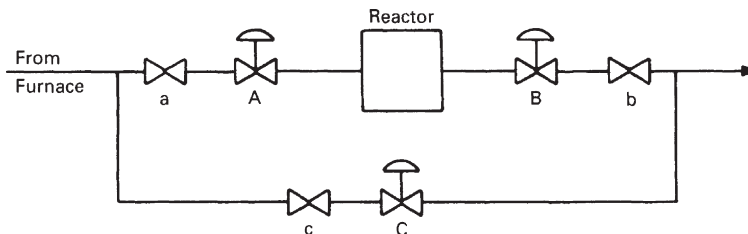
After closing A and B, the operators were instructed to go outside and close the corresponding hand valves a and b. This destroyed the interlocking. One day, an operator could not get A and B to close. He had forgotten to open C. He decided that A and B were faulty and closed a and b. Flow stopped. The tubes in the furnace were overheated. One of them burst, and the lives of the rest were shortened.

FIGURE 2-2b Modified reactor bypass.

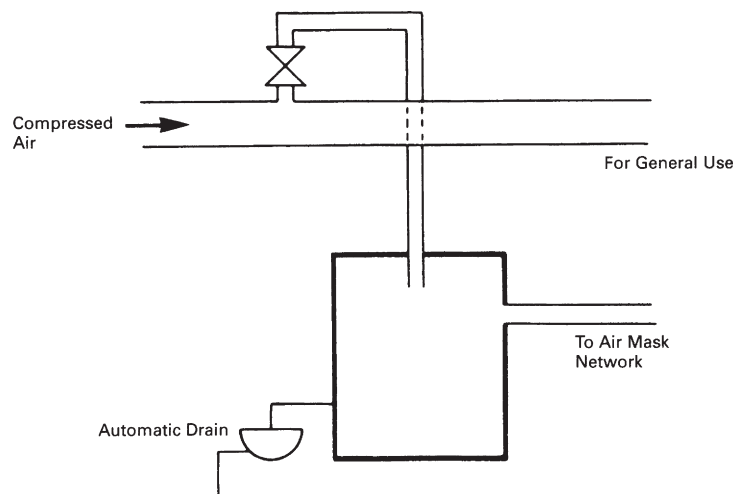
Many years ago, a special network of air lines was installed for use with air masks only. A special branch was taken off the top of the compressed air main as it entered the works (Figure 2-4).

FIGURE 2-4 Original arrangement of air lines.

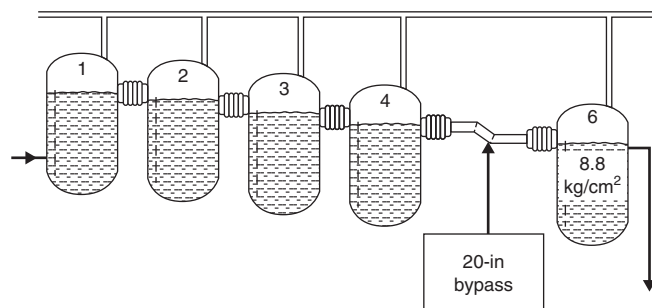
At the Flixborough plant, there were six reactors in series. Each reactor was slightly lower than the one before so that the liquid in them flowed by gravity from No. 1 down to No. 6 through short 28-in.-diameter connecting pipes (Figure 2-5). To allow for expansion, each 28-in. pipe contained a bellows (expansion joint).

One of the reactors developed a crack and had to be removed. (The crack was the result of a process modification; see Section 2.6b.) It was replaced by a temporary 20-in. pipe, which had two bends in it, to allow for the difference in height. The existing bellows were left in position at both ends of the temporary pipe (Figure 2-5).

The design of the pipe and support left much to be desired. The pipe was not properly supported; it merely rested on scaffolding. Because there was a bellows at each end, it was free to rotate or "squirm" and did so when the pressure rose a little above the normal level. This caused the bellows to fail.

FIGURE 2-5 Arrangement of reactors and temporary pipe at Flixborough.

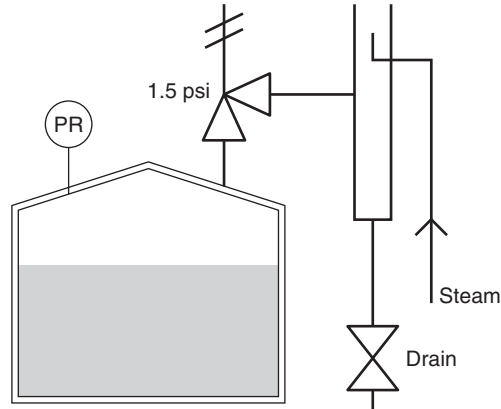
- (a) A low-pressure refrigerated ethylene tank was provided with a relief valve set at a gauge pressure of about 1.5 psi (0.1 bar), which discharged to a vent stack. After the design had been completed, it was realized that cold gas coming out of the stack would, when the wind speed was low, drift down to ground level, where it might be ignited. The stack was too low to be used as a flarestack—the radiation at ground level would be too high—and was not strong enough to be extended. What could be done?

FIGURE 2-6 Liquid ethylene tank venting arrangements.

Someone suggested putting steam up the stack to disperse the cold vapor. This seemed a good idea, and the suggestion was adopted (Figure 2-6).

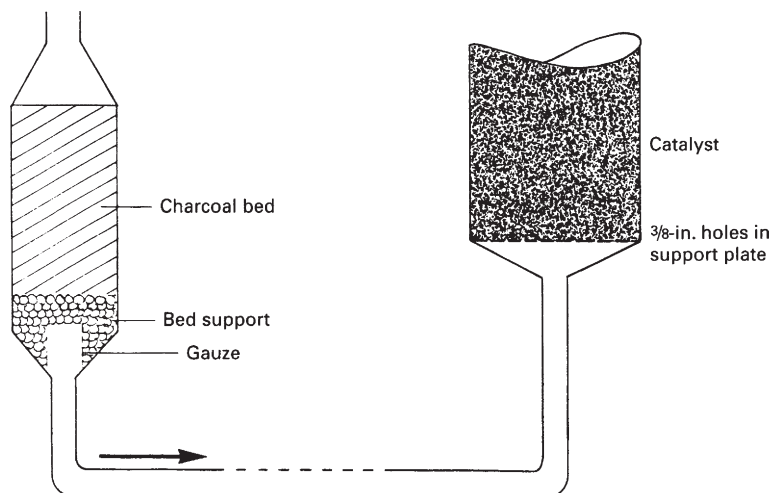
The hydrogen came from another plant and was passed through a charcoal filter to remove traces of oil before it left the supplying plant. Changes of charcoal were infrequent, and the initial stock lasted several years. Reordering resulted in a finer charcoal being supplied and charged without the significance of the change being recognized. Over a long period, the new charcoal passed through its support into the line to the other plant. Small amounts of the charcoal partially clogged the $\frac{3}{8}$ -in. (10 mm) distribution holes in the catalyst retaining plate (Figure 2-7). There was a big loss of production.

FIGURE 2-7 Hydrogen purification system.

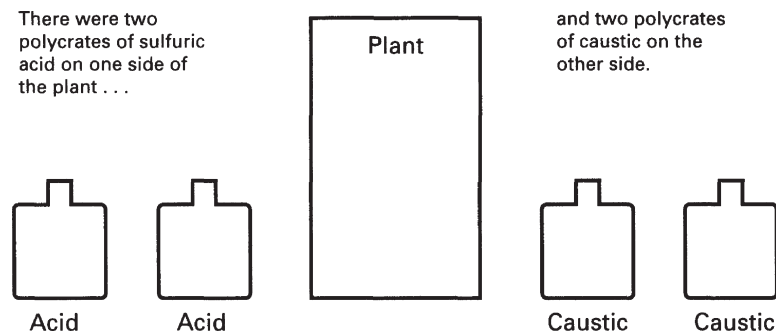
- (a) A plant used sulfuric acid and caustic soda in small quantities, so the two substances were supplied in similar plastic containers called polycrates (Figure 2-9). While an operator was on his day off, someone decided it would be more convenient to have a polycrate of acid and a polycrate of alkali on each side (Figure 2-10). When the operator

FIGURE 2-9 Original layout of acid and caustic containers.

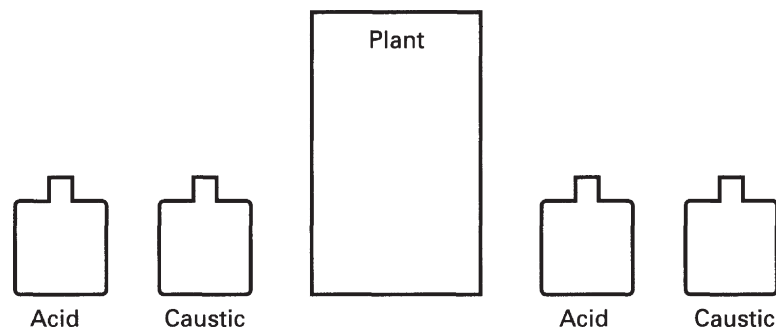
FIGURE 2-10 Modified layout of acid and caustic containers.

came back, no one told him about the change. Without checking the labels, he poured some excess acid into a caustic crate. There was a violent reaction, and the operator was sprayed in the face. Fortunately, he was wearing goggles.

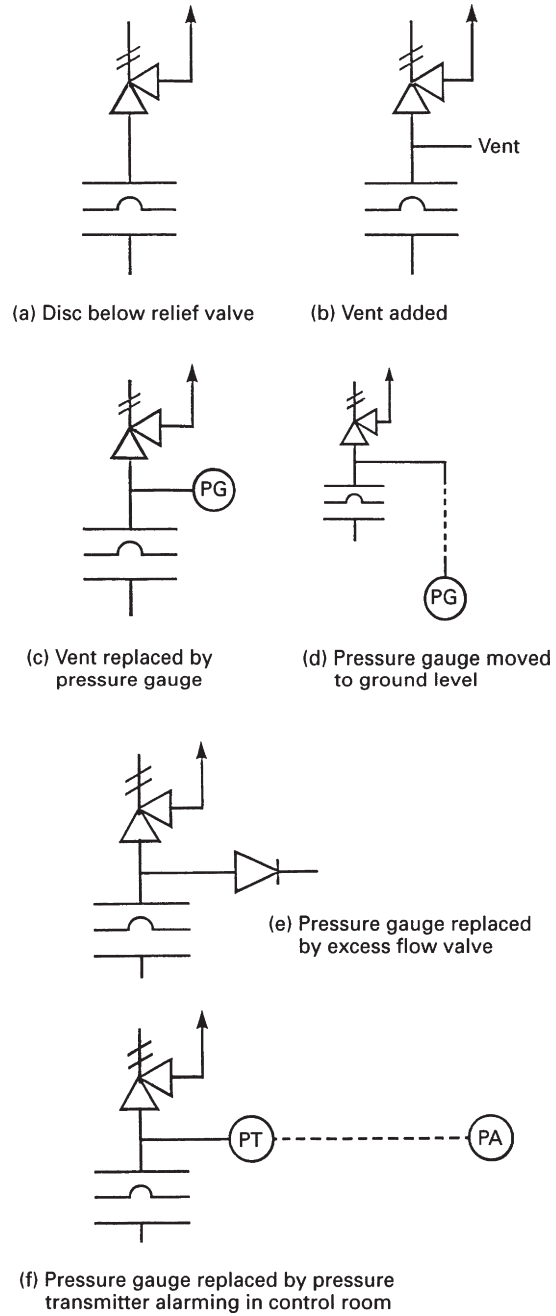
For example, small leaks through relief valves may cause pollution, so rupture discs were fitted below the relief valves (Figure 2-11a). (On other occasions they have been fitted to prevent corrosion of the relief valves.) We soon realized that if there is a pinhole in a rupture disc, the pressure in the space between the disc and the relief valve will rise until it is the same as the pressure below the disc. The disc will then not rupture until the pressure below it rises to about twice the design rupture pressure. Therefore, to prevent the interspace pressure rising, small vents to atmosphere were fitted between the discs and the relief valves (Figure 2-11b).

This is okay if the disc is there to prevent corrosion, but if the disc is intended to prevent pollution, it defeats the object of the disc. Pressure gauges were therefore fitted to the vents and the operators asked to read them every few hours (Figure 2-11c).

Many of the relief valves were on the tops of distillation columns and other high points, so the operators were reluctant to read the pressure gauges. They were therefore brought down to ground level and connected to the vents by long lengths of narrow pipe (Figure 2-11d).

These long lengths of pipe got broken or kinked or liquid collected in them. Sometimes operators disconnected them so the pressure always read zero. The gauges and long lengths of pipe were therefore replaced by excess flow valves, which vent small leaks from pinholes but close if the rupture disc ruptures (Figure 2-11e).

Unfortunately, the excess flow valves were fitted with female threads, and many operators are trained to screw plugs into any open female threads they see. So some of the excess flow valves became plugged.

FIGURE 2-11 A modification chain—rupture discs below relief valves.

Pressure transmitters, alarming in the control room, were therefore fitted in place of the excess flow valves (Figure 2-11f). This was an expensive solution. Perhaps it would have been better to remove the rupture discs and prevent leaks to the atmosphere by taking more care over the machining and lapping of the relief valves.

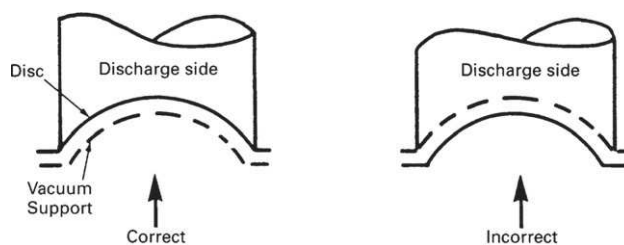
- (e) A runaway reaction occurred in a polymerization reactor. A rupture disc failed to burst. It had been fitted on the wrong side of the vacuum support, thus raising its bursting pressure from a gauge pressure of 150 psi (10 bar) to about 400 psi (27 bar) (Figures 3-1a and 3-1b).

The polymer escaped through some of the flanged joints, burying the reactor in a brown polymer that looked like molasses candy (treacle toffee). The reactor was fitted with class 150 flanges. If these are overpressured, the bolts will stretch, and the flanges will leak,

FIGURE 3-1a Arrangements of rupture disc and vacuum support.

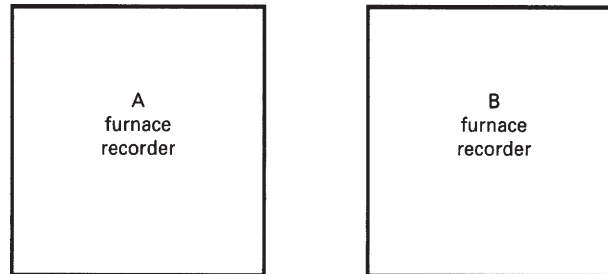
FIGURE 3-2 Layout of recorders on panel.

Two furnaces were each fitted with a temperature recorder controller and high-temperature trip. The two recorders were side by side on the instrument panel in the control room, with the recorder for A furnace on the left (Figure 3-2).

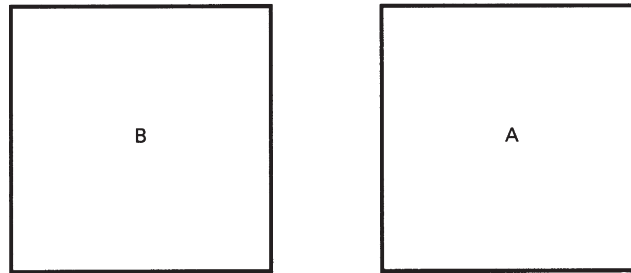
The mechanic, who had done the job many times before, took the cover off the back of B recorder, the one on the left behind the panel (Figure 3-3), and disconnected one of the leads. The effect was the same as if the recorder had registered a high temperature. The controller closed the fuel gas valve, shutting down the furnace and the rest of the plant.

FIGURE 3-3 Layout of recorders behind panel.

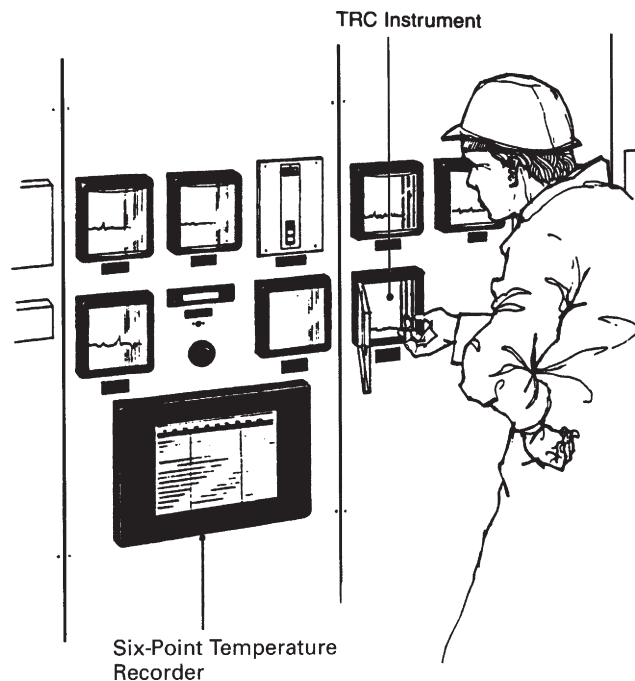
Unfortunately, there was a fault in the temperature recorder, and although the temperature actually rose, this was not indicated. The result was a runaway reaction. The rise in temperature was, however, indicated on a six-point temperature recorder at a lower level on the panel, but the operator did not notice this (Figure 3-4).

An interesting feature of this incident was that no one blamed the operator. The plant manager said he would probably have made the same mistake because the check instrument was at a low level (about 1 m above the floor) and because a change in one temperature on a six-point recorder in that position is not obvious unless you are actually looking for it. It is not the sort of thing you notice out of the corner of your eye.

FIGURE 3-4 Instruments below eye level may not be noticed.

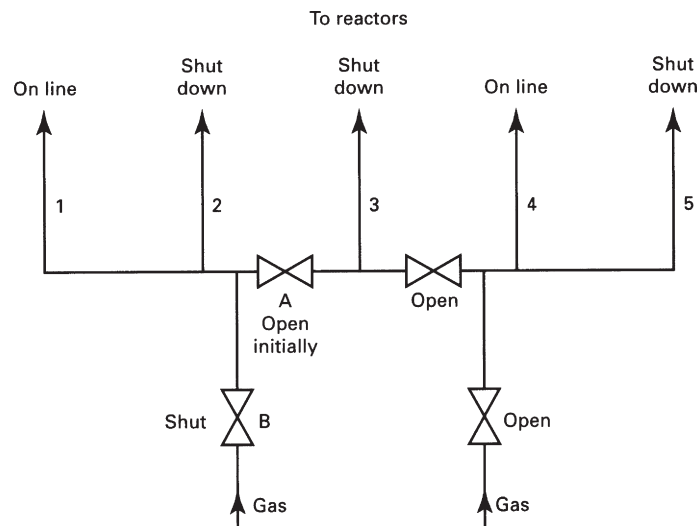
(a) Figure 3-5 shows part of a plant in which five reactors were in parallel. There were two gas-feed lines with cross connections between them. Oxygen was also fed to the reactors, but the oxygen lines are not shown. At the time of the incident, only two reactors, Nos. 1 and 4, were on line.

FIGURE 3-5 Accidental closing of a valve can cause an explosion.

We would never knowingly tolerate a situation in which accidental operation of a valve resulted in the overpressuring of a vessel. We would install a relief valve. In the same way, accidental operation of a valve should not be allowed to result in explosion or runaway reaction.

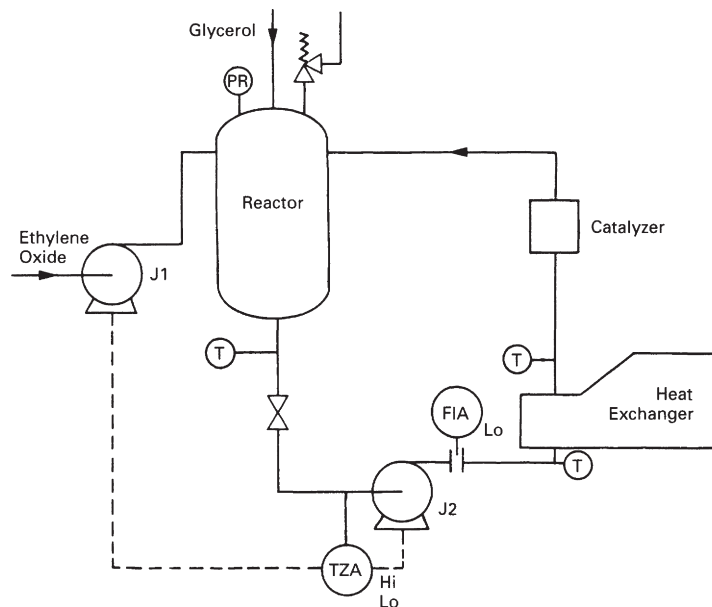
Figure 3-6 shows a batch reaction system. A batch of glycerol was placed in the reactor and circulated through a heat exchanger, which could act as both a heater and a cooler. Initially it was used as a heater, and when the temperature reached 115°C, ethylene oxide was added. The reaction was exothermic, and the exchanger was now used as a cooler.

FIGURE 3-6 Arrangements of reactor circulating system.

Despite these precautions, an explosion occurred. One day, when the ethylene oxide addition was started, the pressure in the reactor rose. This showed that the ethylene oxide was not reacting. The operator decided that perhaps the temperature point was reading low or perhaps a bit more heat was required to start the reaction, so he adjusted the trip setting and allowed the indicated temperature to rise to 200°C (390°F). Still the pressure did not fall.

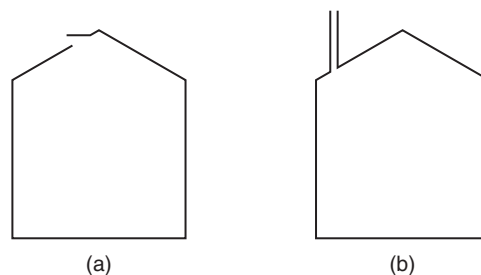
This overflow device should be fitted to the roof near the wall. If it is fitted near the center of the roof, the height of liquid above the top of the walls may exceed 8 in., and the tank may be overpressured (see Figure 5-2a).

Similarly, if the vent is designed to pass liquid, it should be fitted near the edge of the roof, and its top should not be more than 8 in. above the tops of the walls. Vessels have been overpressured because their vent pipes were too long (see Figure 5-2b). Tanks in which hydrogen may be evolved should be fitted with a vent at the highest point as well as an overflow (see Section 16.2).

FIGURE 5-2 A tank may be overpressured if the vent or overflow is more than 8 in. above the tops of the walls.

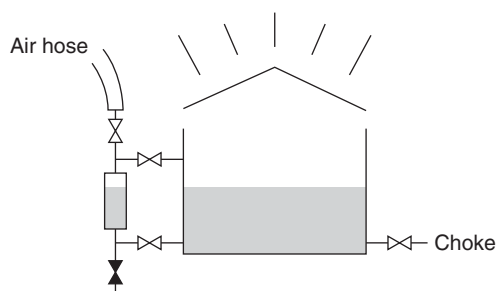
- (a)** There was a choke on the exit line from a small tank. To try to clear the choke, the operator held a compressed air hose against the open end at the top of the level glass. The gauge pressure of the compressed air was 100 psi (7 bar), and the top of the tank was blown off (Figure 5-3).

FIGURE 5-3 Tank top blown off by compressed air.

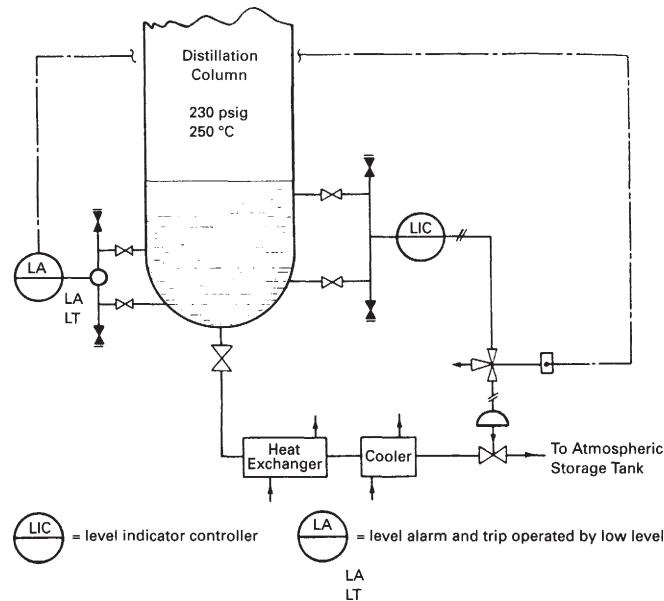
- (c)** On other occasions, tanks have been ruptured because the failure of a level controller (e.g., on a high-pressure distillation column) allowed a gas stream to enter the tank via the bottoms transfer line (Figure 5-4). Pressure vessels have also been ruptured in this way (see Section 9.2.2d). The precautions necessary to prevent this from occurring are analyzed in detail in reference 1.

FIGURE 5-4 How failure of a level controller can overpressure a tank.

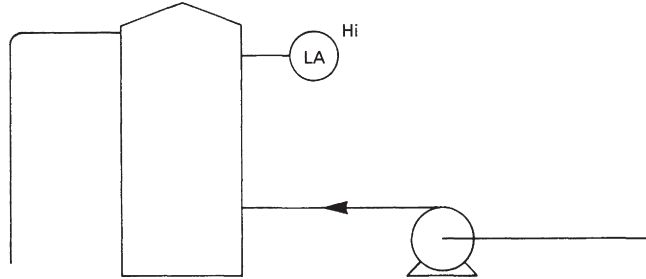
- (j)** Before emptying a tank truck, the driver propped the manhole lid open. It fell shut.
- (k)** A tank was fitted with an overflow, which came down to ground level. There was no other vent. When the tank was overfilled, the contents siphoned out (Figure 5-5). The tank should have been fitted with a vent on its roof, as well as the liquid overflow.

FIGURE 5-5 Overflow to ground level can cause a tank to collapse if there is no other vent.

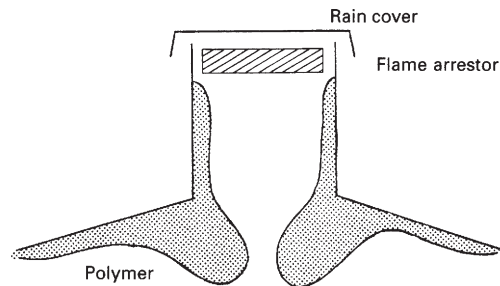
- (l)** A vent was almost blocked by polymer (Figure 5-6). The liquid in the tank was inhibited to prevent polymerization, but the vapor that condensed on the roof was not inhibited. The vent was inspected regularly, but the polymer was not noticed. Now a wooden rod is pushed through the vent to prove it is clear. (The other end of the rod should be enlarged so it cannot fall into the tank.)

FIGURE 5-6 Vent almost blocked by polymer.

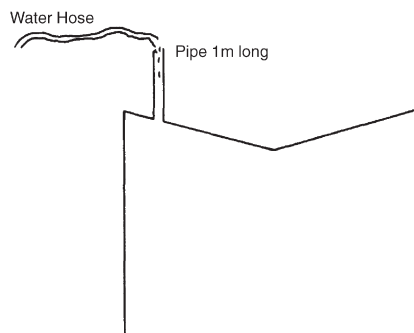
The need for such training is shown by the action taken following one of the incidents. Only the roof had been sucked in, and it was concave instead of convex. The engineer in charge decided to blow the tank back to the correct shape by water pressure. He gave instructions for this to be done. A few hours later, he went to see how the job was progressing. He found that the tank had been filled with water and that a hand-operated hydraulic

FIGURE 5-7 Method of restoring a tank with a concave roof to its original shape.

pump, normally used for pressure-testing pipework, was being connected to the tank. He had it removed, and he replaced the vent with a vertical pipe, 1 m long. He dribbled water into the pipe from a hose, and as he did so, the tank was restored to its original shape (Figure 5-7) to the amazement of onlookers. The static pressure of the water in the pipe was sufficient.

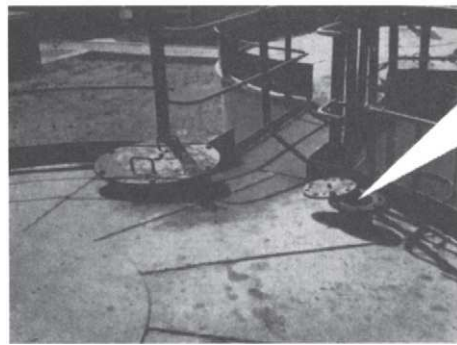
FIGURE 5-8

External sources of ignition, such as lightning (Figure 5-8) or welding near an open vent, can also trigger a tank explosion. Sample and dip

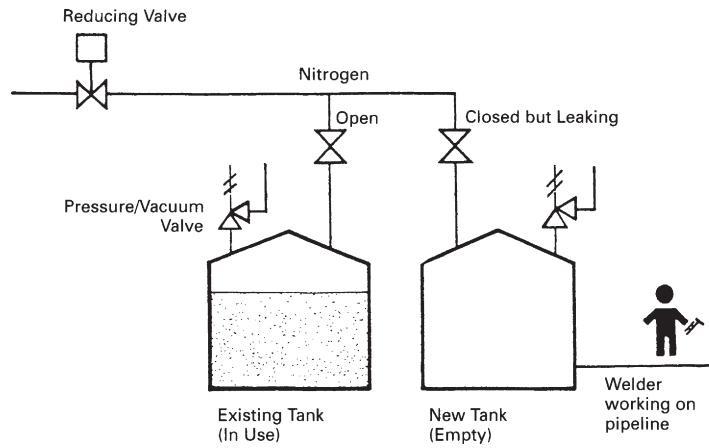
The new tank and an existing one were designed to be on balance with each other to save nitrogen (Figure 5-9), but the contractors did not understand this. The valve to the new tank was closed but leaking. Nitrogen and methanol vapor entered the tank, and a welder who was completing the inlet line to the tank ignited the vapor. The roof was blown right off. By great good fortune, it landed on a patch of empty ground just big enough to contain it (Figure 5-10).

FIGURE 5-9 If tanks are on balance, the nitrogen entering one tank is inevitably mixed with vapor.

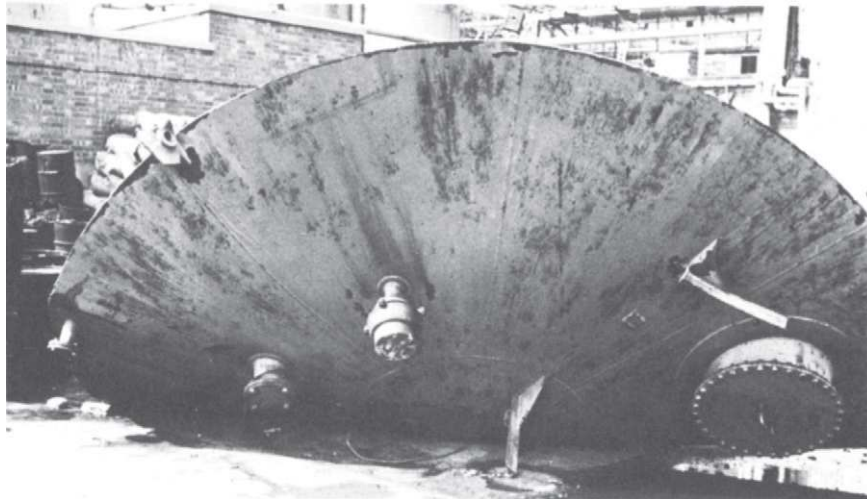
FIGURE 5-10 When an explosion occurred in a tank, the roof landed on an area just big enough to contain it.

Some old tanks are welded along the outside edge of the lap only, thus making a trap from which it is hard to remove liquids. Even light oils can be trapped in this way (see Section 5.4.2c and Figure 5-10).

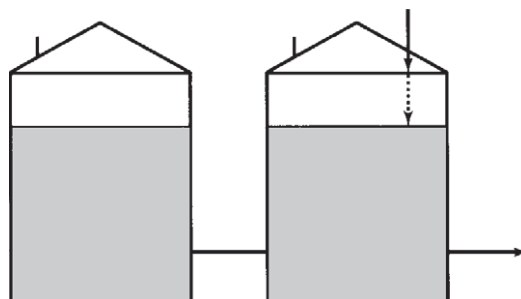
- (f) Paper mills use large quantities of water, and the water is usually recycled. Buffer storage is needed, and at one paper mill, it took the form of a 740-m³ tank. Experience showed that this was insufficient, and another tank of the same size was installed alongside. To simplify installation, it was not connected in parallel with the original tank but on balance with it, as shown in Figure 5-13. A week after the new tank was brought into use, welders were completing the handrails on the roof when an explosion occurred in the tank. Two welders were killed, and the tank was blown 20 m into the air, landing on a nearby building.

Investigation showed that the explosion was due to hydrogen formed by anaerobic bacteria. In the original tank, the splashing of the inlet liquor aerated the water and prevented anaerobic conditions. This did not apply in the new tank [20].

FIGURE 5-13 Extra buffer storage for water was provided by installing a second tank on balance with the first one. Lack of aeration allowed hydrogen-forming bacteria to grow, and an explosion occurred. (Reproduced with permission of the American Institute of Chemical Engineers. Copyright © 1995 AIChE. All rights reserved.)

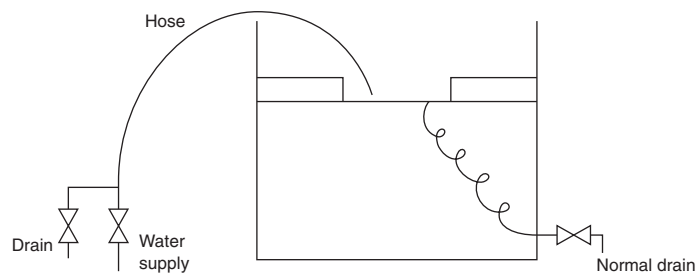
A choke occurred in the flexible pipe that drained the roof of a floating-roof tank. It was decided to drain rainwater off the roof with a hose. To prime the hose and establish a siphon, the hose was connected to the water supply. It was intended to open the valve on the water supply for just long enough to fill the hose. This valve would then be closed and the drain valve opened (Figure 5-14). However, the water valve was opened in error and left open, with the drain valve shut. Water flowed onto the floating roof, and it sank in 30 minutes (see also Section 18.8).

FIGURE 5-14 How to sink the roof of a floating-roof tank.

Temporary modifications should be examined with the same thoroughness as permanent ones (see Section 2.4).

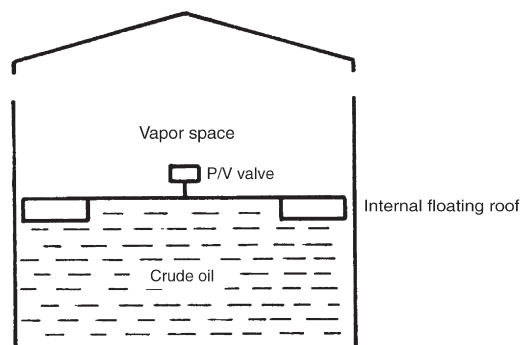
When the tank was refilled with warm crude oil at 37°C (100°F), vapor was pushed out into the space above the floating roof and then out into the atmosphere through vents on the fixed-roof tank (Figure 5-16). This vapor was ignited at a boiler house some distance away.

The fire flashed back to the storage tank, and the vapor burned as it came out of the vents. Pumping was therefore stopped. Vapor no longer came out of the vents, air got in, and a mild explosion occurred inside the fixed-roof tank. This forced the floating roof down like a piston, and some of the crude oil came up through the seal past the side of the floating roof and out of the vents on the fixed-roof tank. This oil caught fire, causing a number of pipeline joints to fail, and this caused further oil leakages. One small tank burst; fortunately, it had a weak seam roof. More than 50 fire appliances and 200 firefighters attended, and the fire was under control in a few hours.

FIGURE 5-16 Tank with internal floating roof.

1. Keep plant modifications under control and keep drawings up to date (see Chapter 2).
 2. Do not take floating-roof tanks off-float except when they are being emptied for repair.

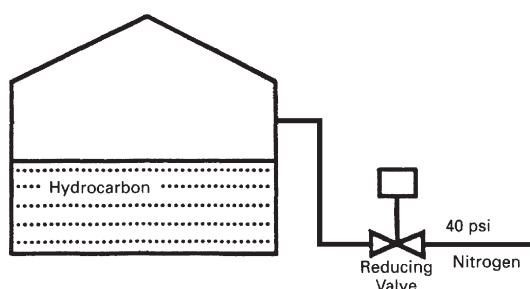
On one group of tanks, the reducing valve on the nitrogen supply was installed at ground level (Figure 5-17). Hydrocarbon vapor condensed in the vertical section of the line and effectively isolated the tank from the nitrogen blanketing.

FIGURE 5-17 Incorrect installation of nitrogen blanketing.

All safety equipment and systems should be scheduled for regular inspection and test. Nitrogen blanketing systems should be inspected at least weekly. It is not sufficient to check that the nitrogen is open to the tank. The atmosphere in the tank should be tested with a portable oxygen analyzer to make sure that the oxygen concentration is below 5%.

Large tanks (say, over 1,000 m³) blanketed with nitrogen should be fitted with low-pressure alarms to give immediate warning of the loss of nitrogen blanketing.

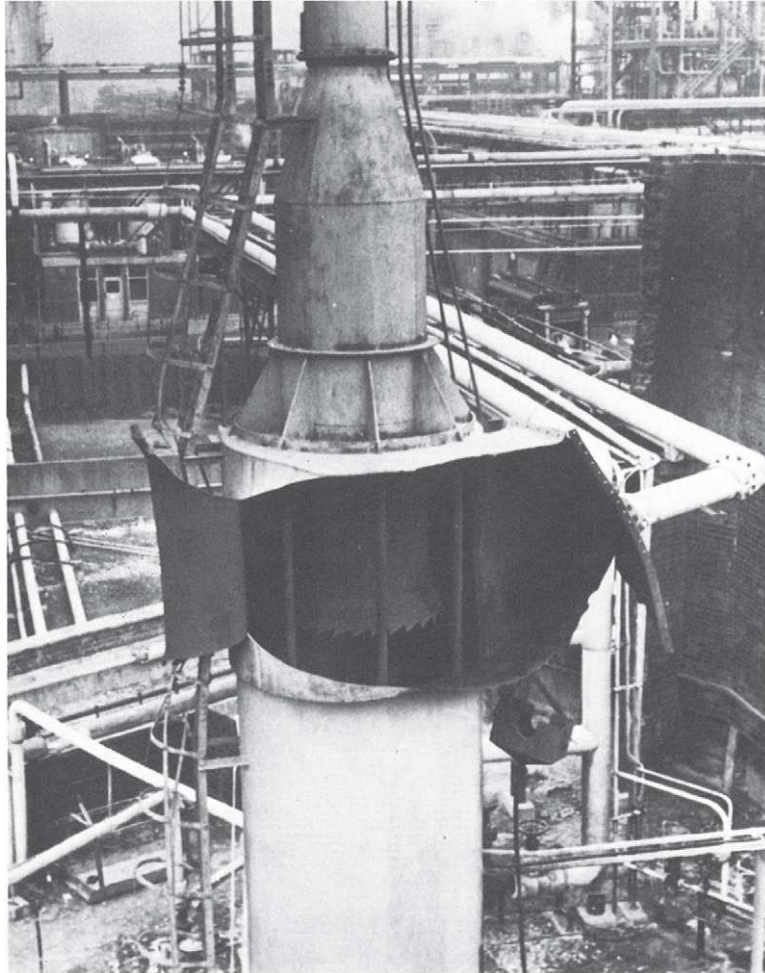
(a) Figure 6-1 shows the results of an explosion in a large flarestack. The stack was supposed to be purged with nitrogen. However, the flow was not measured and had been cut back almost to zero to save nitrogen. Air leaked in through the large bolted joint between unmachined surfaces. The flare had not been lit for some time. Shortly after it was relit, the explosion occurred—the next time some gas was put into the stack. The mixture of gas and air moved up the stack and the pilot flame ignited it.

FIGURE 6-1 Base of flarestack.

1. Stacks should be welded. They should not contain bolted joints between unmachined surfaces.

2. There should be a continuous flow of gas up every stack to prevent air diffusing down and to sweep away small leaks of air into the stack. The continuous flow of gas does not have to be nitrogen—a waste-gas stream is effective. But if gas is not being flared continuously, it is usual to keep nitrogen flowing at a linear velocity of 0.03 to 0.06 m/s (1.2 to 1.4 in/s). The flow of gas should be measured. A higher rate is required if hydrogen or hot condensable gases are being flared. If possible, hydrogen should be discharged through a separate vent stack and not mixed with other gases in a flarestack.
3. The atmosphere inside every stack should be monitored regularly, say daily, for oxygen content. Large stacks should be fitted with oxygen

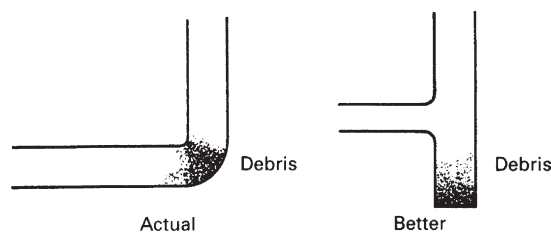
FIGURE 6-2 Flarestack after fall of debris.

- (b) The vent stack was replaced by a 14-in.-diameter flarestack with a supply of steam to a ring around the top of the stack. A few years later, this stack choked again, this time because of a deposit of refractory debris from the tip, cemented together by ice (as some condensate from the steam had found its way down the stack). Fortunately, in this case someone noticed the high pressure in the tank before any damage occurred. There was no boot at the bottom of the stack to collect debris (Figure 6-2). A boot was fitted [2].

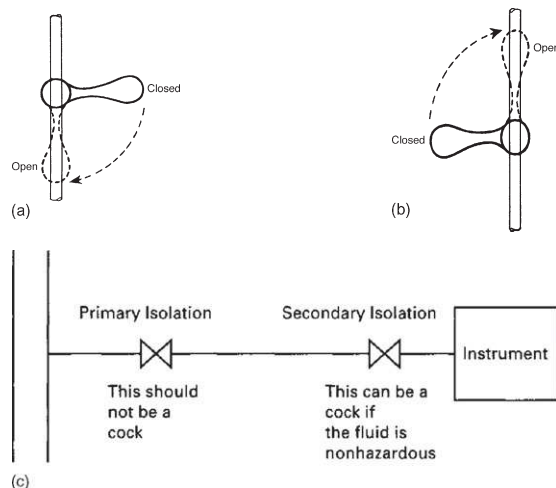
Small cocks have often been knocked open or have vibrated open, as shown in Figure 7-1a. To prevent this from happening the valves should be installed so that when they are open the valve handle points upward, as shown in Figure 7-1b. Cocks should never be used as the sole isolation valve (and preferably not at all) on lines carrying hazardous materials, particularly flammable or toxic liquids, at pressures above their atmospheric boiling points (for example, liquefied flammable gases and most heat transfer oils when hot). These liquids turn to vapor and spray when they leak and can spread long distances. It is good practice to use other types of valves for the first isolation valve, as shown in Figure 7-1c.

FIGURE 7-1 (a) Vibration can cause the cock to open. (b) A better arrangement. (c) Small cocks should not be used as primary isolation valves.

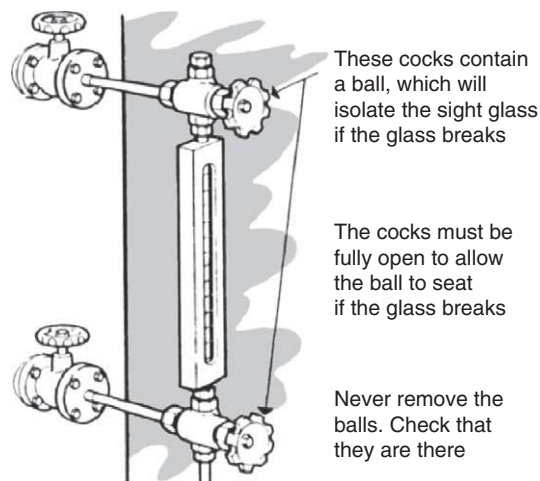
Level glasses and sight glasses (except magnetic types) should not be used on vessels containing flashing flammable or toxic liquids—that is, liquids under pressure above their normal boiling points. When level glasses are used, they should be fitted with ball check cocks, which prevent a massive leak if the glass breaks. Unfortunately, people who did not understand their purpose have sometimes removed the balls. The hand valves must be fully opened or the balls cannot operate (Figure 7-2).

FIGURE 7-2 Ball check cocks.

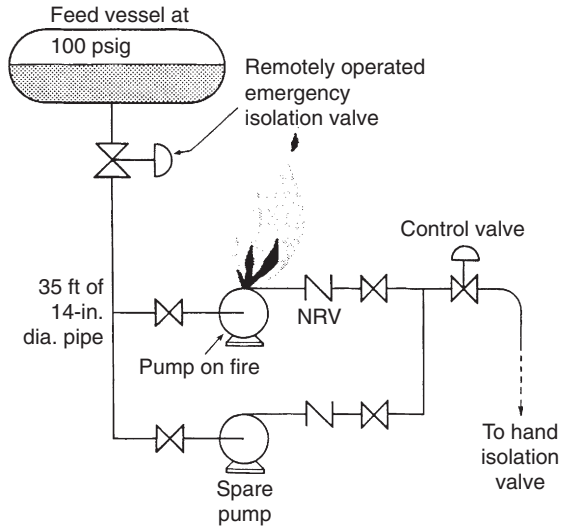
Backflow from the delivery side of the pump was prevented by a check (nonreturn) valve. In addition, a control valve and a hand valve well away from the fire were closed (Figure 7-5).

FIGURE 7-5 An emergency isolation valve stopped a fire.

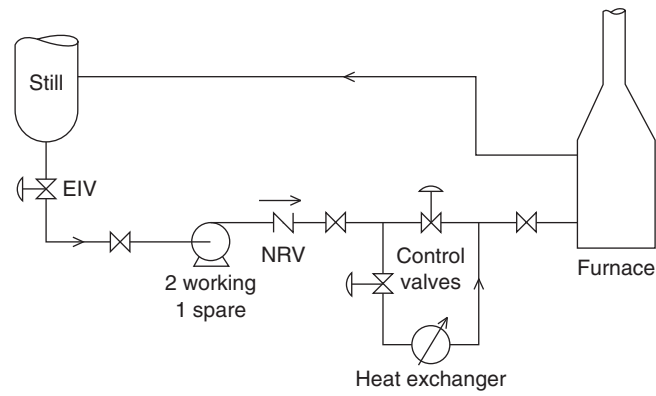
(b) The bearing on the feed pump to a furnace failed, causing a gland failure and a leak of hot oil. The oil caught fire, but an emergency isolation valve in the pump suction line was closed immediately, and the fire soon died out (Figure 7-6).

FIGURE 7-6 Another emergency isolation valve stopped a fire.

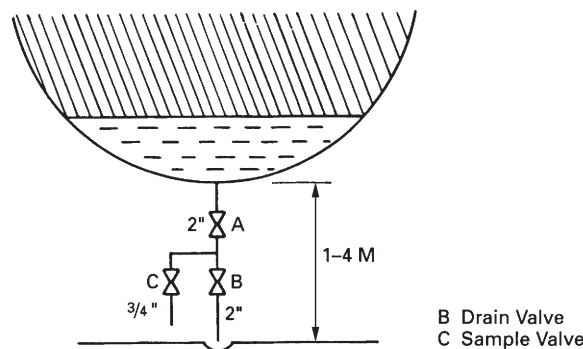
An operator had to drain water from a 1,200-m³ spherical storage vessel nearly full of propane (Figure 8-1). He opened valves A and B. When traces of oil showed that the draining was nearly complete, he shut A and then cracked it to complete the draining. No flow came. He opened A fully. The choke—presumably hydrate, a compound of water and a light hydrocarbon with a melting point above 0°C (32°F)—cleared suddenly, and the operator and two others were splashed with liquid. The handle came off valve A, and they could not get it back on. Valve B was frozen and could not be moved. Access was poor because the drain valves were immediately below the tank, which was only 1.4 m (4.5 ft) above the ground.

FIGURE 8-1 Drain valves underneath propane tank at Feyzin.

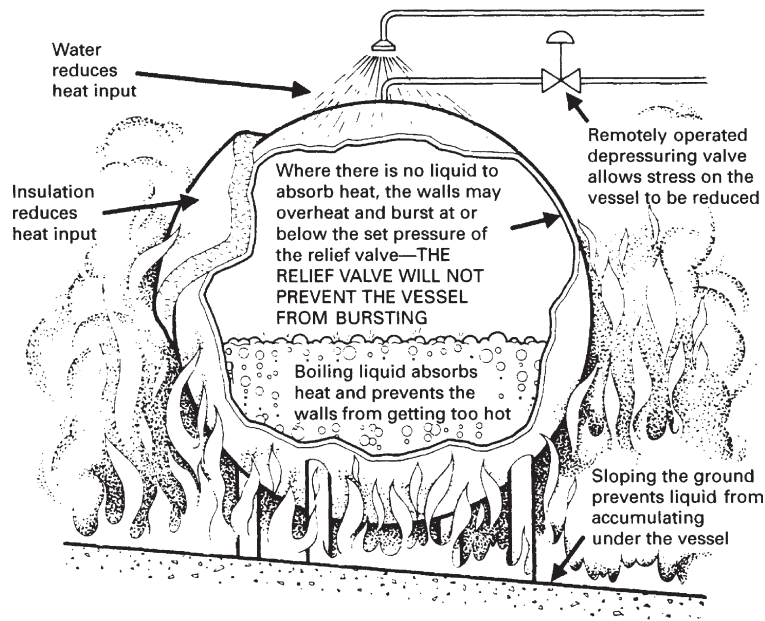
FIGURE 8-2 Methods of protecting a pressure vessel against fire.

- Slope the ground so that any spillage runs off to a collection pit.
- Fit an emergency depressuring valve so that the pressure in the vessel can be reduced to one-fifth of design in 10 minutes to reduce the strain on the metal [13]. The time can be increased to 30 minutes if the vessel is insulated and to one hour if, in addition, the ground is sloped.

Figure 8-2 summarizes these proposals.
