Library of Congress Cataloging-in-Publication Data
Kletz, Trevor A.

What went wrong? : case histories of process plant disasters and how they could have been avoided / Trevor Kletz. —5th ed.

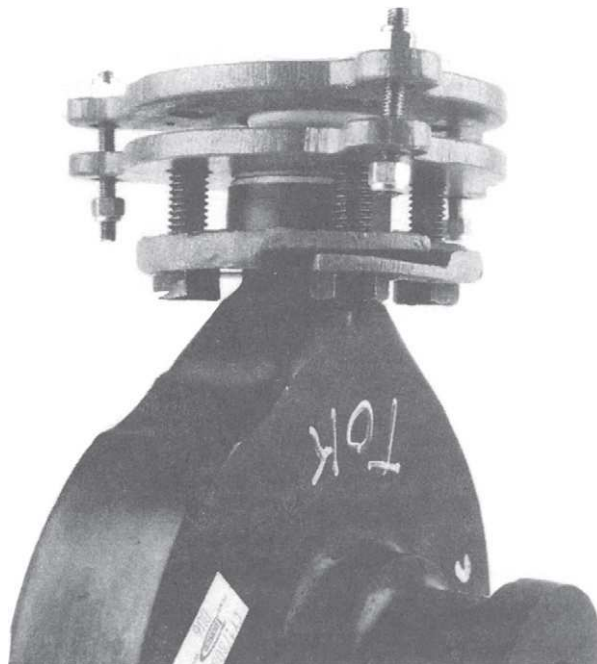
that it had to be rebuilt. Fortunately, no one was killed or injured. The leak started at a flange assembly on the delivery of a pump (Figure 8-3), probably the result of corrosion of the flanges but possibly caused by the failure of a plastic bellows. The official report [23] made the following points:

- The split flanges were badly corroded; their thickness was reduced, and the bolt holes were much enlarged. (Split flanges are not a good feature because they expose twice as much surface to the effects of corrosion.) There was no system for identifying critical items, the failure of which could have serious results, and registering them for regular inspection. Maintenance was on a breakdown basis, and there were no formal records that could be used to identify items needing regular inspection or replacement.

FIGURE 8-3 Split flange assembly similar to one that leaked. (Photo courtesy of the UK Health and Safety Executive.)

- The leak could have been stopped as soon as it was detected if an emergency isolation valve (Section 7.2.1) had been fitted in the pump suction line. On the rebuilt plant, such valves were fitted on the pump suction lines, more combustible gas detectors and more extensive insulation were installed, plastic pump bodies were replaced by metal ones, and spillages were directed to collection pits. The plant

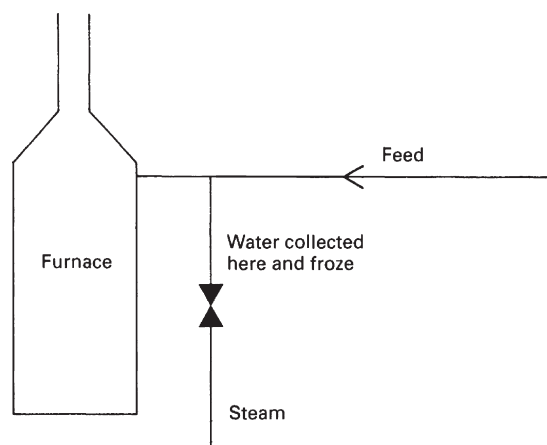
There are other sorts of dead-ends besides pipes that have been blanked. Rarely used valved branches are just as dangerous. The feed line to a furnace (Figure 9-1) was provided with a permanent steam connection for use during de-coking.

The connection was on the bottom of the feed line, and the steam valve was not close to the feed line. Water collected above the steam valve,

FIGURE 9-1 The steam connection to the furnace formed a dead-end.

froze during cold weather, and ruptured the line, allowing oil at a gauge pressure of 450 psi (30 bar) to escape. If dead-ends cannot be avoided, they should be connected to the *top* of the main pipeline (unless the liquid in the pipeline is denser than water).

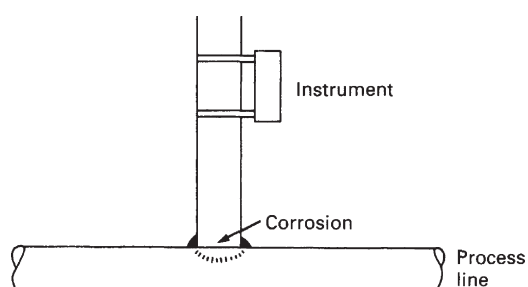
FIGURE 9-2 Water collected in the instrument support and corroded the process line.

An unusual—and unnecessary—dead-end was a length of 2-in. pipe welded onto a process line to provide a support for an instrument (Figure 9-2). Water collected in the support. Four years after it had been installed, the process line corroded through, and a leak of liquefied gas occurred.

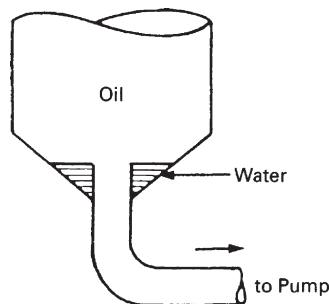
Another serious failure occurred because water in a dead-end was suddenly vaporized. A heavy oil was dried by heating it to 120°C (250°F) in a tank filled with steam coils. The oil was circulated while it was being dried. The suction line projected into the conical base of the tank, forming a dead-end, as shown in Figure 9-3.

FIGURE 9-3 Water in this dead-end was vaporized by oil.

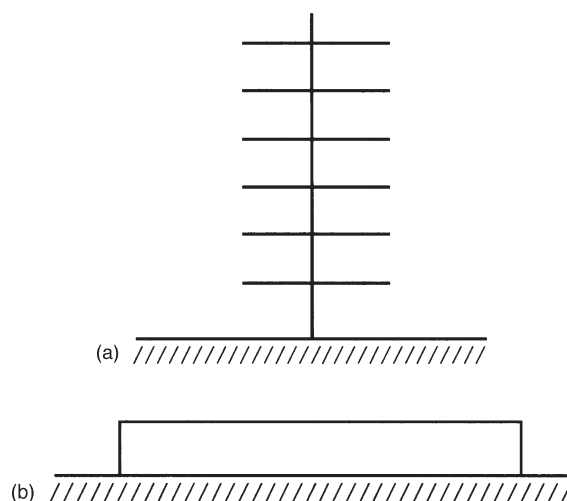
- (h)** Eleven pipelines, 50 to 200 mm (2 to 8 in.) in diameter, containing hydrocarbon liquids and gases, were supported on brackets of the type shown in Figure 9-5a, 2.1 m (7 ft) tall and 6 m (10 ft) apart. The pipes

FIGURE 9-5 (a) The original pipe supports. (b) The supports used after the collapse.

were fixed to two of the brackets and rested on the others. The pipe run passed through a tank farm, and the wind flow through the gaps between the tanks caused the upright part of the supports to incline 2 degrees from the vertical. This was noticed when the pipe run was inspected, but no one regarded it as serious.

As the result of a power failure, the flow through many of the pipes suddenly stopped, and the surge caused the angle of inclination to increase to 6 degrees. The tops of the supports were now 5 in. (125 mm) out of line. The supports were now unstable. Eleven hours after the power failure and three hours after the flows had been restored, the pipe run collapsed over a length of 23 m (75 ft); 14 tons of gasoline spilled. Three hours later, a further length collapsed. The pipe supports were replaced by the type shown in Figure 9-5b.

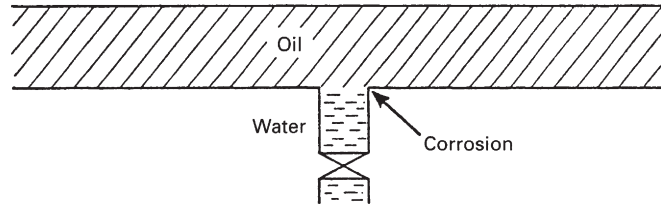
Water was injected into an oil stream using the simple arrangement shown in Figure 9-6. Corrosion occurred near the point shown, and the oil leak caught fire [5]. The rate of corrosion far exceeded the corrosion allowance of 0.05 in. per year.

FIGURE 9-6 Water injection—a poor arrangement.

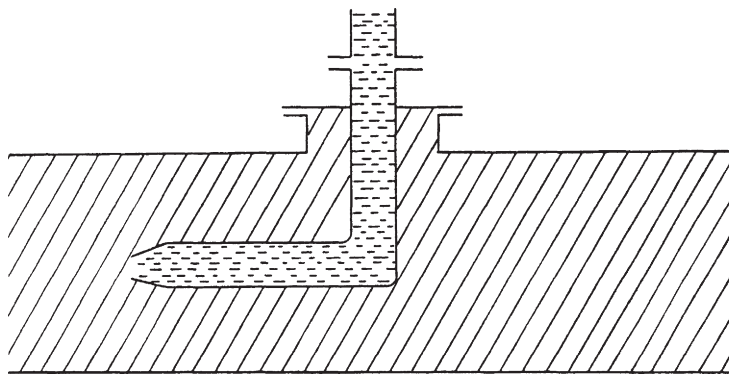
A better arrangement is shown in Figure 9-7. The dimensions are chosen so that the water injection pipe can be removed for inspection. However, this system is not foolproof. One system of this design was assembled with the injection pipe pointing upstream instead of downstream. This increased corrosion.

FIGURE 9-7 Water injection—a better arrangement.

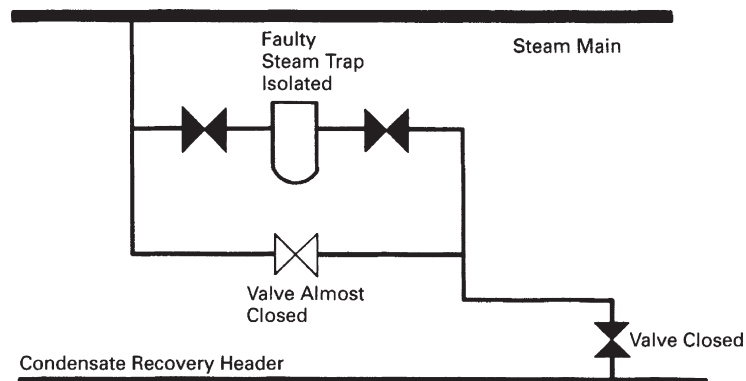
FIGURE 9-9 Arrangement of valves on a steam main that was broken by a water hammer.

The incident occurred soon after the main had been brought back into use after a turnaround. It was up to pressure, but there was no flow along it. The steam trap was leaking and had been isolated. An attempt was made to get rid of condensate through the bypass valve. But steam entered the condensate header, and the line was isolated, as shown in Figure 9-9. Condensate then accumulated in the steam main.

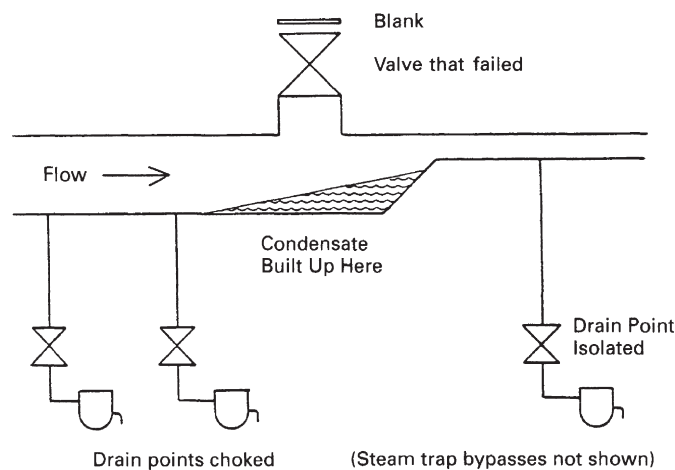
- (b) Figure 9-10 shows how water hammer burst another steam main—this time one operating at a gauge pressure of 20 psi (1.4 bar). Two drain points were choked and one isolated. In addition, the change in diameter of the main provided an opportunity for condensate to accumulate. The main should have been constructed so that the bottom was straight and so the change in diameter took place at the top.

FIGURE 9-10 Arrangement of drains on a steam main that was broken by a water hammer.

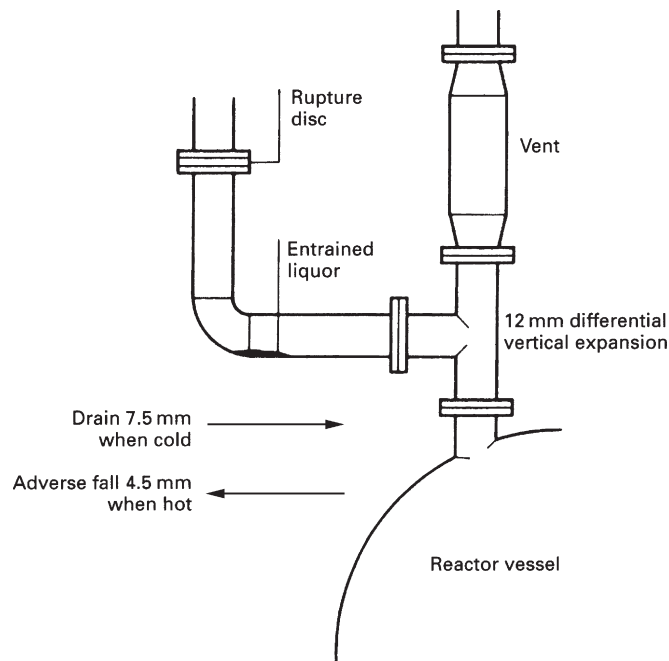
- (g) Figure 9-13 shows the pipework on the top of a reactor. When the pipework was cold, any liquid in the branch leading to the rupture disc drained out; when it was hot, it remained in the branch, where it caused corrosion and cracking [18].

FIGURE 9-13 The vent arrangements at the top of the reactor. Liquid drained out when the pipework was cold but not when it was hot.

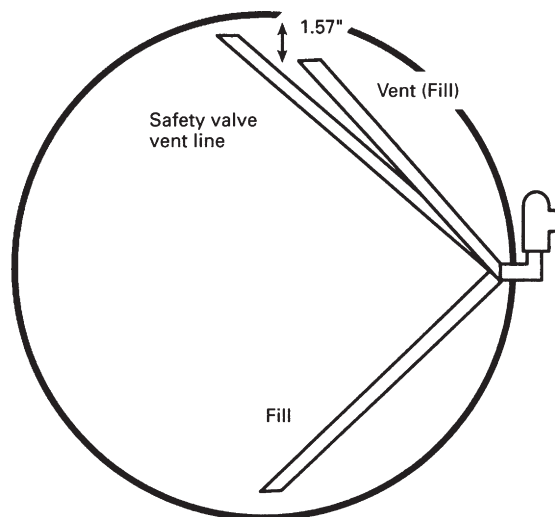
- Five weeks later, the heater failed again, this time in the On position, and the pressure in the tank rose. The two relief valves failed to open because they were fixed to the side of the vessel and connected to the vapor space at the top by an internal line (Figure 9-14)—a most unusual arrangement, presumably adopted so that one nozzle could be used for filling, venting (during filling), and relief. As a result, the relief valve was cooled by the liquid in the vessel and became blocked by ice from condensed atmospheric moisture. There

FIGURE 9-14 Unusual arrangement of a relief valve and pipework on a tank truck used to transport liquid carbon dioxide. The relief valve was cooled by the liquid and became blocked by ice from condensed atmospheric moisture. (Illustration courtesy of the Institution of Chemical Engineers.)

was no drain hole in the relief valve tailpipe (see Section 10.2.4).

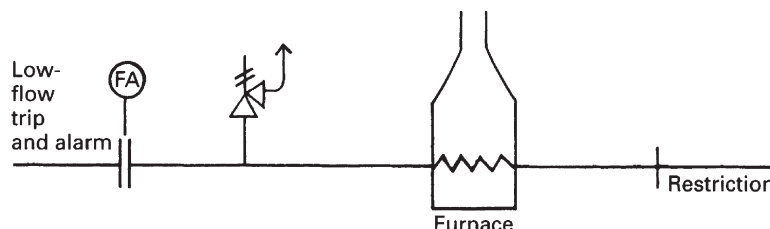
A furnace was protected by a relief valve on its inlet line (Figure 10-1). A restriction developed after the furnace. The relief valve lifted and took most of the flow. The flow through the furnace tubes fell to such a low level that they overheated and burst. The low-flow trip, which should have isolated the fuel supply to the furnace when the flow fell to a low value, could not do so because the flow through it was normal.

FIGURE 10-1 When the relief valve lifted, the flow through the furnace was reduced.

The relief valve should have been placed after the furnace or, if this was not possible, before the low-flow trip.

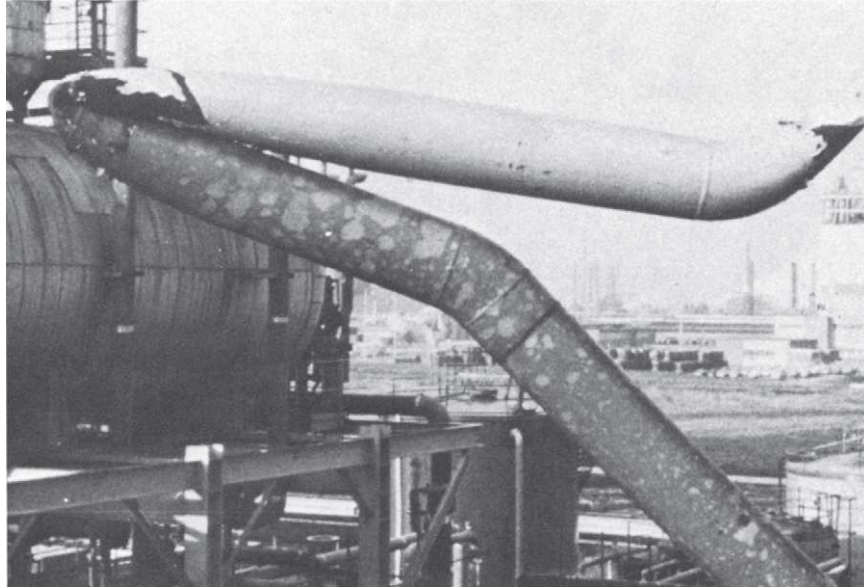
Figure 10-4 shows what happened to the tailpipe of a steam relief valve that was not adequately supported. The tailpipe was not provided with a drain hole (or if one was provided, it was too small), and the tailpipe filled with water. When the relief valve lifted, the water hit the curved top of the tailpipe with great force. Absence of a drain hole in a tailpipe also led to the incident described in Section 9.2.1g.

FIGURE 10-4 This relief-valve tailpipe was not adequately supported.

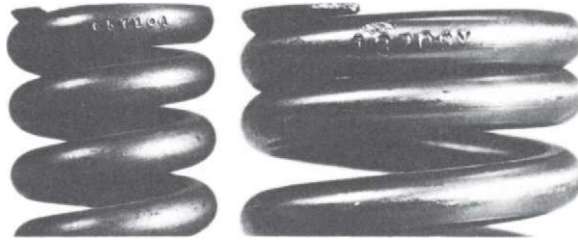
FIGURE 10-5 Identification marks on body coils could lead to spring failure.

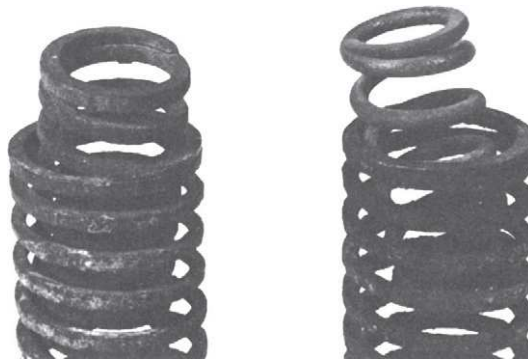
FIGURE 10-6 Use of additional inner springs of unknown quality in an attempt to obtain set pressure.

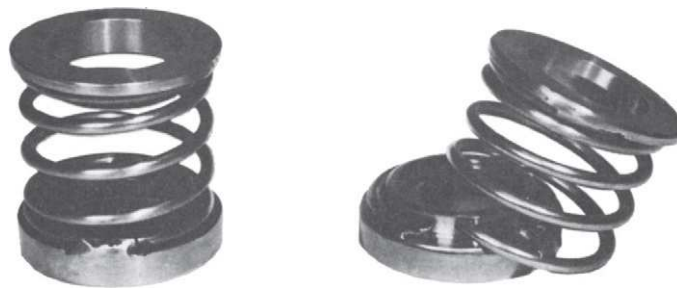
FIGURE 10-7 End caps welded to spring. Failure occurred at weld.

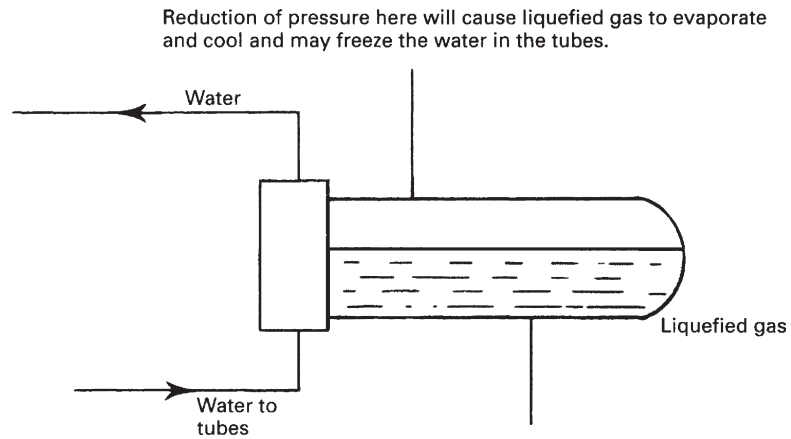
Figure 10-10 illustrates another incident. When a plant was shutting down, the flow of cooling water to the tubes of a heat exchanger was isolated. The propylene on the shell side got colder as its pressure fell. The water in the tubes froze, breaking seven bolts. The operators saw ice forming on the outside of the cooler but did not realize that this was hazardous and took no action. When the plant started up again, propylene entered the cooling-water system, and the pressure blew out a section of the 16-in. (400-mm) line. A furnace located 40 m (130 ft) away ignited the gas, and the fire caused serious damage.

FIGURE 10-10 Evaporative cooling.

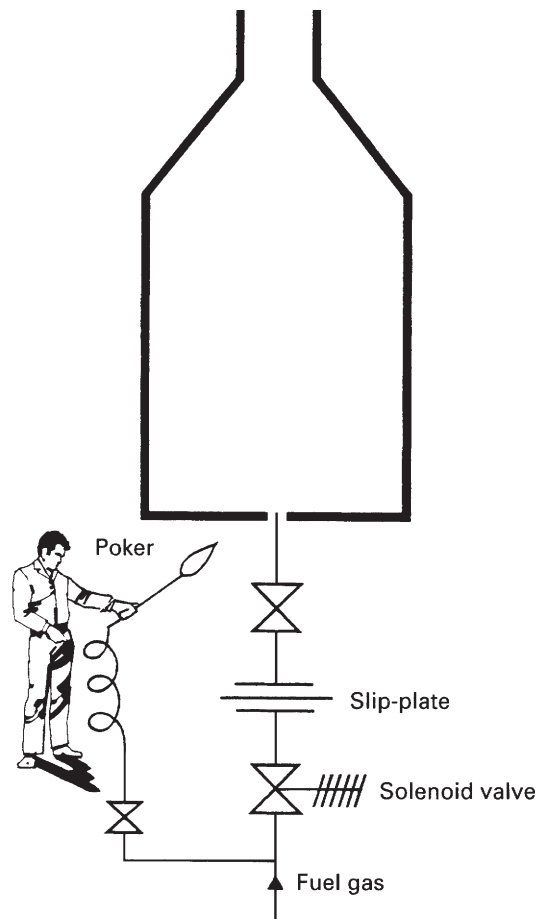
- (a) A foreman tested the atmosphere inside a furnace (Figure 10-12) with a combustible gas detector. No gas was detected, so the slip-plate (blind) was removed, and two minutes later, a lighted poker

was inserted. An explosion occurred. The foreman and another man were hit by flying bricks, and the brickwork was badly damaged.

1. Test the atmosphere inside the furnace.
2. If you do not detect gas, light and then insert the poker (or switch on the electric igniter).
3. Remove the slip-plate (or connect the hose, drain the lute, or change over the double block and bleed valves). If the isolation valve is leaking, the poker or igniter will ignite the leaking fuel before it forms an explosive mixture. (The solenoid valve shown in Figure 10-12 should open automatically when the poker is inserted or the igniter is switched on. If it does not, it should be held open until the main burner is lit.)
4. Open the fuel-gas isolation valve.

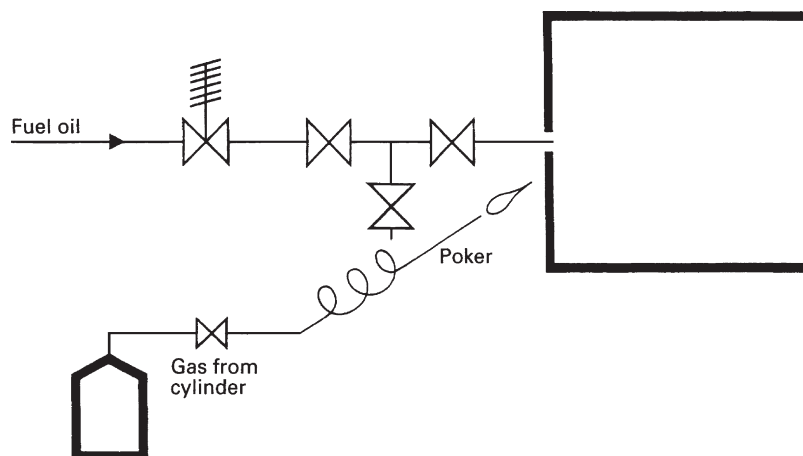
- (b)** A reduction in fuel oil pressure caused the burner in an oil-fired furnace to go out, and the flame failure device closed the solenoid valve in the fuel oil line (Figure 10-13). The operator closed the two hand-isolation valves and opened the bleed between them. (The group of three valves is equivalent to the slip-plate shown in Figure 10-12.) When the fuel oil pressure was restored, the foreman tested the atmosphere in the furnace with a combustible gas detector. No gas was detected, so he inserted a lighted poker. The fuel oil supply was

To calculate the purge time, do the following:

1. Calculate the amount of oil between the solenoid valve and the burner.
2. Assume it all drains into the furnace and evaporates. Calculate the volume of the flammable mixture, assuming it is at the lower flammable limit, probably about 0.5% v/v. (If it forms a richer mixture, the volume will be less.)

3. Multiply by four to give a safety margin, and sweep out the furnace with this volume of air [11].

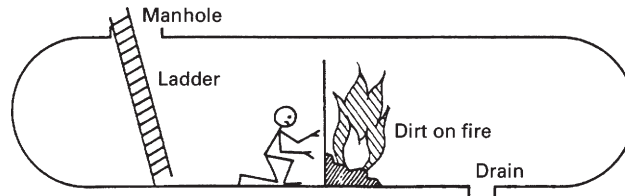
- (a)** A vessel was divided into two halves by a baffle, which had to be removed. The vessel was cleaned out, inspected, and a permit issued for a worker to enter the left-hand side of the vessel to burn out the baffle. It was impossible to see into the right-hand half. But because the left-hand half was clean and because no combustible gas could be detected, it was assumed that the other half was also clean (Figure 11-1). While

FIGURE 11-1 If part of a vessel cannot be seen, assume it is dirty.

the welder was in the vessel, some deposit in the right-hand half caught fire. The welder got out without serious injury but bruised himself in his haste.

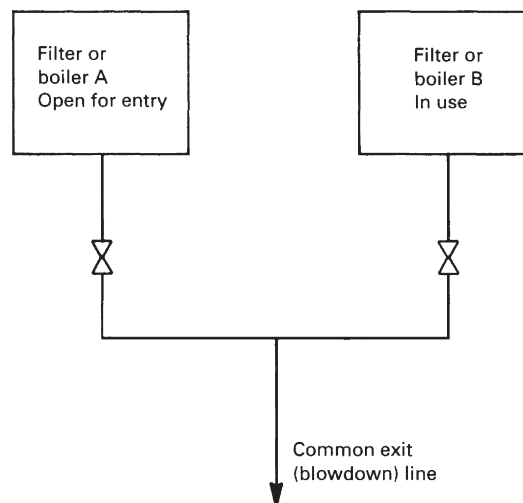
The liquid, after passing through the outlet valve, joined the line from another filter that was in use. It is believed that carbon dioxide gas from the filter liquid passed up the outlet line into the filter that was being inspected (Figure 11-2). A test showed that "contamination was not sufficient to prevent a candle burning."

- (f) Forty-five years later, in the same company, the accident was repeated, and this time a man was killed. While a man was working inside a boiler, the process foreman noticed that the water level in another boiler was too high. He asked an operator to lower the level through the blowdown (drain) valve, which discharged into a common drain line. Steam entered the boiler under repair from this common line. None of the lines had been slip-plated or disconnected, and the blowdown valve had been left open (Figure 11-2).

FIGURE 11-2 Liquid or gas traveled backward from the common line into the vessel that was open for entry.

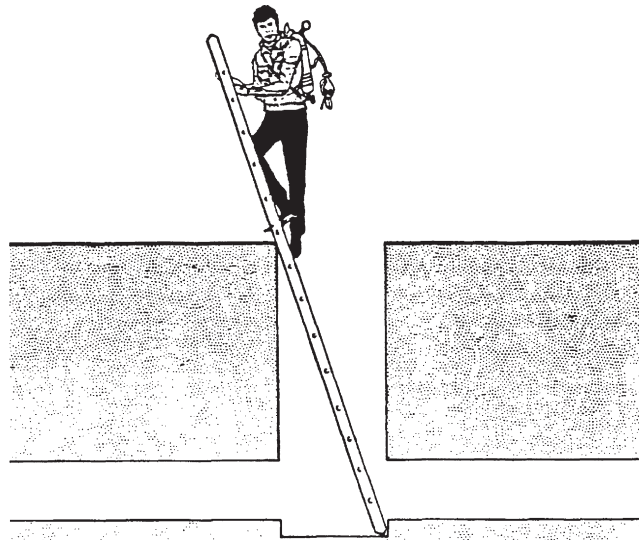
A man was standing on a ladder, ready to go down into a drain manhole to plug one of the inlet lines. The drain contained some hydrogen sulfide, so he had an air mask ready. But he had not yet put it on because he was well outside the manhole. His feet were at ground level (Figure 11-3). He was about to put on a safety harness when his two companions heard a shout and saw him sliding into the manhole. They were unable to catch him, and his body was recovered from the outfall. He had been

FIGURE 11-3 A man was overcome by fumes from the manhole.

overcome by hydrogen sulfide arising from the drains, although his face was 1.5 m above ground level.

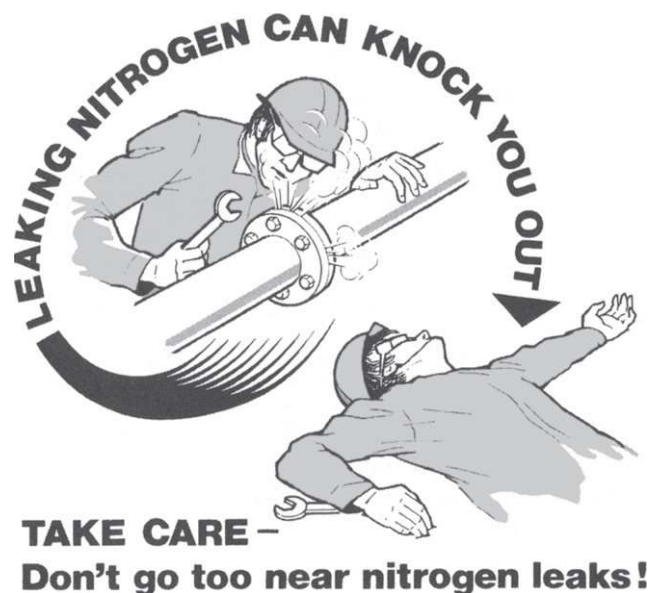
FIGURE 12-1

- (a) A member of a cleaning crew decided to recover a rope, which was half inside a vessel and was caught up on something inside. While kneeling down, trying to disentangle the rope, he was overcome by nitrogen. Afterward he admitted that if necessary, he would have entered the vessel.
- (b) On several occasions, people who were working on or near leaky joints on nitrogen lines have been affected. Although they knew nitrogen is harmful, they did not consider that the amount coming out of a leaky joint would harm them (Figure 12-1).

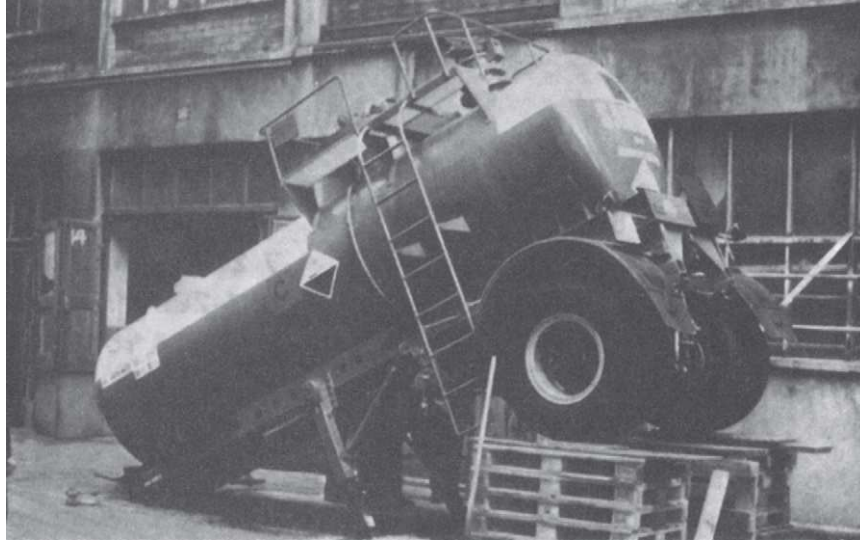
On several occasions, tank trailers have tipped up because the rear compartments were emptied first, as shown in Figure 13-1.

FIGURE 13-1 A tank trailer may tip up if the rear compartments are emptied first.

It is not always possible to keep the trailer connected to the truck's unit during loading/unloading. If it is not connected, the front compartments should be filled last and emptied first or a support put under the front of the trailer.

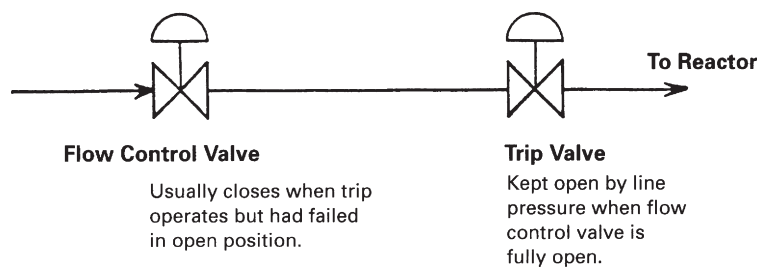
Investigation showed that the pressure drop through the trip valve—a globe valve—was so high that the valve could not close against it. There was a flow control valve in series with the trip valve (Figure 14-1), and the trip normally closed this valve as well. However, this valve failed in the open position—this was the reason for the high temperature in the reactor—and the full upstream pressure was applied to the trip valve.

FIGURE 14-1 When the control valve was open, the pressure prevented the trip valve from closing.

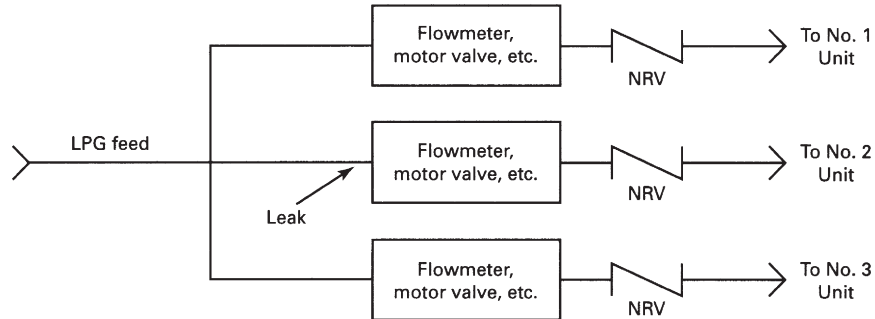
- (f) A plant was pressure-tested before startup, but the check valves (nonreturn valves, NRV) in the feed lines to each unit (Figure 14-2) made it impossible to test the equipment to the left of them. A leak of liquefied petroleum gas (LPG) occurred during startup at the point indicated. The three check valves were then replaced by a single one in the common feed line at the extreme left of the diagram.

FIGURE 14-2 The check valves (nonreturn valves, NRV) prevented a leak test of the equipment to the left of them. During startup, a leak occurred at the point indicated.

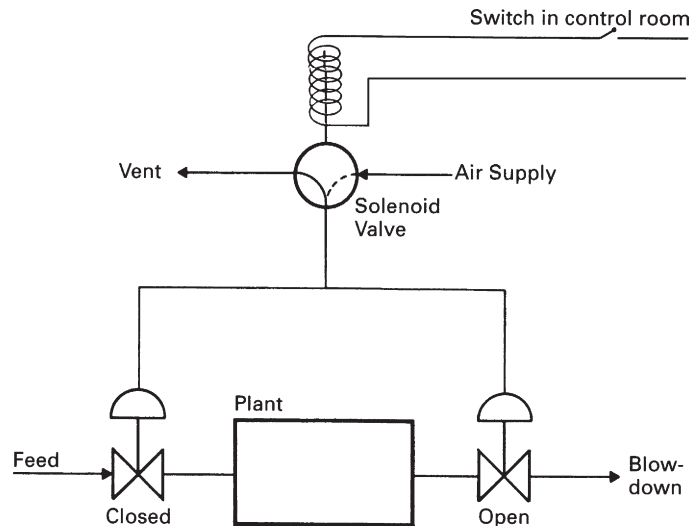
(a) A gas leak occurred at a plant and caught fire. The operator saw the fire through the window of the control room and operated a switch, which should have isolated the feed and opened a blowdown valve. Nothing happened. He operated the switch several times, but still nothing happened. He then went outside and closed the feed valve and opened the blowdown valve by hand.

The switch operated a solenoid valve, which vented the compressed air line leading to valves in the feed and blowdown lines (Figure 14-3). The feed valve then closed, and the blowdown valve opened. This did not happen instantly because it took a minute or so for the air pressure to fall in the relatively long lines between the solenoid valve and the other valves.

FIGURE 14-3 An automatic system, which will take a minute or so to operate.

The operator expected the system to function as soon as he operated the switch. When it did not, he assumed it was faulty. Unfortunately, after operating the switch several times, he left it in its normal position.

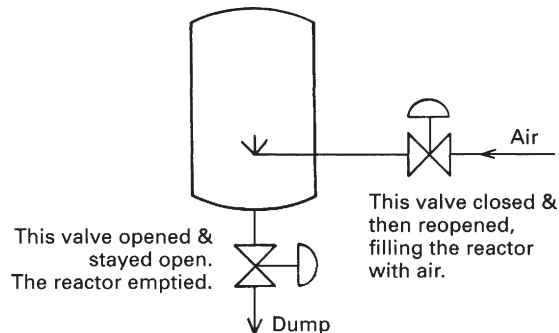
- (b) A liquid-phase hydrocarbon oxidation plant was fitted with a high-temperature trip, which shut off the air and opened a drain valve that dumped the contents of the reactor in a safe place (Figure 14-4). If the air valve reopened after a dump, a flammable mixture could form in the reactor.

One day the temperature-measuring device gave a false indication of high temperature. The air valve closed, and the drain valve opened. The temperature indication fell, perhaps because the reactor was now empty. The drain valve stayed open, but the air valve reopened, and a flammable mixture was formed in the reactor. Fortunately, it did not ignite.

The air valve reopened because the solenoid valve in the instrument air line leading to the air valve would not stay in the tripped position. It should have been fitted with a latch.

FIGURE 14-4 When the air valve reopened after a dump, a flammable mixture formed in the reactor.

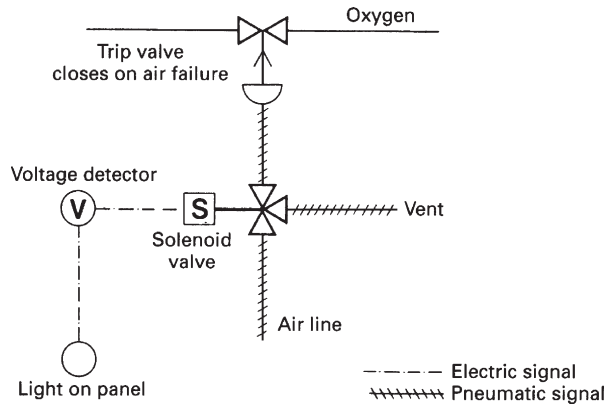
An ethylene oxide plant tripped, and a light on the panel told the operator that the oxygen valve had closed. Because the plant was going to be restarted immediately, he did not close the hand-operated isolation valve as well. Before the plant could be restarted, an explosion occurred. The oxygen valve had not closed, and oxygen continued to enter the plant (Figure 14-5).

Actually the air was not vented. A wasp's nest choked the 1-in. vent line on the air supply. Whenever possible, we should measure directly

FIGURE 14-5 The light shows that the solenoid is de-energized, not that the oxygen flow has stopped.

what we need to know and not some other parameter from which it can be inferred [1].

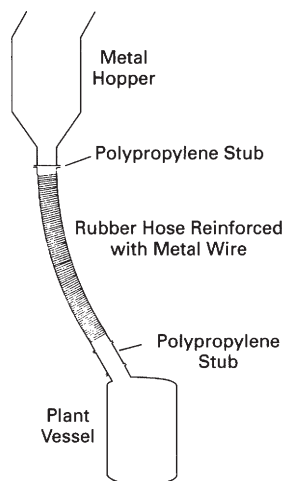
A powder was emptied down a metal duct into a plant vessel. The duct was replaced by a rubber hose, as shown in Figure 15-2. The flow of powder down the hose caused a charge to collect on it. Although the hose was reinforced with metal wire and was therefore conducting,

FIGURE 15-2 The flow of powder caused a static charge to collect on the insulated hose.

it was connected to the plant at each end by short polypropylene pipes that were nonconducting. A charge therefore accumulated on the hose, a spark occurred, the dust exploded, and a man was killed.

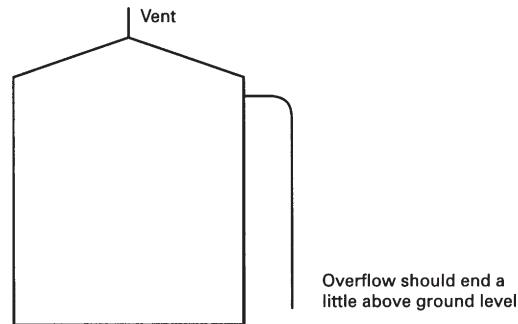
FIGURE 16-1 Acid tanks should be fitted with a high-point vent, as well as an overflow, so that hydrogen can escape.

The tank should have been fitted with a vent at the highest point, as shown in Figure 16-1.

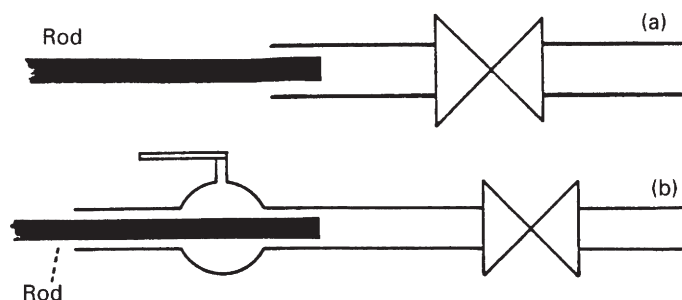
- (a) A man was rodding out a choked $\frac{1}{4}$ -in. line leading to an instrument (Figure 17-1a). When he had cleared the choke, he found that the valve would not close and he could not stop the flow of flammable liquid. Part of the unit had to be shut down.

FIGURE 17-1 The wrong (a) and right (b) ways of clearing a choked line.

Rodding out *narrow bore* lines is sometimes necessary. But before doing so, a ball valve or cock should be fitted on the end (Figure 17-1b). It is then possible to isolate the flow when the choke has been cleared, even if the original valve will not close.

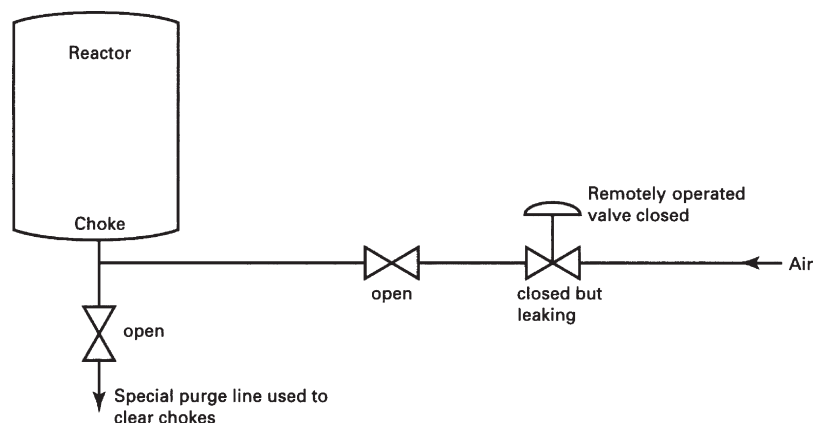
FIGURE 17-2 Liquid purge burned in the drain line.

- (a) As described in Section 3.3.4c, the emergency blowdown valves on a plant were kept closed by a hydraulic oil supply. One day the valves opened, and the plant started to blow down. It was then discovered that, unknown to the manager and contrary to instructions, the foreman had developed the practice of isolating the oil supply valve "in case the supply pressure in the oil system failed." This was a most unlikely occurrence and much less likely than the oil pressure leaking away from an isolated system.
- (b) The air inlet to a liquid-phase oxidation plant became choked from time to time. To clear the choke, the flow of air was isolated, and some of the liquid in the reactor was allowed to flow backward through the air inlet and out through a purge line, which was provided for this purpose (Figure 17-2).

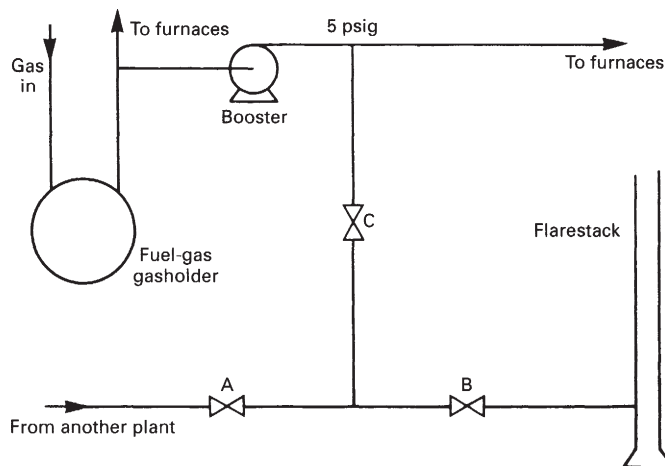
The flarestack shown in Figure 17-3 was used to dispose of surplus fuel gas, which was delivered from the gasholder by a booster through valves C and B. Valve C was normally left open because valve B was more accessible.

One day the operator responsible for the gasholder saw that it had started to fall. He therefore imported some gas from another unit. Nevertheless, a half-hour later the gasholder was sucked in.

Another flarestack at a different plant had to be taken out of service for repair. An operator at this plant therefore locked open valves A and B so that he could use the "gasholder flarestack." He had done this before, though not recently, and some changes had been made since he last used the flarestack. He did not realize that his action would result in the gasholder emptying itself through valves C and B. He told three other men what he was going to do, but he did not tell the gasholder operator. He did not know that this man was concerned.

FIGURE 17-3 Different operators controlled valve B.

Responsibility for each item of equipment should be clearly defined at the supervisor, foreman, and operator levels, and only the people responsible for each item should operate it. If different teams are allowed to operate the same equipment, then sooner or later an incident will occur.

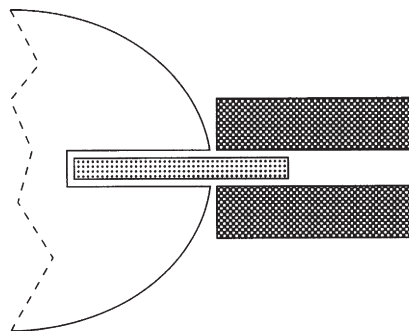
A vessel was fitted with a simple mechanical interlock: a horizontal pin fitted into a slot in the vessel lid; the lid could not be moved sideways until the pin was withdrawn (Figure 17-4). A solenoid controlled movement of the pin. The solenoid could not be activated and the pin withdrawn until various measurements, including the temperature and level of the liquid in the vessel, were within specified ranges.

Nevertheless the lid was moved, although the measurements were not correct. Several possible explanations were considered:

1. The pin might have been seized inside the solenoid. Unfortunately, the operator, believing this to be the case, had squirted a lubricant into the solenoid chamber before any investigation could be carried out. A vertical pin would have been less likely to stick.
2. The operator, believing that all measurements were correct, might have assumed that the system was faulty and inserted a thin strip of metal into the end of the slot and moved the pin back into the solenoid. He denies doing this but admits that he did not check the temperature and level readings to make sure they were correct before trying to move the lid.

FIGURE 17-4 A simple mechanical interlock: the lid could not be moved until the pin was withdrawn from the slot.

In the original design, the pin fitted into a hole, but the hole was changed to a slot so the operator could see the position of the pin. At the time no one realized that this made it possible for someone to move the pin by hand, another example of the unseen results of a plant modification. To prevent this, a sheet of transparent plastic could have been used to cover the slot.

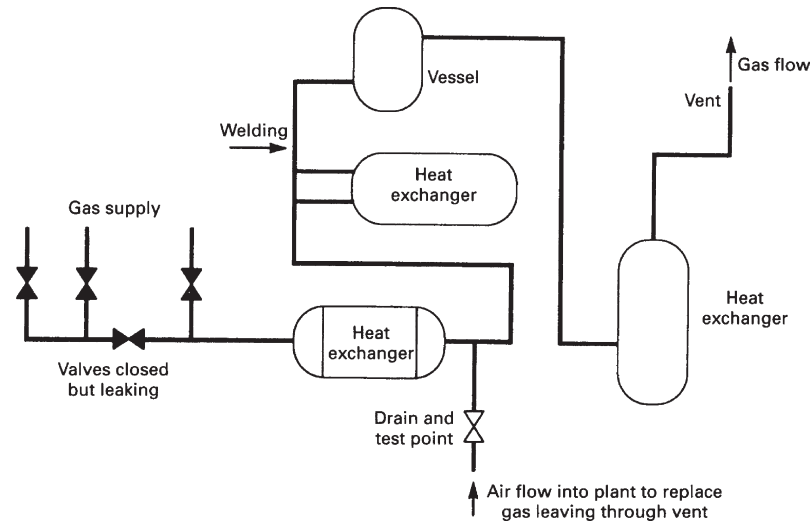
- (b)** A hydrogen line, about 12-in. diameter, had to be repaired by welding. The hydrogen supply was isolated by closing three valves in parallel (one of which was duplicated) (Figure 17-5). The line was purged with nitrogen and was tested at a drain point before welding started, to confirm that no hydrogen was present. When the welder struck his arc, an explosion occurred, and he was injured. The investigation showed that two of the isolation valves were leaking. It also showed why the hydrogen was not detected at the drain point: the drain point was at a low level, and air was drawn through it into the plant to replace gas leaving through a vent. The source of ignition was sparking, which occurred because the welding return lead was not securely connected to the plant (another familiar problem) [13].

FIGURE 17-5 A simplified diagram of a plant, showing why hydrogen gas was not detected at the drain point. (Reproduced with permission of the American Institute of Chemical Engineers. Copyright © 1995 AIChE. All rights reserved.)

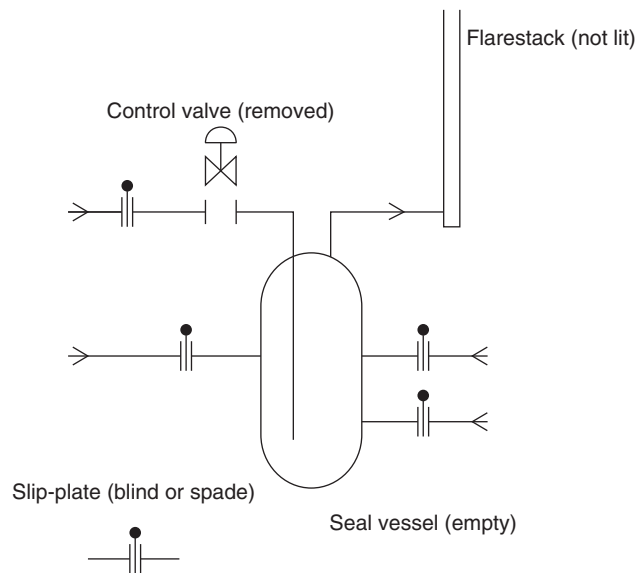
- (c)** A flarestack and its associated seal vessel were being prepared for maintenance. The seal vessel was emptied, and all inlet lines were slip-plated (blinded). A control valve located in one of the inlet lines, between the vessel and one of the spades, was removed (Figure 17-6). Five minutes later, an explosion occurred inside the equipment. Thirty seconds later, there was a second explosion, and flames came out of the opening where the control valve had been. As the result of the chimney effect, air had entered the system, and a mixture of air and vapor had moved up the stack. The source of ignition was probably another flarestack nearby [14].

FIGURE 17-6 When the control valve was removed, a chimney effect caused air to enter the system, and an explosion occurred. (Reproduced with permission of the American Institute of Chemical Engineers. Copyright © 1995 AIChE. All rights reserved.)

The flare system should have been purged with nitrogen before the lines were spaded or the control valve removed. At the very least, the open end should have been blanked as soon as the valve was removed.

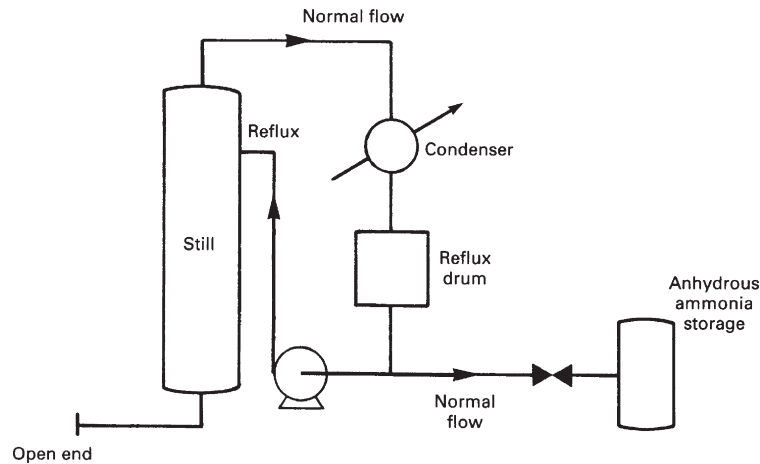
- (a)** Accidents have occurred because gas flowed from a product receiver into a plant that was shut down and depressured. In one incident,

FIGURE 18-1 Reverse flow occurred from the storage vessel to the open end.

ammonia flowed backward from a storage vessel, through a leaking valve, into a reflux drum, into a still, and out of an open end in the bottoms line, which was open for maintenance (Figure 18-1).

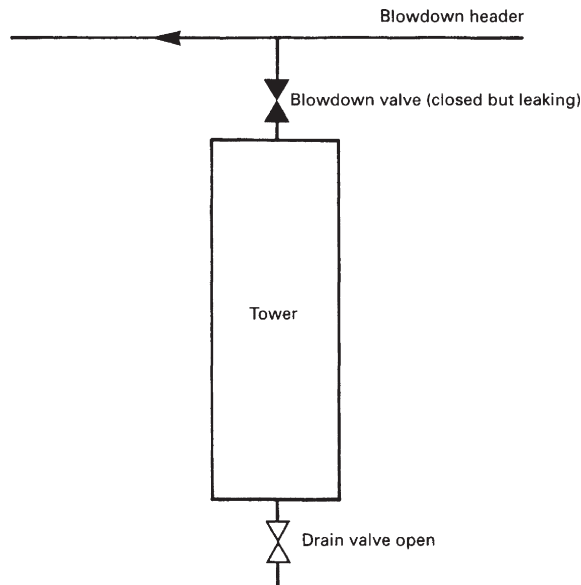
- (b) In another incident, a toxic gas in a blowdown header flowed through a leaking blowdown valve into a tower and out of the drain valve. The operator who was draining the tower was killed (Figure 18-2).
- (c) The contents of a reactor were pumped out into another vessel for further treatment. The pump delivery valve should have closed automatically when the reactor was empty, but on this occasion the automatic system was not working correctly and was on manual control. Fifteen minutes passed before it was closed, and during this time, steam traveled backward up the transfer line between the treatment vessel and the reactor and heated a heel of reaction product (about 150 kg), left behind in the reactor, from about 100°C (212°F) to about 175°C (365°F). At this temperature, the reaction product, a nitro compound, decomposed explosively, causing extensive damage [12].

FIGURE 18-2 Flow occurred from the blowdown header into the vessel and out of the drain valve.

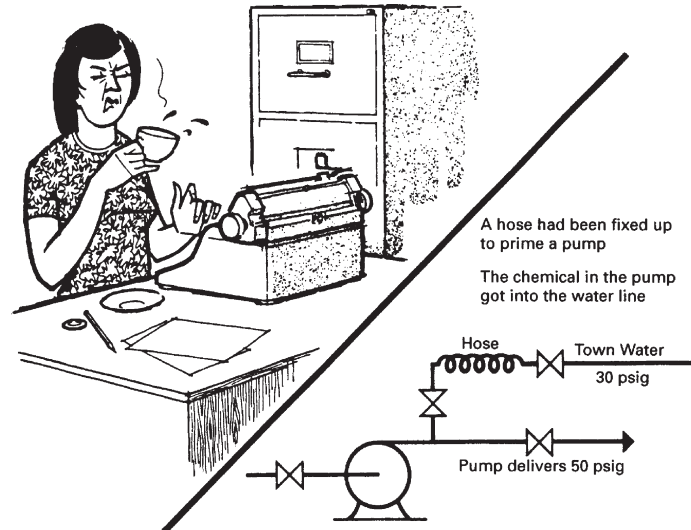
FIGURE 18-3 Never connect town water to process equipment.

Another incident is illustrated in Figure 18-3. Town water should never be directly connected to process lines by a hose [19] or permanent connections. A break tank should be provided.

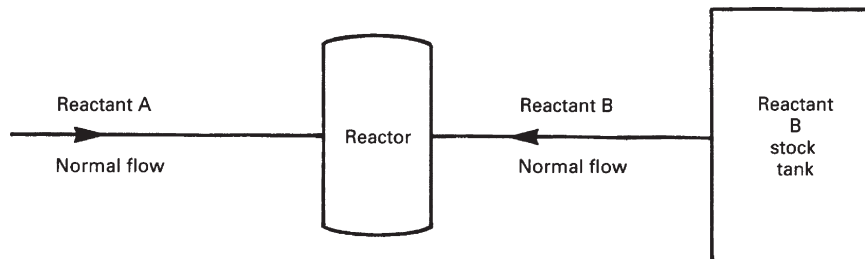
The most serious incidents resulting from reverse flow have occurred when reactant A (Figure 18-5) has passed from the reactor up the reactant B feed line and reacted violently with B.

In one incident, paraffin wax and chlorine were reacted at atmospheric pressure. Some paraffin traveled from the reactor back up the chlorine line and reacted with liquid chlorine in a catchpot, which exploded with great violence. Bits were found 30 m (100 ft) away [3].

A more serious incident occurred at a plant in which ethylene oxide and aqueous ammonia were reacted to produce ethanolamine. Some ammonia got back into the ethylene oxide storage tank, past several check valves in series and a positive pump. It got past the pump through the relief valve, which discharged into the pump suction line. The ammonia reacted with 30 m³ of ethylene oxide in the storage tank. There was a

FIGURE 18-5 Reverse flow of A occurred from the reactor into the B stock tank.

violent rupture of the tank, followed by an explosion of the vapor cloud, which caused damage and destruction over a wide area [4].

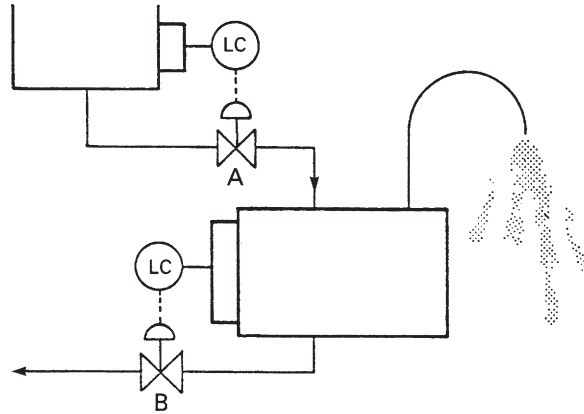
- (a)** Figure 18-6 shows part of an old unit. Valve A could pass a higher rate than valve B. Inevitably, in the end the lower tank overflowed.
- (b)** Raw material was fed to a unit from two stock tanks, A and B. Tank A was usually used; tank B was used infrequently. The raw material was pumped to a head tank from which excess flowed back, as shown in Figure 18-7. The system was in use for several years before the inevitable happened. Tank B was in use; tank A was full, and the flow from the head tank caused it to overflow.
- (c)** A funnel was installed below a sample point so that excess liquid was not wasted but returned to the process (Figure 18-8). What will happen if a sample is taken while the vessel is being drained?

FIGURE 18-6 Valve A could pass a higher rate than valve B, thus making a spillage inevitable.

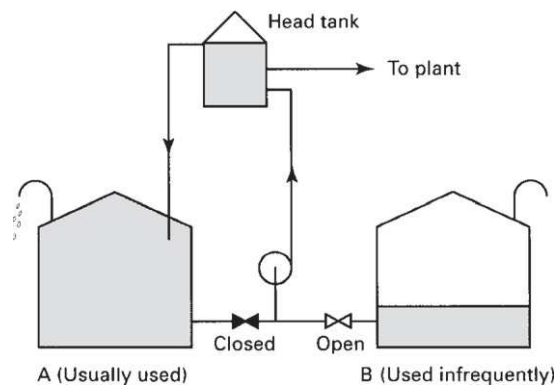
FIGURE 18-7 If A is full and suction is taken from B, A will overflow.

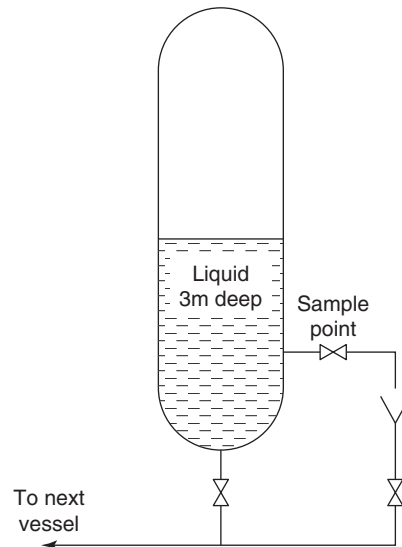
FIGURE 18-8 What will happen if the vessel is drained while a sample is being taken?

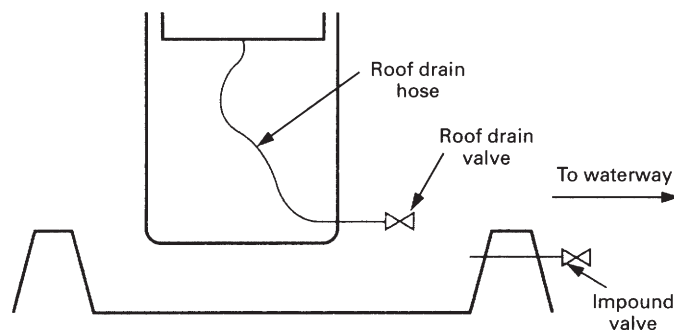
- (a) Figure 18-9 shows a floating-roof tank located in a dike. Rainwater can be drained from the roof into the dike and from the dike into a waterway. The team members are considering whether any substance other than water can get into the waterway. For this to occur, there would have to be a hole in the hose, and both valves would have to be left open. An inexperienced team may decide that a triple failure is so improbable that there is no need to consider it further.

FIGURE 18-9 Liquid other than rainwater can reach the waterway only if there is a hole in the hose and both valves are left open. This is not as unlikely as it seems at first sight. (Used with permission from *Hydrocarbon Processing*, Apr. 1992. Copyright © 1992 Gulf Publishing Co. All rights reserved.)

Someone with knowledge of the practicalities of plant operation would realize that during prolonged rain the operators may leave both drain valves open, whatever the instructions say, to avoid frequent visits to the tank. Any hole in the hose will then contaminate the waterway with oil [20].

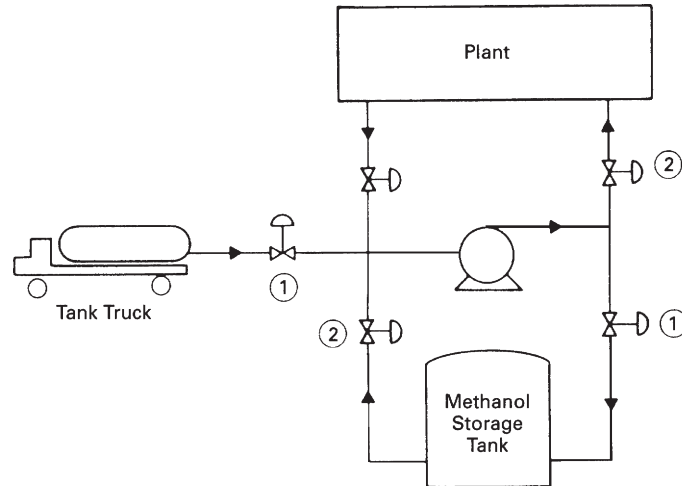
A tank truck was emptied. The pump had been started from the control room but had been stopped by means of a local button. The next job was to transfer some methanol from storage to the plant. The computer set the valves, but as the pump had been stopped manually, it had to be started manually. When the transfer was complete, the computer told the pump to stop; but as it had been started manually, it did not stop, and a spillage occurred [3].

FIGURE 20-1 A pump and lines, controlled by a computer, were used for several different jobs. The pump could also be started and stopped locally. (1) Valves open for first job; others closed. (2) Valves open for second job; others closed.

A thorough Hazop probably would have revealed that this error could have occurred. The control system could have been modified, or better still, separate lines could have been installed for the various different movements, thus greatly reducing the opportunities for error. The incident shows how easily errors in complex systems can be overlooked if the system is not thoroughly analyzed. In addition, it illustrates the paradox that we are willing to spend money on complexity but are less willing to spend it on simplicity [4]. Yet the simpler solution, independent lines (actually installed after the spillage), makes errors less likely and may not be more expensive if lifetime costs are considered. Control systems need regular testing and maintenance, which roughly doubles their lifetime

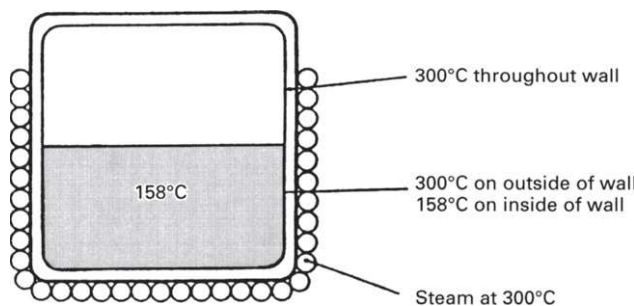
A reactor containing an uncompleted batch of 2,4,5-trichlorophenol (TCP) was left for the weekend. Its temperature was 158°C (316°F), well below the temperature at which a runaway reaction can start (believed at the time to be 230°C [645°F] but possibly as low as 185°C [365°F]). The reaction was carried out under vacuum, and the reactor was heated by an external steam coil supplied with exhaust steam from a turbine at 190°C (374°F) and a gauge pressure of 12 bar (Figure 21-1). The turbine was on reduced load, as various other plants were also shutting down for the weekend (as required by Italian law), and the temperature of the steam rose to about 300°C (570°F). The temperature of the bulk liquid could not

FIGURE 21-1 The Seveso reactor.

get much above 158°C (316°F) because of its heat capacity, and so below the liquid level there was a temperature gradient through the walls of the reactor, 300°C (570°F) on the outside, 158°C (316°F) on the inside. Above the liquid level, the walls were at 300°C (570°F) right through.
