Library of Congress Cataloging-in-Publication Data
Kletz, Trevor A.

What went wrong? : case histories of process plant disasters and how they could have been avoided / Trevor Kletz. —5th ed.

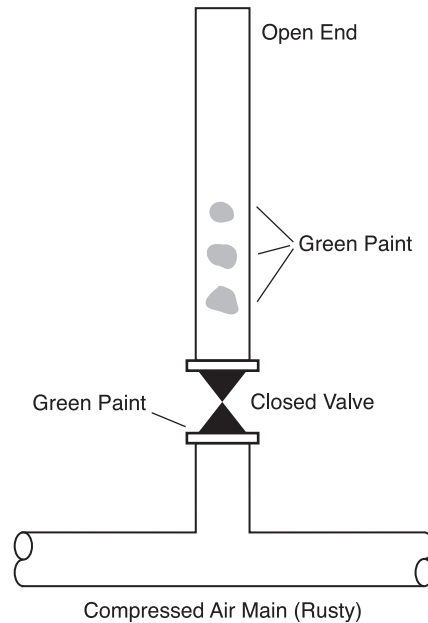
One of the sections was a short vertical length of pipe, 75 mm (3 in.) in diameter and ≈ 1.5 m (5 ft) long, sticking up above a compressed air main that was still in use (Figure 23-1). The valve between the pipe and the main was tagged to show that it was closed to protect equipment under maintenance. The short length of pipe was marked with several green patches. Unfortunately, there was also some green paint on the flange below the isolation valve. This green paint might have been the remains of an earlier job or it might have accidentally got onto the flange while the pipe above it was being sprayed. The mechanic who had been asked to remove the pipe broke this flange. There was a sudden release of compressed air at a gauge pressure of ≈ 7 bar (100 psig). Fortunately, the mechanic escaped injury.

The mechanic did not, of course, realize that the compressed air line was still in use. Like the old pipes he was removing, it was rusty and he assumed it was out of use.

FIGURE 23-1 The lower flange was unbolted in error.

which joint or joints should be broken. The report on the incident stated that in the future, maintenance workers should be shown precisely which piece of equipment is to be maintained, which joint to break, and so on. However, experience shows that this is not enough. Before starting work, the maintenance worker may go for tools or for spares and then come back and break the wrong joint or remove the wrong valve. Equipment to be worked on should be numbered or labeled and the number or name put on the permit-to-work. If there is no permanent number, a numbered tag should be tied to the flange that is to be broken, the valve that is to be changed, or the pipe that is to be cut (and at the point at which it has to be cut).

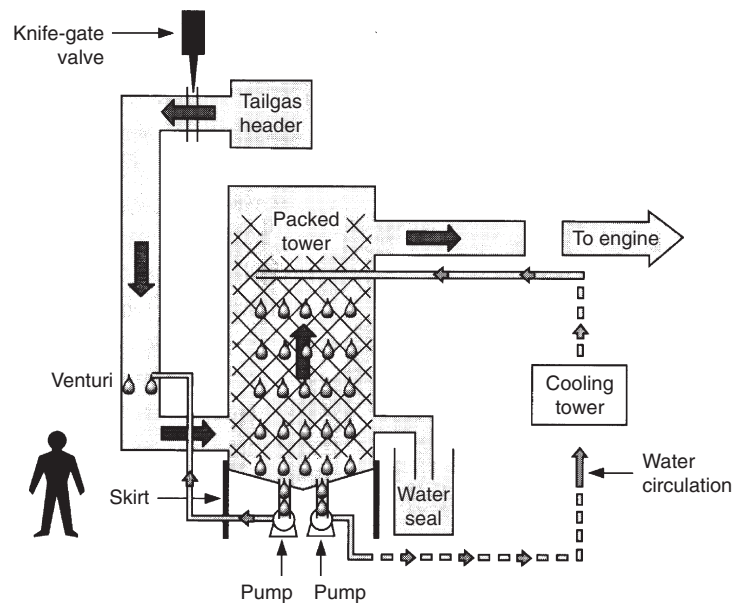
To save energy, a company decided to use a flammable and toxic waste gas (known as tail gas) to run a diesel engine and generate power. The gas first had to be cooled and this was carried out in the equipment shown in Figure 24-1. Two pumps were located inside the skirt of the column. One pumped some of the wash water from the base of the column into the venturi and the other circulated the bulk of the water through a cooling tower and back to the top of the column. There were four arched openings in the base of the column so it was not considered a confined space. However, the location was congested, and this reduced ventilation.

An electrician and an engineering student were asked to repair the circulation pump. The procedure they were told to follow, never written down, was to close the knife-gate valve, thus stopping the flow of gas to the column, and then to get rid of the gas already in the column as well as any leaking past the valve—a type that does not give complete isolation—by draining the water seal. There were no valves in the suction lines to the two pumps.

FIGURE 24-1 A man was overcome by leaking gas while replacing a pump in a confined space. From reference 7. (Reprinted with the permission of the Institution of Chemical Engineers.)

Unfortunately, the electrician and the student forgot to drain the water seal. Nevertheless, they removed the pump and blanked the open end without incident. They then refilled the tower with gas to prevent air from leaking in. Later that day they replaced the pump, presumably using the same procedure as before. While they were working on their hands and knees, they felt unwell. Before they could get out, the student noticed that the electrician had become unresponsive. Fortunately, the student was able to pull him out and he soon recovered.

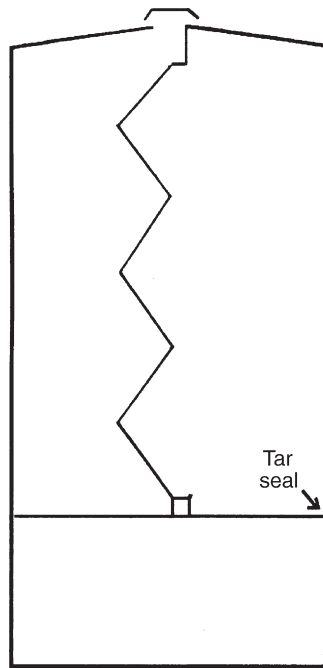
At a guess, the volume of the gasholder was several thousand m^3 and its height was $\approx 3 \times$ its diameter. To get inside it, we had to go up a staircase onto the roof, through an opening in the center, and then down a Jacob's ladder, a folding ladder, onto the disc. As Figure 24-2 shows, during half the descent we were clinging to the wrong side of the sloping ladder. Fortunately, the gasholder was nearly empty and the angle of the ladder was not too great.

FIGURE 24-2 Diagram of dry gasholder showing Jacob's ladder.

atmosphere above the disc in the gasholder was not tested before we entered and there was no entry permit and no standby man, although the foreman mentioned that strictly speaking there should have been one (this was many years ago). The whole experience was eerie, and I have never forgotten it.

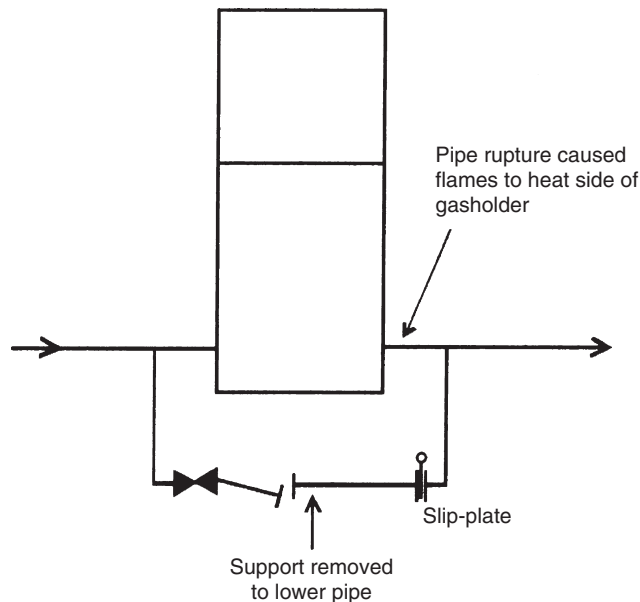
The gasholder contained coke oven gas. A section of the bypass pipe was removed for cleaning as it was partially blocked with naphthalene. On the inlet side, the section of pipe was isolated by a closed valve (Figure 24-3) and on the outlet side by a blind slip-plate. When the missing section was replaced, it was found that the pipe coming from the valve had sunk and the two pipes could not be lined up. It was then decided to remove the support at the end of the replaced section so that it would also sink. This involved welding. It ignited gas that had leaked through the closed valve and the resultant explosion tore the outlet main close to the gasholder. The flame from this much larger leak went up the side of the gasholder and five minutes later the gasholder exploded. Either the heat distorted the walls or evaporated the tar. Either way, this would allow gas to bypass the disc and mix with the air in the upper

FIGURE 24-3 Gas leaked through a closed valve while burning was in progress nearby.

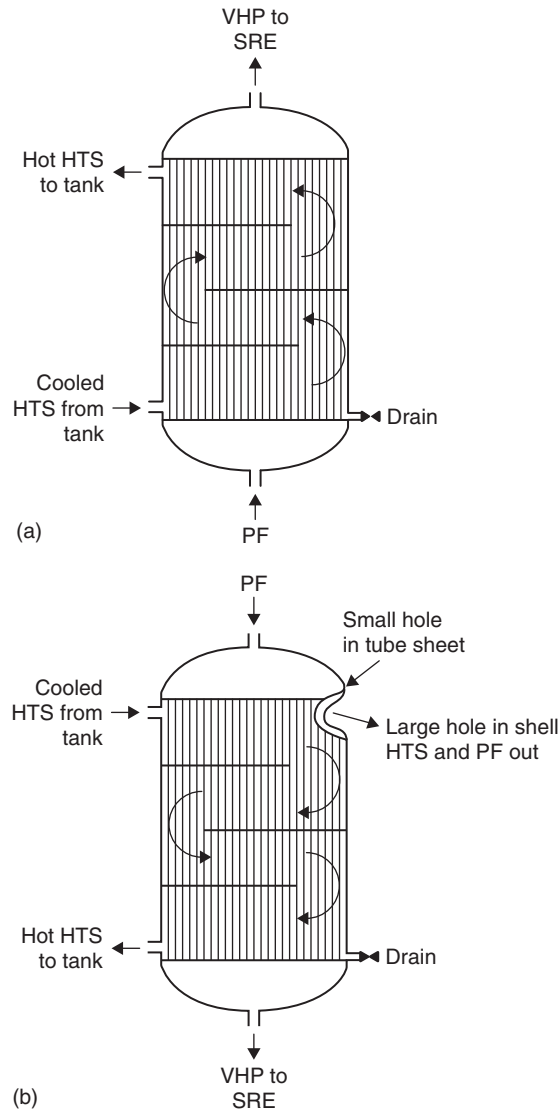
Figure 25-1a shows the original design of a reactor. Hot feed gas (PF [preheated feed]) was passed upward through catalyst tubes 3 m (10 ft) long. The heat of reaction was removed by circulating a molten salt (HTS [heat transfer salt]) through the shell. Note that the flow of this liquid was also upward.

The hot exit gases were cooled in a waste heat boiler. During a review of the model, the contractors pointed out that the boiler required an expensive structure to support it. They could avoid this cost, they said, by reversing both flows through the reactor, as shown in Figure 25-1b, and putting the boiler at ground level. This was agreed.

The change in design was made without following the company's normal procedure for control of change. Reversing the flow seemed

FIGURE 25-1 (a) Original design of reactor. (b) Reversing the flow allowed a gas bubble to be trapped below the top tubesheet and led to overheating of the tops of the tubes. PF = preheated feed; HTS = heat transfer salt; VHP = very hot product gases; and SRE = steam raising exchanger. From reference 10. (Reprinted with the permission of the Institution of Chemical Engineers.)

It might have been possible to retain the downward flow and to vent any gas bubbles back to the suction tank in the salt system. However, preventing the formation of bubbles is better than letting them form and then getting rid of them.

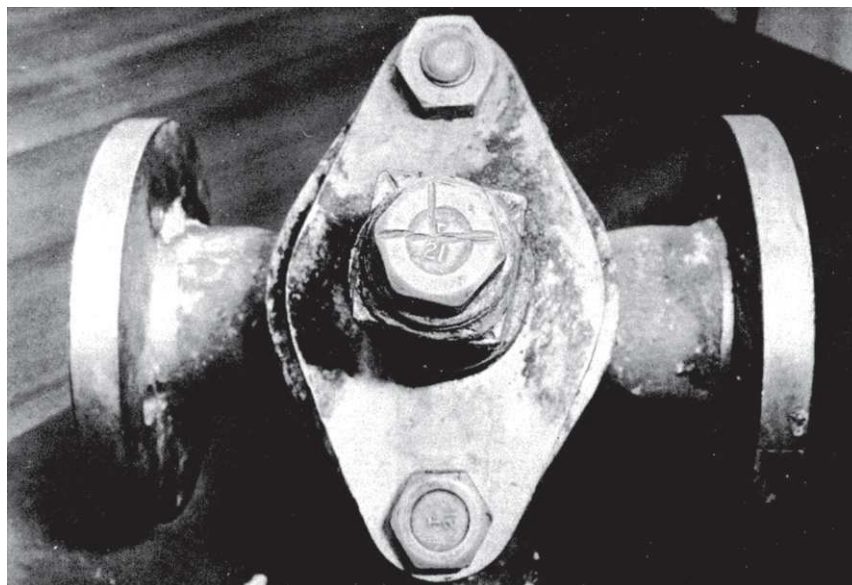
Figure 25-3 shows a three-way cock in which the top of the central bolt has been marked to show the position of the cock. This was presumably done because the marks on the plug itself are hard to see. They are just faintly visible in the photograph.

Originally the marks on the bolt corresponded to those on the plug. At some time, two washers were placed underneath the bolt. It could no longer be screwed right in and the marks no longer corresponded.

FIGURE 25-3 The central bolt was marked to show the position of the cock. When two washers were inserted under the bolt, it could not be screwed down as far as before and the marks no longer corresponded with the position of the cock.

Most of the operators on the unit set the cock according to the marks on the bolt. Ultimately, this led to misdirection of a process stream, formation of an explosive byproduct, and an explosion.

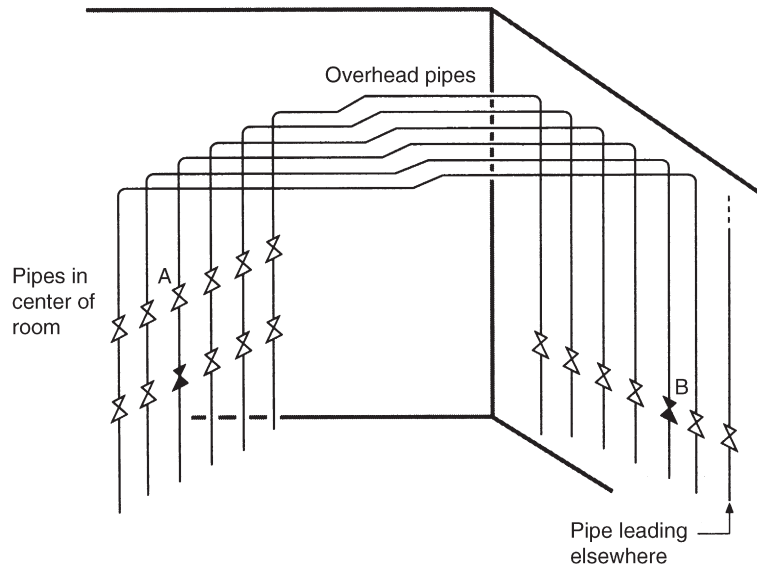
The fine adjustment valve A in Figure 27-1 had to be changed. The operator closed the valve below it. To complete the isolation, he intended to close the valve on the other side of the room in the pipe leading to valve A. He overlooked the double bends overhead and closed valve B, the one opposite valve A. Both of the valves that were closed were the third from the ends of their rows. Note that the bends in the overhead pipes are in the horizontal plane. When the topwork of valve A was unbolted, the pressure of the gas in the line caused the topwork to fly off and hit the wall, fortunately missing the mechanic who had unbolted it.

FIGURE 27-1 To change valve A, the operator closed valve B and the valve below valve A. Both closed valves are shown in black. From reference 5. (Reprinted with the permission of the Institution of Chemical Engineers.)

The report on the incident recommended various changes in the instructions to make the duties of people who prepare equipment for maintenance clearer than they were. They were told to trace lines to make sure that the correct isolations have been made.

Color coding of the pipes or valves would have been much more effective but was not considered. The default action of many of the people

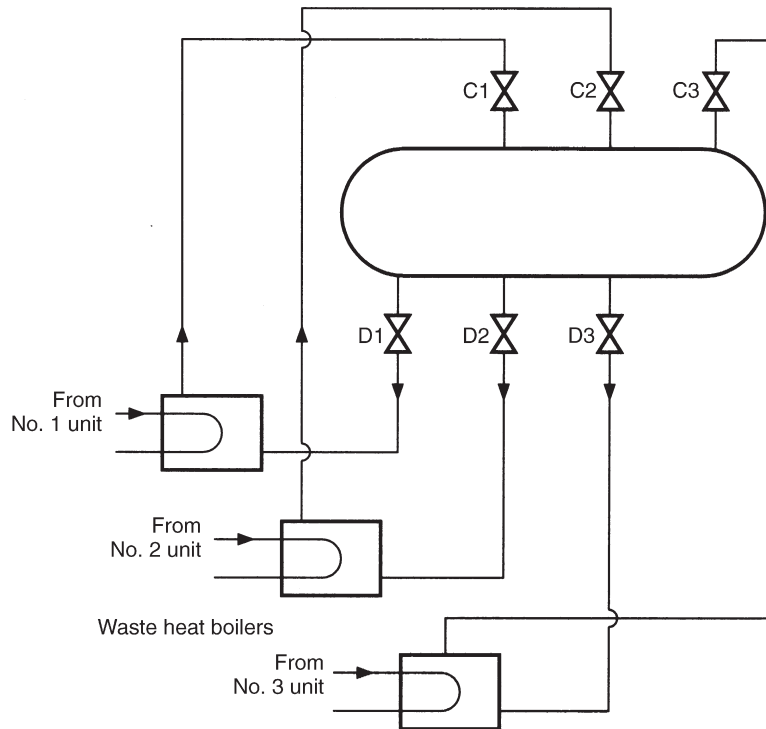
Figure 27-2 shows a similar situation. To save cost, three waste heat boilers shared a common steam drum. Each boiler had to be taken off

FIGURE 27-2 Note the positions of isolation valves on the common steam drum. (Reprinted with the permission of the Institution of Chemical Engineers.)

line from time to time for cleaning. On two occasions, the wrong valve was closed (D3 instead of D2) and an online boiler was starved of water and overheated. The chance of an error was increased by the lack of labeling and the arrangement of the valves—D3 was below C2. On the first occasion the damage was serious. High temperature alarms were then installed on the boilers. On the second occasion they prevented serious damage but some tubes still had to be changed. A series of interlocks were then installed so that a unit had to be shut down before a key could be removed; this key was needed to isolate the corresponding valves on the steam drum.

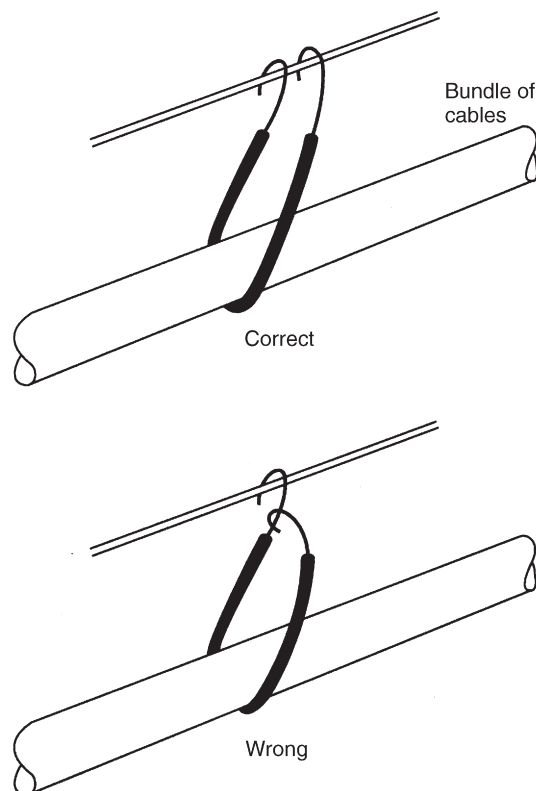
A bundle of electric cables was supported by cable hangers. The hooks on the ends of the cable hangers were curved over the top of a metal strip (Figure 27-3, *top*). The electric cables had to be lowered to the ground to provide access to whatever lay behind them and then replaced. They were put back as shown in the second part of Figure 27-3. This increased the load on the upper hooks. One failed, thereby increasing the load on the adjacent ones and then they also failed. Altogether, a 60-m (200-ft) length of cables fell down [2].

FIGURE 27-3 Different ways of supporting a bundle of cables. (Reprinted with the permission of the Institution of Chemical Engineers.)

Many people would fail to see this hazard. Training is impracticable if, as is probably the case, many years will pass before the job has to be done again. The best solution is to use cable hangers strong enough to carry the weight even if they are used incorrectly.

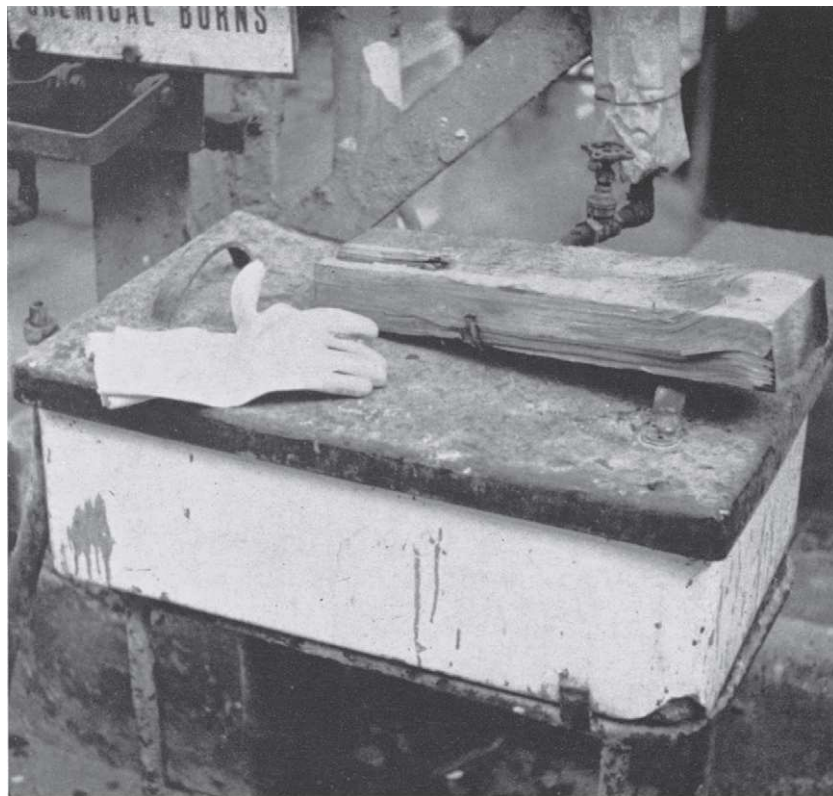
Washbasins filled with water were installed at a plant so that anyone splashed with a corrosive chemical could wash it off immediately. The basins were covered to keep the water clean, but people used the covers as tables (Figure 27-4a). Figure 27-4b shows the action taken, and Figure 27-4c shows a better solution.

FIGURE 27-4 (a) The cover over the washbasin was used as a table. (b) The solution. (c) A better solution.

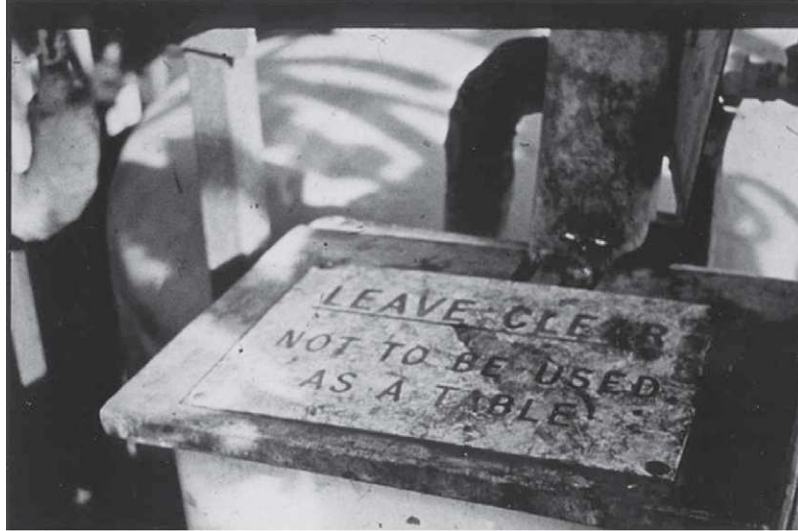
(b)

Perhaps there is something wrong with our educational system or company culture when educated and professionally trained people take the action shown in Figure 27-4b.

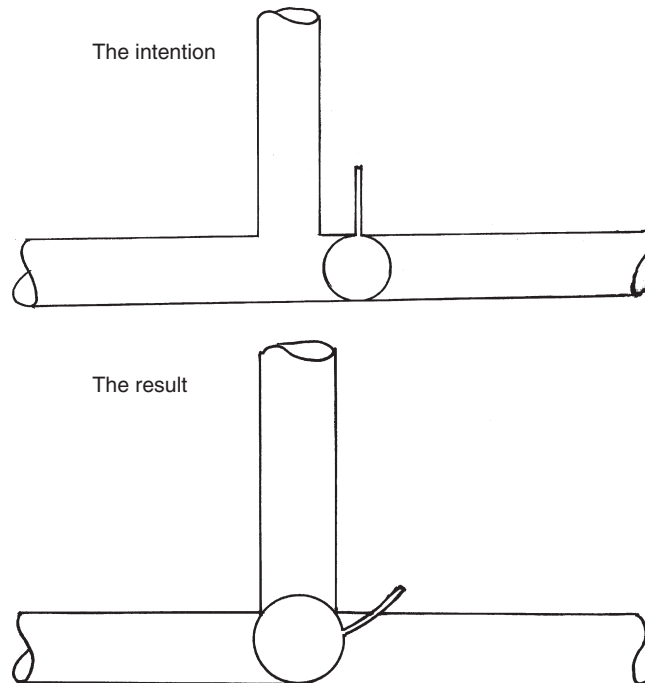
Some changes had to be made to a length of low-pressure ventilation ductwork that was <0.6 m (24 in.) in diameter. To keep the rest of it in operation during the modification, a bypass of almost the same diameter was made around the affected section. To isolate this section,

FIGURE 31-1 An inflatable stopper with a rigid stem was wanted, but a *similar* one was fitted instead.

the contractor was told to drill a hole in the main duct and push an inflatable rubber balloon through it. This is a standard item of equipment that had been used successfully on previous occasions. The drawing specified “[manufacturer’s name] inflatable pipeline stopper or similar.” This manufacturer’s stopper is fitted with a metal inflation tube that ensures that the balloon remains in position beneath the insertion hole. The contractor instead used a balloon fitted with a flexible tube. The inflated balloon moved a little way down the duct and blocked the bypass line (see Figure 31-1). Ventilation flow stopped. The operators in the control room had been warned that changing over to the bypass line might cause the low flow alarm to operate, and therefore they ignored it. Some time elapsed before they realized what had happened.

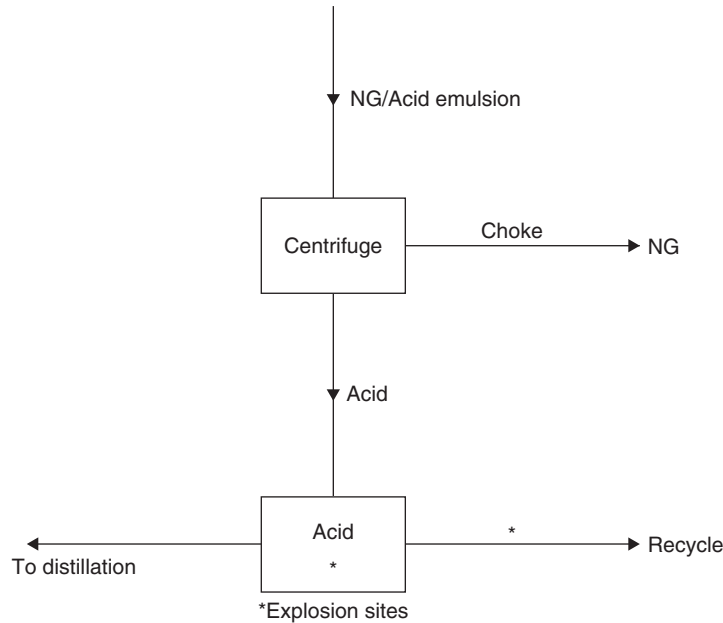
FIGURE 32-1 A choke caused NG to enter the acid line. A Hazop could have foreseen this.

The NG was separated from surplus acid in a centrifuge (Figure 32-1). The NG caused the plastic pipe to swell so that some of the NG passed down the acid line into the acid tank and settled on top of the acid. Two explosions occurred, one in the acid tank and one in the recycle line out of the tank. Vibration probably triggered the first explosion, and the sun's heat probably triggered the second. A Hazop could have prevented the explosions, provided the team realized that "Less of" flow could occur in the NG line.

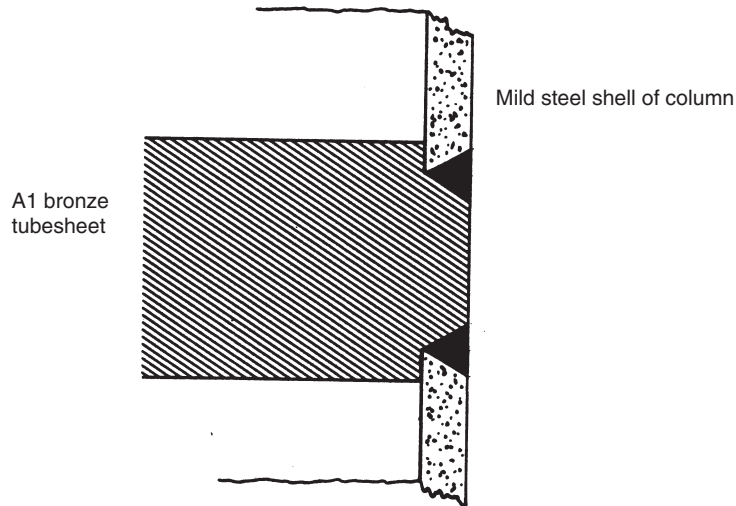
FIGURE 32-2 No one at the plant was aware of this unusual method of construction.

An unusual method of construction produced another hidden hazard. A steel fractionation column was fitted with an internal condenser that had an aluminum-bronze tubesheet. It had the same diameter as the vessel but was welded to it in an unusual way, as shown in Figure 32-2. One of the welds cracked in service, and flammable vapor escaped. Fortunately, it did not ignite.

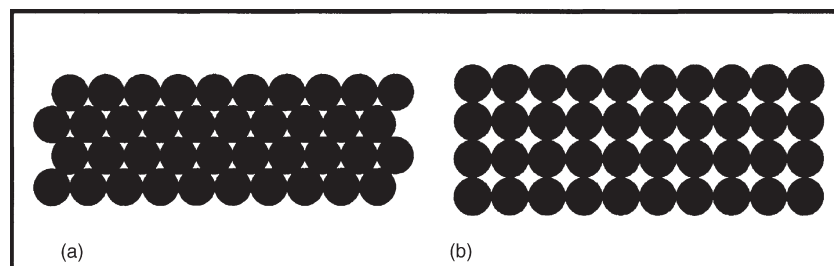
FIGURE 32-3 (a) Close packing of uncharged spheres. (b) Open packing of charged spheres.

showed that this amount of powder would fit into the bags, nevertheless it backed up into the machine and caused it to stall. It had to be stripped down and cleaned before packing could continue.

Experiments showed that rapid filling of the powder lowered the bulk density by 10% as charges of static electricity on the particles pushed them farther apart. Instead of being closely packed as in Figure 32-3a, they were more openly packed as shown in Figure 32-3b. As the output of the plant was large, a machine for eliminating the static charge was designed and installed [13].

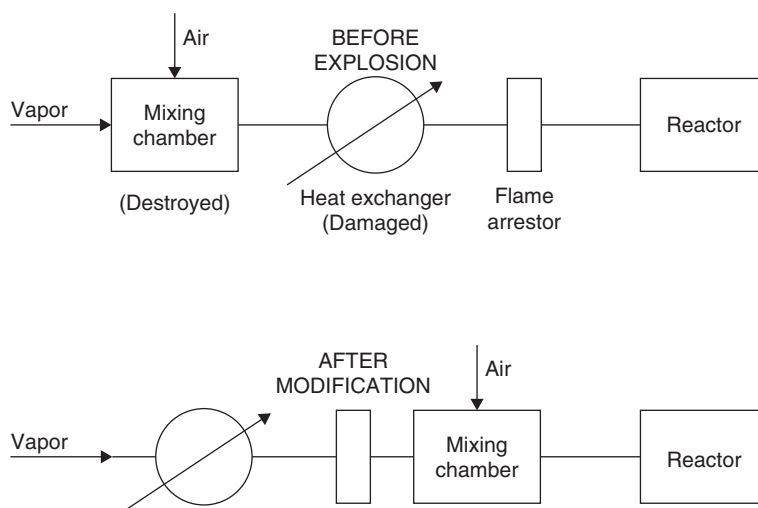
After a two-year operation, an explosion demolished the mixer and damaged the heat exchanger. The probable source of ignition was an

FIGURE 32-4 Layout of equipment in vapor phase oxidation unit before and after explosion in reactor.

unlikely one. The vaporizer had to be cleaned from time to time. Various agents had been used including acids, which had attacked the vaporizer and deposited a mixture of metal and organic residues in the mixer. These oxidized and became hot enough to ignite the flammable mixture of reactant vapor and air in the mixer.

When the plant was repaired, the reactant vapor and air were mixed immediately before entering the reactor. A flammable mixture was then present only in the reactor. This is an inherently safer solution [17]. This could have been done in the original design if someone had realized that flammable mixtures are easily ignited and that we should therefore avoid the need for them when possible and assume they might explode when their presence is essential. In addition to the necessary repairs, the whole plant was strengthened.

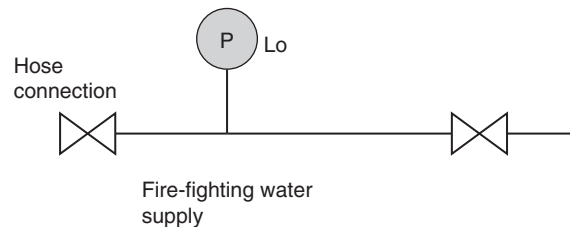
The pressure of a water supply was normally high enough for it to be used for firefighting. If the supply pressure fell, a low-pressure alarm sounded and an alternative supply of water was then made available. When someone isolated the water supply in error, the trapped pressure in the line prevented the alarm from operating. The instrumentation could do what it was asked to do—detect a low pressure—but not what its designers wanted it to do—that is, detect that the water supply was unavailable (see Figure 33-1).

FIGURE 33-1 When the valve on the right was closed, the low-pressure arm became ineffective.

As often happens, something else was wrong as well: the valve in the water line should have been locked open but was not. Valves that are locked open for safety reasons should be listed and checked periodically to make sure that they are still locked. They are part of a protective system.

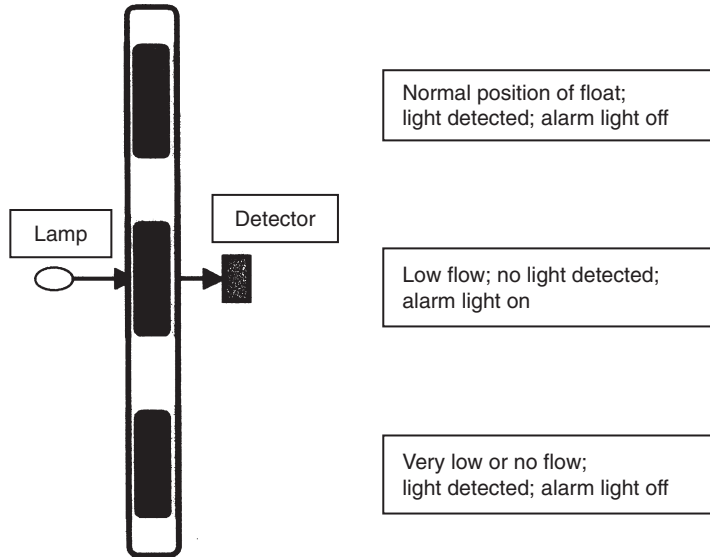
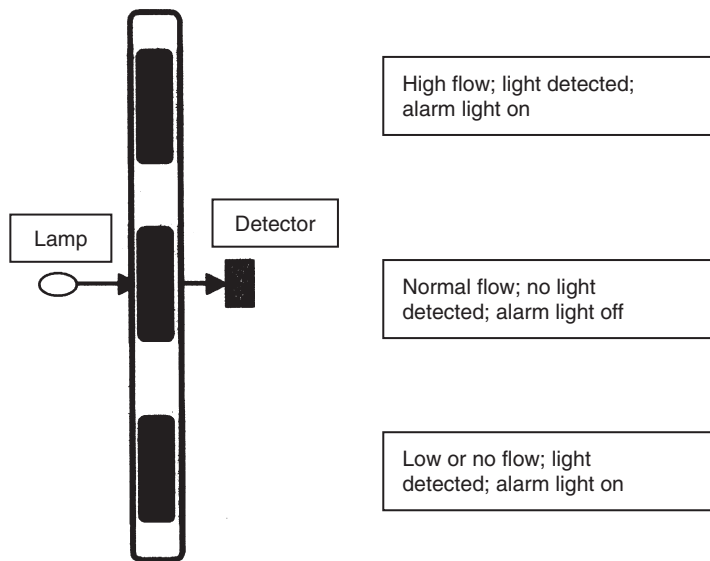
The design had limitations. If the flow diminished only slightly, the light beam remained broken and the alarm light stayed on after the alarm bell was silenced. However, if the flow fell substantially or stopped completely, the float dropped farther, the light beam was no longer broken, and the alarm light went out (Figure 33-2a). One day when the flow actually failed, the operator canceled the alarm, but with no light to remind him he was distracted by other problems and forgot that the gas flow had stopped. Several hours passed before this was discovered.

FIGURE 33-2 (a) Original design of rotameter low-flow alarm. (b) Revised design of rotameter low-flow alarm.

Afterward, the design was changed so that the light beam was broken when the flow was normal but fell on the light sensor if the flow changed (see Figure 33-2b). The alarm light then remained lit as long as the low flow continued. As a bonus, it was also activated by a high flow.

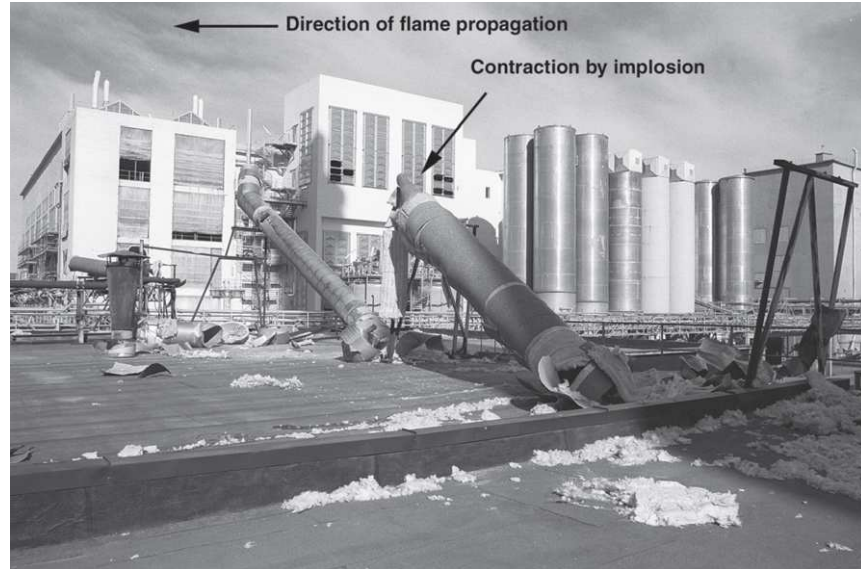
During shutdowns, the ammonia plant was swept out with nitrogen, which contaminated the carbon dioxide. Nitrogen has twice the thermal conductivity of hydrogen, so the hydrogen measurements were ignored until the nitrogen had been swept out of the pipeline. You have already guessed what happened: air got into the transfer line during this period and an explosion occurred; 850 m (2,800 ft) of the pipeline was destroyed (Figure 33-3).

The source of the air was never identified. Following an earlier incident, different types of connector were used for compressed air and nitrogen hoses, so compressed air could not have been used by mistake

FIGURE 33-3 The result of hydrogen and air entering a pipeline. From reference 1. (Reprinted with the permission of the American Institute of Chemical Engineers.)

instead of nitrogen for sweeping out the ammonia plant. The source of ignition may have been heat from cutting a bolt.

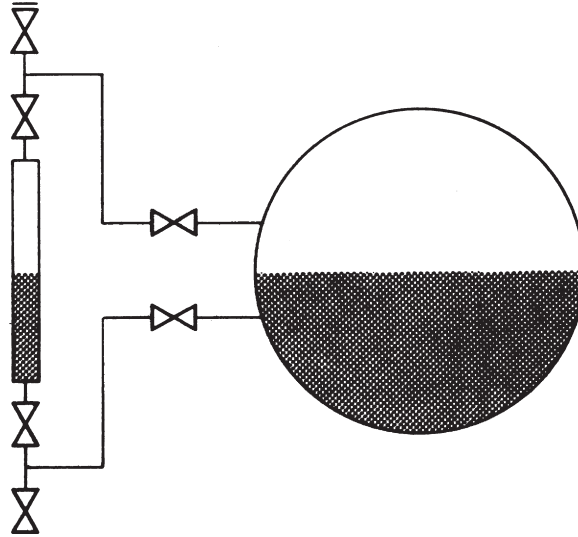
A sight-glass 1.2 m (4 ft) long was connected to vessel branches 0.6 m (2 ft) apart as shown in Figure 33-4. It will indicate the correct level only when the liquid in the vessel is between the two branches. If the liquid level is below the lower branch, the liquid in the sight-glass is isolated and its level cannot fall. If the liquid level is above the upper branch, vapor will be trapped in the upper part of the sight-glass. As the level rises, this vapor will be compressed. If any noncondensable gas is present, the

FIGURE 33-4 A level glass with a limited range. From *Chemical Engineering Progress*, July 1980. (Reprinted with the permission of the American Institute of Chemical Engineers.)

pressure in the sight-glass will rise and the level in the sight-glass will be depressed below the level in the vessel.

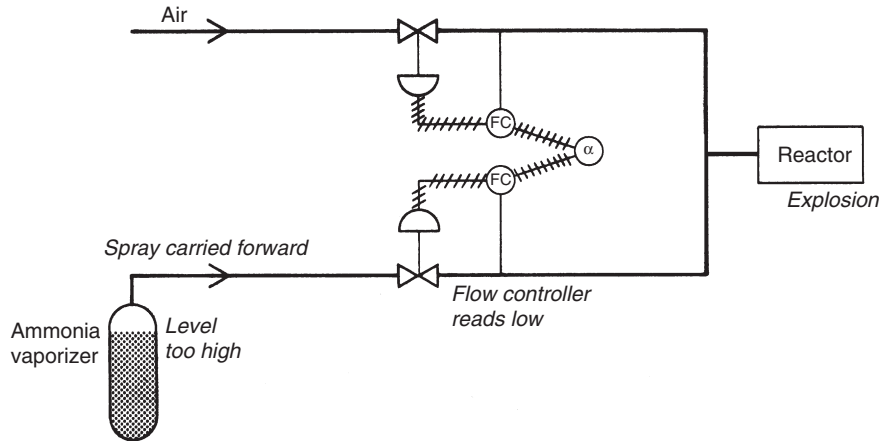
Ammonia was vaporized, mixed with air, and then passed over a catalyst. The ammonia and air flows were measured, and a flow ratio controller was supposed to keep the ammonia concentration below the explosive level (Figure 33-5). The level controller on the vaporizer was out of order, and the level of ammonia was being controlled manually. The level got too high and droplets of ammonia were carried forward. All flow measurements are inaccurate when spray is present, so the flow ratio controller did not detect the increased flow of ammonia and an explosion occurred. The size of the error in the flow measurement depends on the detailed design; if the spray increases the density of the gas by 50%, the flow of vapor and liquid could be 25% higher than the flowmeter reading.

FIGURE 33-5 An increase in the level in the vaporizer led to an explosion in the nitric acid reactor. From *Chemical Engineering Progress*, July 1980. (Reprinted with the permission of the American Institute of Chemical Engineers.)

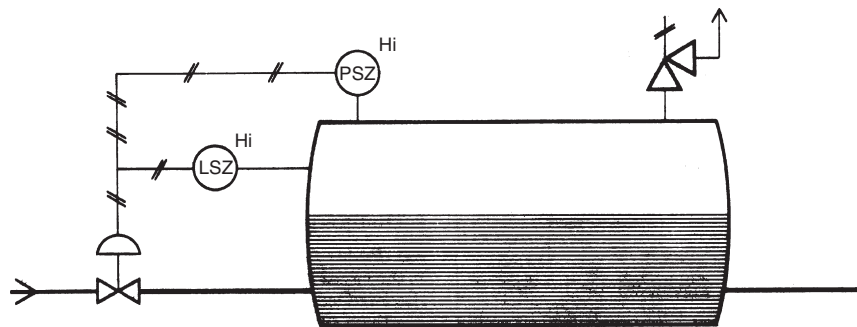
FIGURE 33-6 The designer of this system seemed unaware of the difference between vapors and noncondensable gases. From *Chemical Engineering Progress*, July 1980. (Reprinted with the permission of the Institution of Chemical Engineers.)

petroleum gas (LPG) is fitted with a level controller (not shown) and, in addition, a high-level trip to isolate the inlet line if the level gets too high (Figure 33-6). The high-level trip might fail; the relief valve will then lift and discharge liquid to the atmosphere so a high-pressure trip is installed as well.

If the space above the liquid contains some nitrogen or other noncondensable gas, the system will work. As the level rises, the gas will be compressed and the pressure will rise gradually. However, if no noncondensable gas is present and the level rises slowly, the system will not work.

The vapor will condense and the pressure will not change until the vessel is completely full of liquid. The pressure will then rise too rapidly for the high-pressure trip to operate and the relief valve will lift.

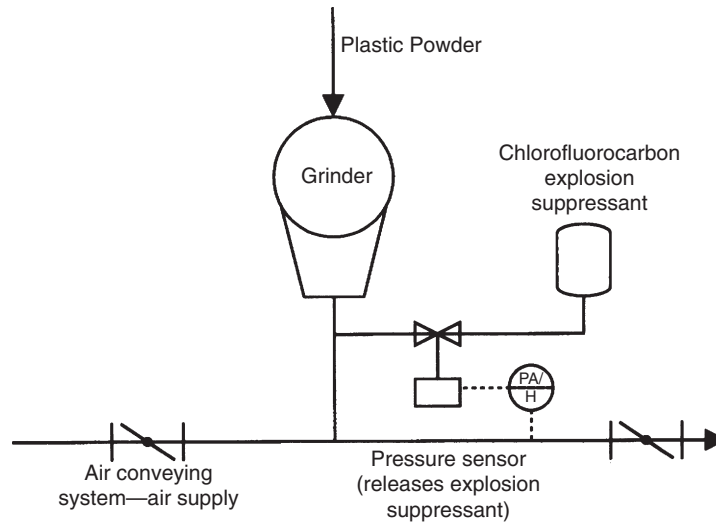
FIGURE 33-7 Accidental operation of the protective equipment—the explosion suppressant—caused an explosion. From reference 2. (Reprinted with the permission of the American Institute of Chemical Engineers.)

A plastics manufacturing plant included a grinder to eliminate over-size particles. A stream of air removed the ground powder. To prevent a dust explosion, there was an explosion suppression system: if a pressure sensor detected a rise in pressure, chlorofluorocarbon (CFC) was released into the grinder and its associated piping to quench the explosion (Figure 33-7).

The system was in use for nearly 20 years but was never called upon to operate. Then the grinder exploded and the cause was the suppression system. An upset in another part of the unit allowed water to get into the grinding system and form a slurry with the powder. Some of the water or slurry worked its way into the branch leading to the pressure detector. This detector was very sensitive—the pressure exerted by only a few inches of water was sufficient to activate it—so the suppression system

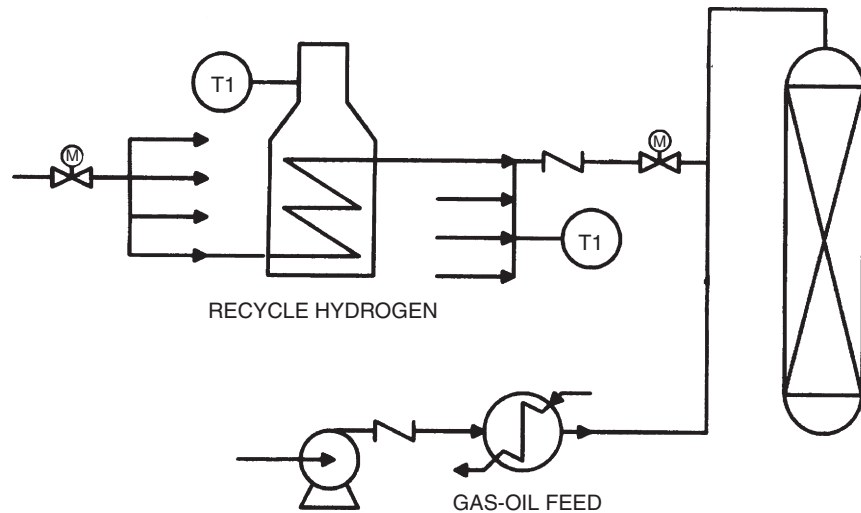
A tube rupture and fire in a furnace were the result of too little measurement and control. Two furnaces heated the hydrogen supply to a hydrogenation reactor in four parallel streams (Figure 33-9). The check valve in the combined line beyond the heaters was leaking. When the unit was shut down, liquid flowed backward from the reactor to the furnaces and settled in a bend in a low point of one stream. This restricted the flow in that stream and the tube got too hot. It did not rupture immediately but expanded more than usual; this caused a small crack and leak elsewhere in the furnace, in the convection section of the furnace. The leak ignited and the flame impinged on another part of the tube, which ruptured. The resulting fire damaged half the tubes. Replacement took six weeks and cost \$1 million, but the consequential loss was much greater.

FIGURE 33-9 Restricted flow in one of the parallel streams led to a tube rupture and fire. From reference 4. (Reprinted with the permission of Elsevier (United Kingdom).)

When the furnace was rebuilt, changes were made to the design to reduce the stress in the convection section, more temperature measurements were installed, isolation and control valves were installed in each of the four paths, and fire-protected remotely operated emergency isolation valves were fitted so that ruptured tubes could be isolated quickly.

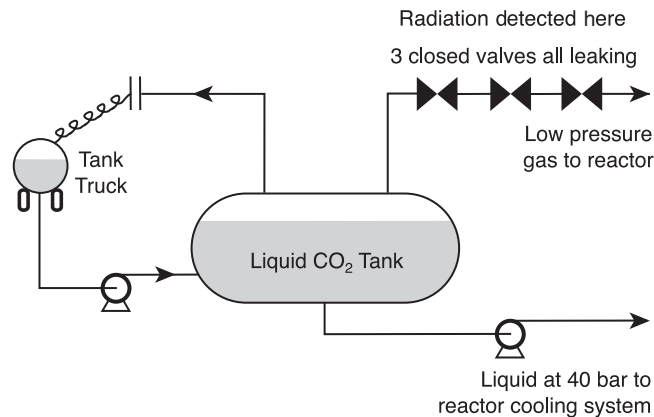
A routine test showed a higher level of radioactivity than usual near this gas line. It was then found that three closed valves in this line were all leaking and some gas was flowing backward into the storage tanks. It might therefore have got into the tank trucks during recent deliveries and contaminated the next load, which might have been delivered to a manufacturer of carbonated drinks. Many tests were carried out, no contamination was found, and calculations showed that even if it had occurred, the dose to the public would have been negligible. Anyone drinking a liter of a contaminated carbonated drink would have received

FIGURE 34-1 Contaminated gas leaked through three valves into the fixed tank and from there could have entered the tank truck.

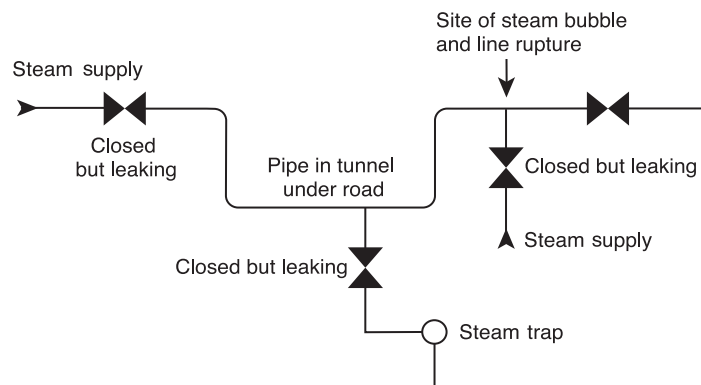
- The steam main went down through a tunnel under a road, rose up on the other side, and was joined by another supply line (see Figure 34-2).
- Following flooding, someone entered the tunnel to inspect the insulation. As the steam trap in the tunnel was blowing, it was isolated before entry was allowed but was not reopened afterward.
- The steam supply valve located before the tunnel was reached, as well as the valve on the other supply line, were both closed and both were passing. The leak in the first valve filled the dip in the main with condensate and the leak in the other valve maintained a steam bubble in the higher part of the main.
- Ultimately, the cold condensate completely filled the dip and overflowed into the horizontal part of the main, causing the steam bubble to condense. The resultant surge pressure ruptured the main at a T-joint, the weakest part.

FIGURE 34-2 Condensate filled the dip in the steam main and overflowed into the horizontal section on the right, condensing a steam bubble. The resultant water hammer ruptured the main.

Afterward, the company trained more than 700 employees on the operation of steam systems. Consultants surveyed the steam system, including 3,000 traps. More than 100 were repaired or replaced, and a better system for their inspection and maintenance was set up. However, many other steam mains have also failed due to water hammer. The hazard is well known and has often been described, for example, in the booklet *Hazards of Steam*, first published by Amoco in 1963 and revised by BP in 2004 [9]. A similar incident had occurred in the same power station 25 years earlier. Why did the company not learn from its own and others' experience?

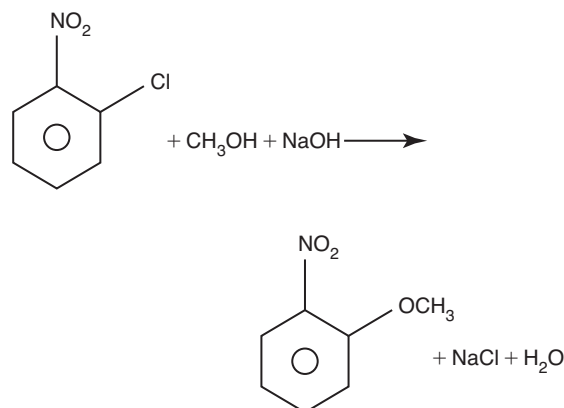
One day, after replacing the manway cover (step 3), the operator forgot to switch the stirrer back on. There was no mixing, and the caustic soda plus methanol (added in step 5) formed a separate layer. No reaction occurred,

FIGURE 35-1 Late mixing of this reaction led to a leak that covered 75 acres.

and the operator had to apply heat instead of cooling to the jacket to maintain the temperature at 80°C (175°F). When the operator realized that the stirrer was not running, he switched it on. A very rapid reaction occurred, the temperature rose to at least 160°C (320°F), and the pressure rose to 16 bar gauge (230 psig). Most of the contents of the reactor, 10 tons of liquid, were discharged through the relief valve and a yellow deposit was distributed over 300,000 m² (75 acres) of a builtup area, a suburb of Frankfurt, Germany.

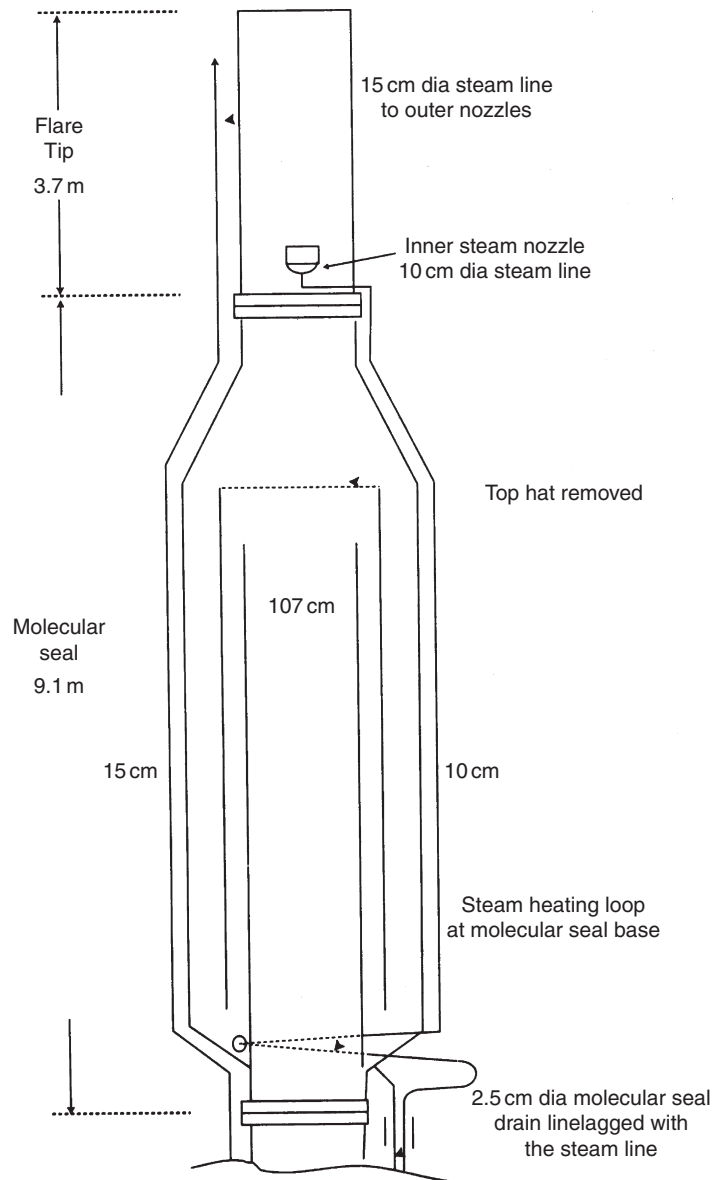
Many explosions have occurred in flarestacks because a normally continuous flow of gas failed or fell to a very low level and air diffused down the stack, forming an explosive mixture (see Chapter 6). To reduce such diffusion, many companies have installed molecular seals: the gas leaving the stack and any air diffusing down follow a labyrinthine path, as shown in Figure 36-2. However, these seals have disadvantages. Carbon from incompletely burned gas can fall into the bottom of the seal and block the flow. Ideally, material discharged from a relief valve should follow a simple and straightforward path without any equipment that might obstruct the flow. For this reason, some companies have had second thoughts and removed the top of the molecular seal, called the “top hat,” as shown by the dotted line in Figure 36-2. This effectively neutralizes the seal but leaves the rest of it in position. On one plant, a steam nozzle was added inside the stack to cool the tip and to reduce smoke formation. Some of the steam condensed and flowed down the drain line into the knock-out drum. In the stack shown in Figure 36-2, the drain line was insulated with the steam line to prevent freezing.

Unfortunately, the drain line had only a 1-in. diameter. It became partially blocked with carbon and a pool of water formed in the bottom of the molecular seal. It filled the outer rings of the seal and overflowed into the inner pipe. Some of it froze when unusually large quantities of cold gas had to be flared during cold weather, partially choking the inner pipe. Finally, there was a rumbling noise and bits of ice and a stream of water were blown out of the stack. The flame was extinguished. Similar

FIGURE 36-2 The top of a flarestack fitted with a "top hat." From reference 6. (Reprinted with the permission of the Institution of Chemical Engineers.)

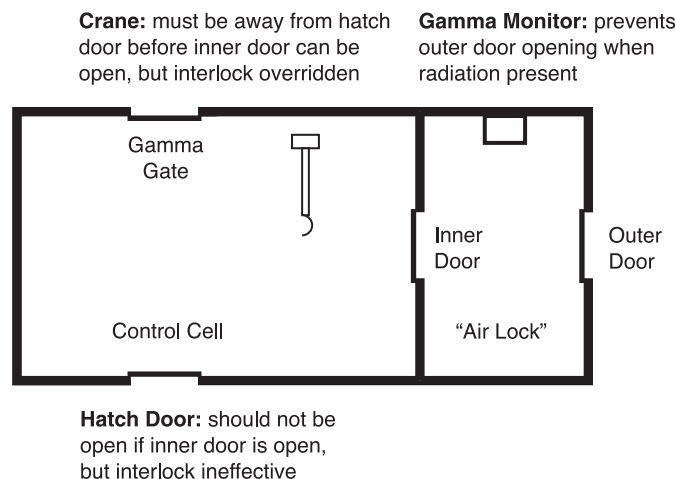
FIGURE 36-3 An overly complex system of interlocks to prevent both doors being open at the same time, unless maintenance is in progress.

was brought into the cell through a hole in the floor (the hatch door) and removed after cleaning through a hole in the ceiling (the gamma gate). Cleaning and other operations were carried out by remote control. No one was allowed in the cell when radioactive equipment was present but people could enter the cell at other times to maintain the cleaning equipment. They entered through double doors that acted as an air lock. A key exchange system—only one key could be withdrawn at a time—ensured that only one door could be open at a time.

Despite these precautions, both doors were found open when radioactive equipment was in the cell. Fortunately, no one was in the path of the open doors. If someone had been, he or she could have received a serious dose of radiation.

While preparing the plant for maintenance, the foreman found that the inner door would not open. The foreman did not realize that the crane was in the wrong position and that interlock (b) was keeping the door closed. After the maintenance department had spent most of the day trying to determine why the door would not open, the shift manager decided to override interlock (b) by making the PES “think” that the crane was in the right position. He noted what he had done in his log.

When the inner door would not open, the foreman assumed it was faulty. He should have checked the state of all the interlocks. Afterwards, a number of interlocks elsewhere on the plant were found to be overridden. Assuming instruments to be faulty is a common failing. For example, when a high-level alarm on a tank sounds, many operators have said, "It can't possibly be full," and sent for the instrument technician. By the time he arrived, the tank was overflowing.

There was no self-checking (logic checking) in the software controlling the crane. It *believed* the crane was in a position where it could not open the hatch door while it was actually opening it! This is artificial stupidity, not artificial intelligence, greater stupidity than any human would have. No human operator would tell someone who could see him carrying out a hazardous task, "Don't worry, I am now somewhere else." However, in one plant (see Section 29.4), certain packages were supposed to be moved downstairs only in the elevator. When the elevator was out of use, no one noticed anything anomalous when a package arrived downstairs.

After the incident, the regulators asked the company to replace the software interlocks by hardwired ones. If safety interlocks are based on software, they should at least be on a separate PES from the normal control and operating system.

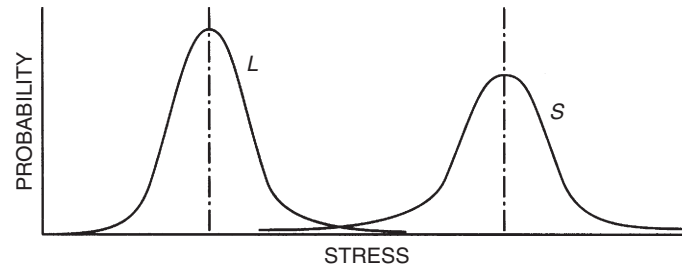
As described in Section 25.3.2, in 2000 a railway accident at Hatfield, United Kingdom, killed four people and drew attention to a literal interface problem. The immediate cause was a cracked rail, but the underlying cause was that British Railways had been privatized and split into a hundred companies. Responsibility for the rails and the wheels now lay with different organizations. To quote the head of the railways' safety organization, "Both sides of the wheel/rail interface may be operating

FIGURE 37-1 Overlapping distributions of load (L) and strength (S). (Reprinted with permission of the Institution of Chemical Engineers.)

Figure 37-1 may make this clearer. In any system, the strength and the load vary to some extent from their design values, and there is inevitably a small overlap between the two asymptotes. Its area is a measure of the probability that the load will exceed the strength and the system will fail, not necessarily immediately but in the long run. Normally, this probability is negligible. In the case of the railways, the wear on the wheel increases the load and cracks in the rail decrease the strength. Both were just within specification, and the overlap was too large. This led to rolling contact fatigue of the track (also called gauge corner cracking), the train crash, and the consequent upheaval while hundreds of miles of faulty rail were replaced.
