NBS BUILDING SCIENCE SERIES 100

# Building To Resist The Effect Of Wind

VOLUME 3. A Guide for Improved Masonry  
and Timber Connections  
in Buildings

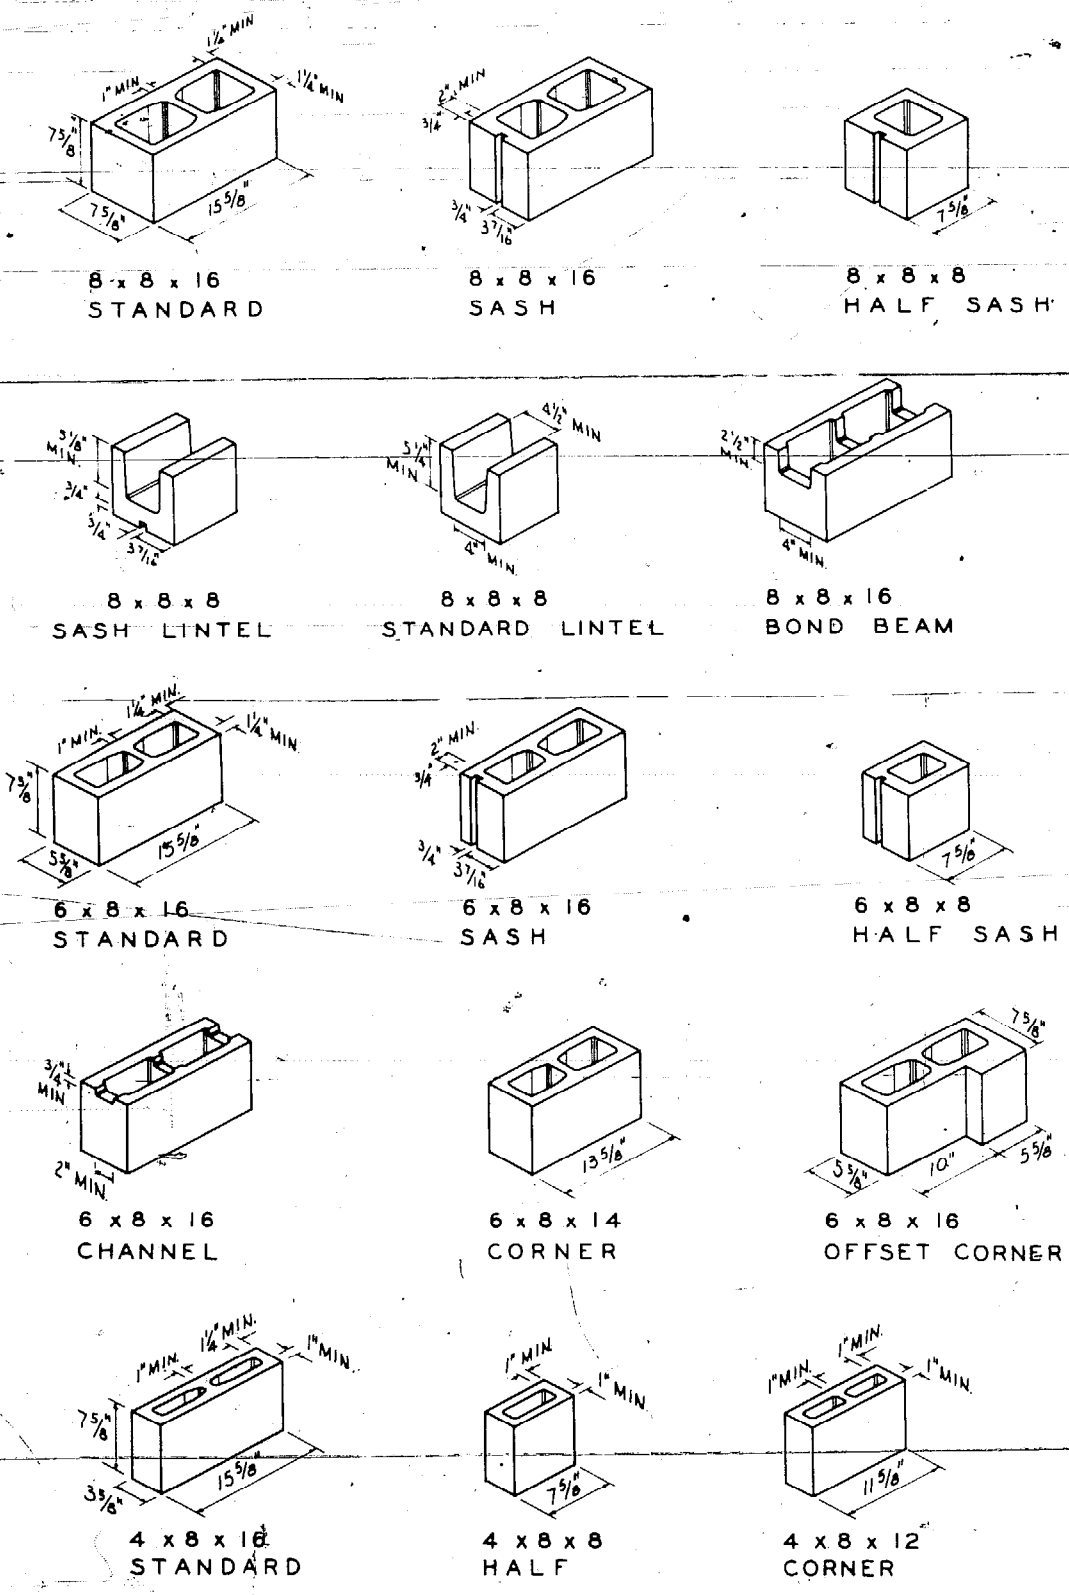
FIGURE 6 CONCRETE MASONRY UNITS.

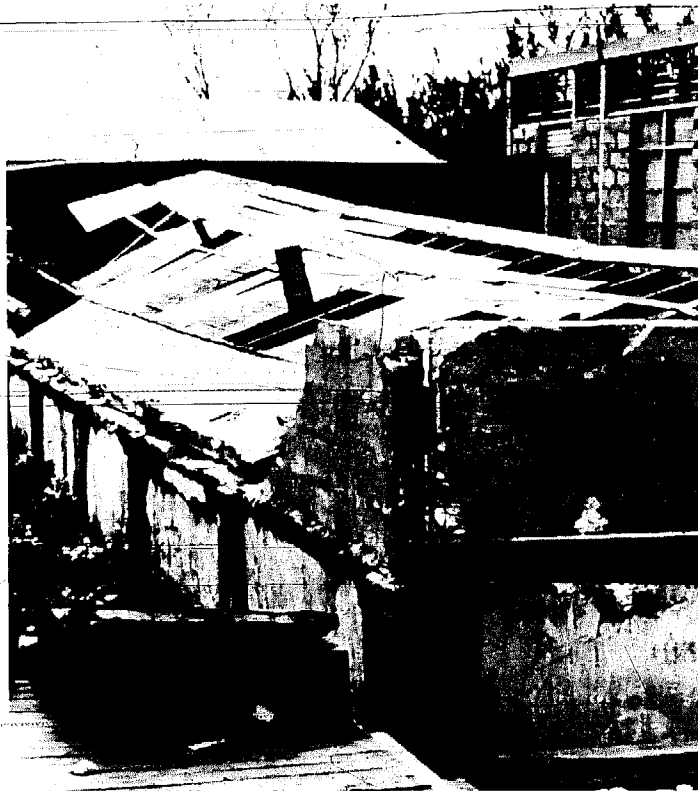
FIGURE 8 COLLAPSE OF ONE-STORY BUILDING CAUSED BY THE NOVEMBER 1974, TYPHOON IN THE PHILIPPINES.

Figures 8 to 17 exhibit buildings damaged or destroyed by recent hurricanes and typhoons. The buildings shown in figures 8 to 10 belong to a group of one-story structures in Northern Luzon, the Philippines, which either sustained severe damage or collapsed as a result of the November 1974 typhoon. These structures consisted of masonry walls and wood posts, a pitched roof system of wood trusses, purlins and corrugated iron cover, and a continuous foundation wall of cast concrete.

Figure 10 exhibits a typical failure of the fasteners connecting the purlins to the top chords of the trusses. Most of the roofing was "peeled off" in this manner. Portions of the corrugated iron roofing found on the ground contained the purlins with their metal wire attachments still in place (fig. 50). Instability of the trusses, few of which were still standing, was attributed to the loss of purlins and the absence of other longitudinal bracing between the trusses. The collapse of the masonry walls as shown in figure 8 was likewise attributed to the loss of lateral support at the roof level. However, the extent and severity of wall damage is also attributed to the absence of connections between abutting walls and the ineffectiveness of the vertical anchorage at the base. As indicated in figure 9, the only anchorage consisted of steel plates bolted to the wood posts. Close inspection revealed severe corrosion of these plates, especially at the ruptured section through the bolt-holes (fig. 9). The masonry walls in these buildings were nonload-bearing as they were stopped short of the roof to provide openings at the top (fig. 8). Thus the wood posts were the only vertical load-bearing elements and with the loss of the roof many of the corner posts were tipped over (fig. 8).

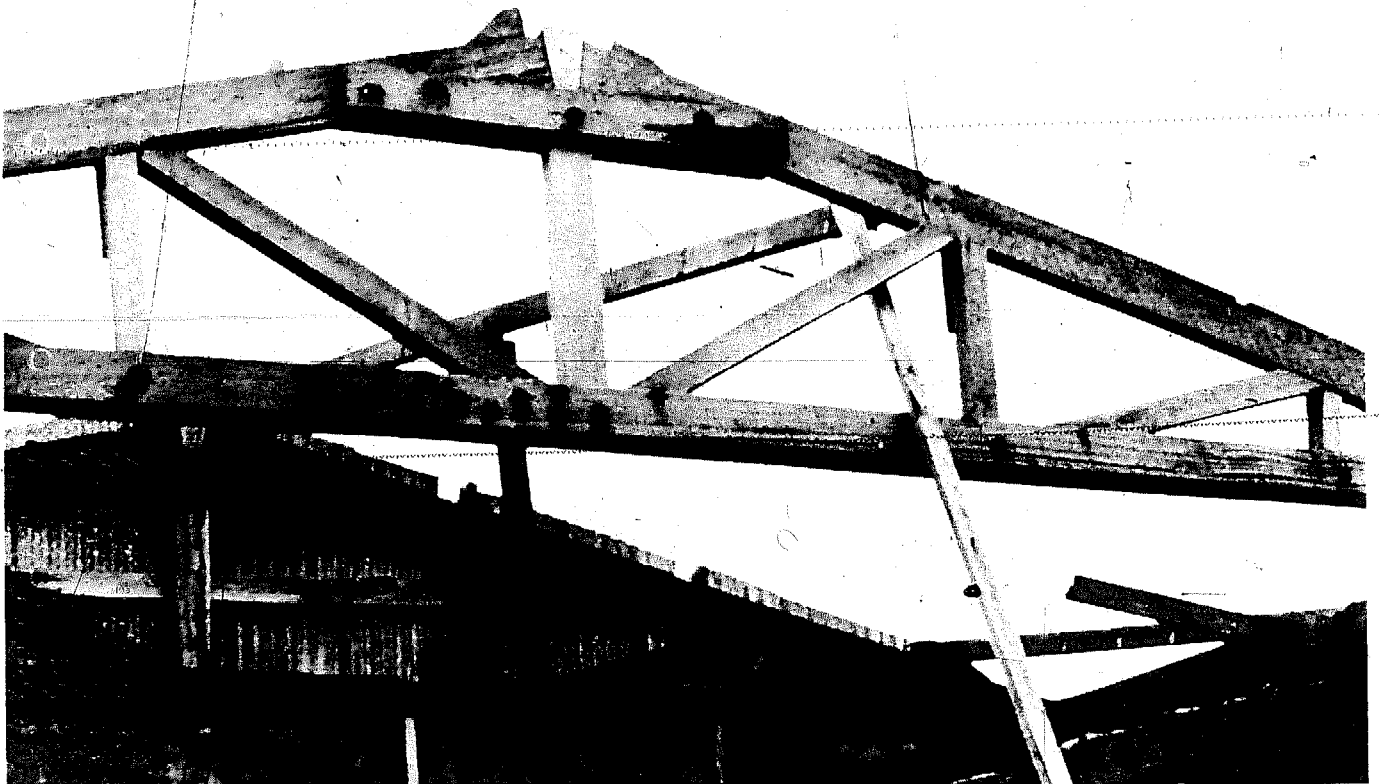
FIGURE 10 ROOF FAILURE IN BUILDING CAUSED BY NOVEMBER 1974 TYPHOON IN  
THE PHILIPPINES.

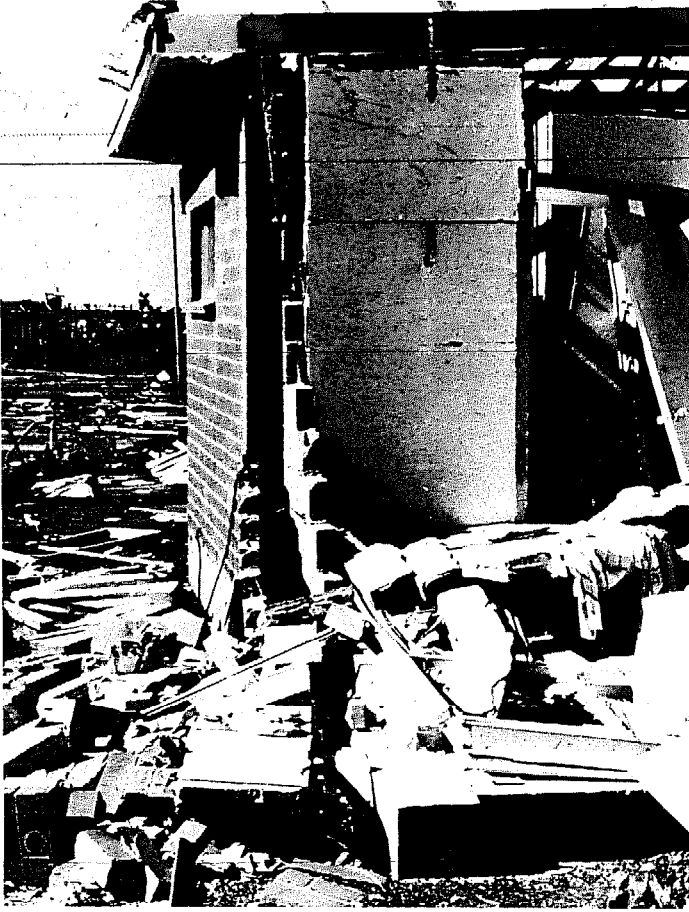
FIGURE 16 BUILDING IN DARWIN, AUSTRALIA SHOWING PARTIAL COLLAPSE OF ROOF AND MASONRY INFILL WALLS CAUSED BY THE DECEMBER 1974 CYCLONE.

Figure 16 shows an infill wall construction with a steel frame and concrete masonry filler walls. There is no visual evidence of any reinforcement having been used in the filler walls. Note the severity of vertical cracking through the wall on the right and also the separation between the steel column and the wall at the left. It is not possible to establish by examination of the figure whether there were any connectors between the steel columns and the filler walls. Figure 17 shows the portion of a concrete masonry wall under the sill of a large window opening that has failed. Note that the top course was connected to the window frame with anchor straps embedded into the grouted cores. It is likely that failure was caused by the movement of the window frame, prying the top course loose from the rest of the wall.

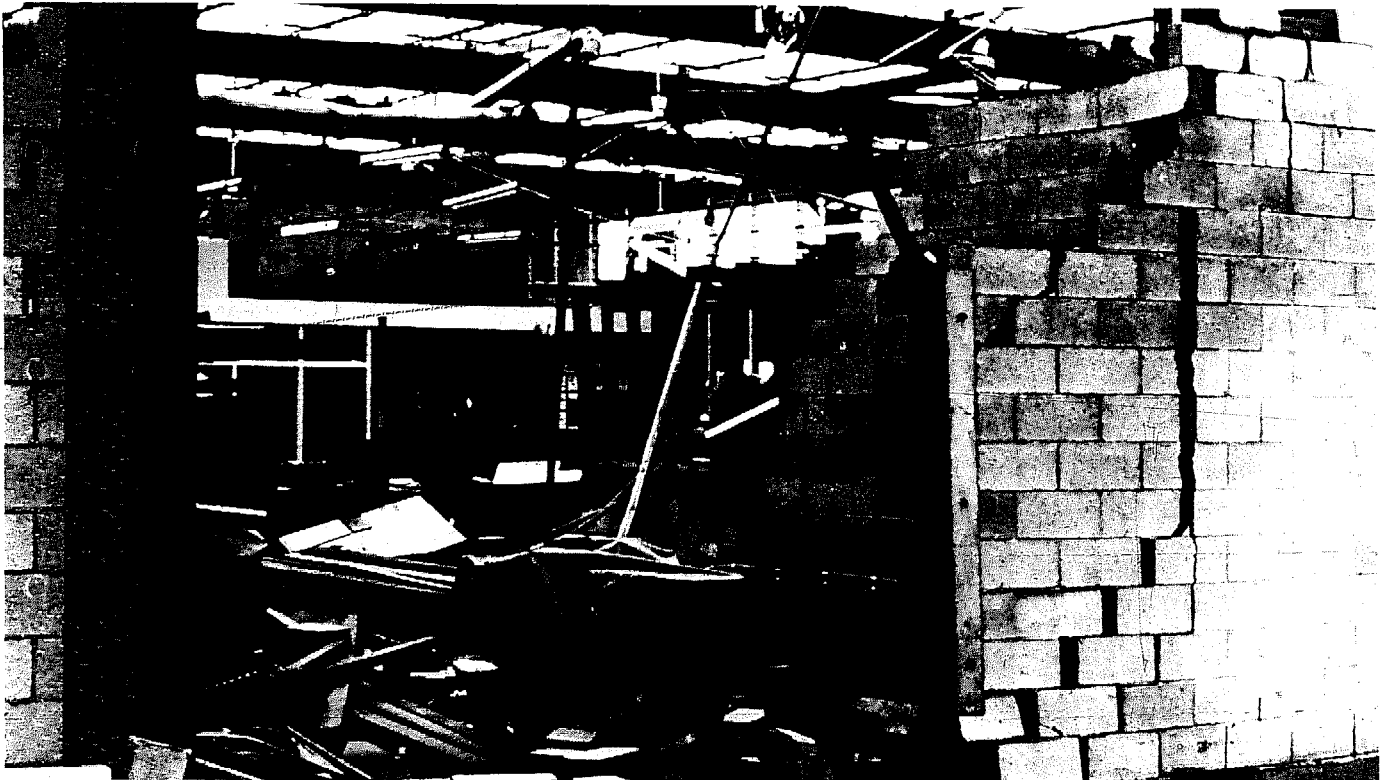
FIGURE 17 FAILURE OF CONCRETE BLOCK MASONRY WALL IN BUILDING  
SUBJECTED TO THE DECEMBER 1974 CYCLONE IN DARWIN, AUSTRALIA.

Figures 14 to 17 exhibit structures consisting of different types of masonry wall systems that sustained severe damage or were destroyed by the December 1974 cyclone in Darwin, Australia. These structures represented engineered masonry construction with respect to the quality of workmanship and adherence to Australian masonry codes and standards (which are comparable to those in the United States). The Darwin experience demonstrated that compliance with current standards does not necessarily produce a structure capable of resisting the estimated 65 m/s (150 mph) winds experienced during this storm. However, it does indicate the need to reexamine the existing provisions with the objective of developing improved design criteria, connection details, and construction practices in order to mitigate the extent of damage associated with extreme winds.

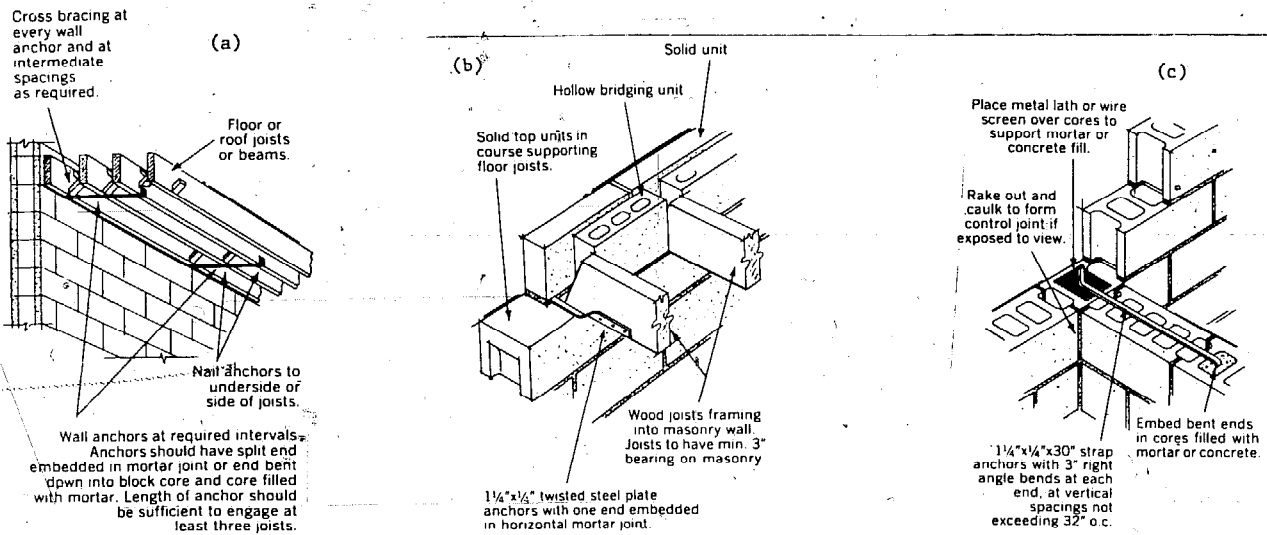
**FIGURE 29 APPLICATION OF METAL ANCHORS IN MASONRY CONSTRUCTION: (a) TIEBAR ANCHOR TO WOOD JOISTS; (b) TWISTED ANCHOR CONNECTING WOOD JOIST TO CONCRETE MASONRY BEARING WALL; (c) TIEBAR ANCHOR CONNECTING CONCRETE MASONRY INTERSECTING WALLS.**

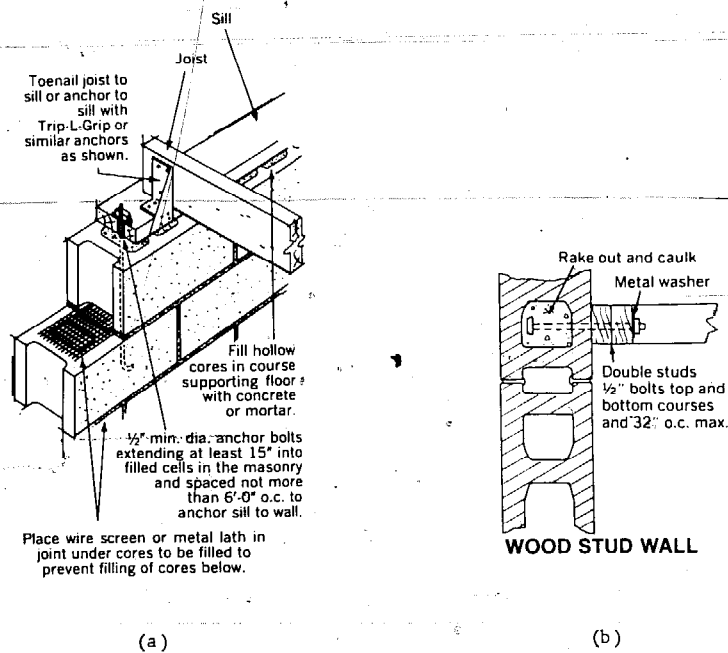
**FIGURE 30 APPLICATION OF ANCHOR BOLT FOR MASONRY CONNECTION: (a) CONNECTION OF SILL PLATE TO CONCRETE MASONRY BEARING WALL; (b) CONNECTION OF CONCRETE MASONRY WALL TO WOOD STUD WALL.**

two anchor bolt applications: (a) anchorage of sill to masonry wall and (b) anchorage of stud wall to masonry wall. Also consult figures 55 and 56 which illustrate the use of anchor bolts to connect a stud wall system to cast concrete slab footings and concrete masonry foundation walls.

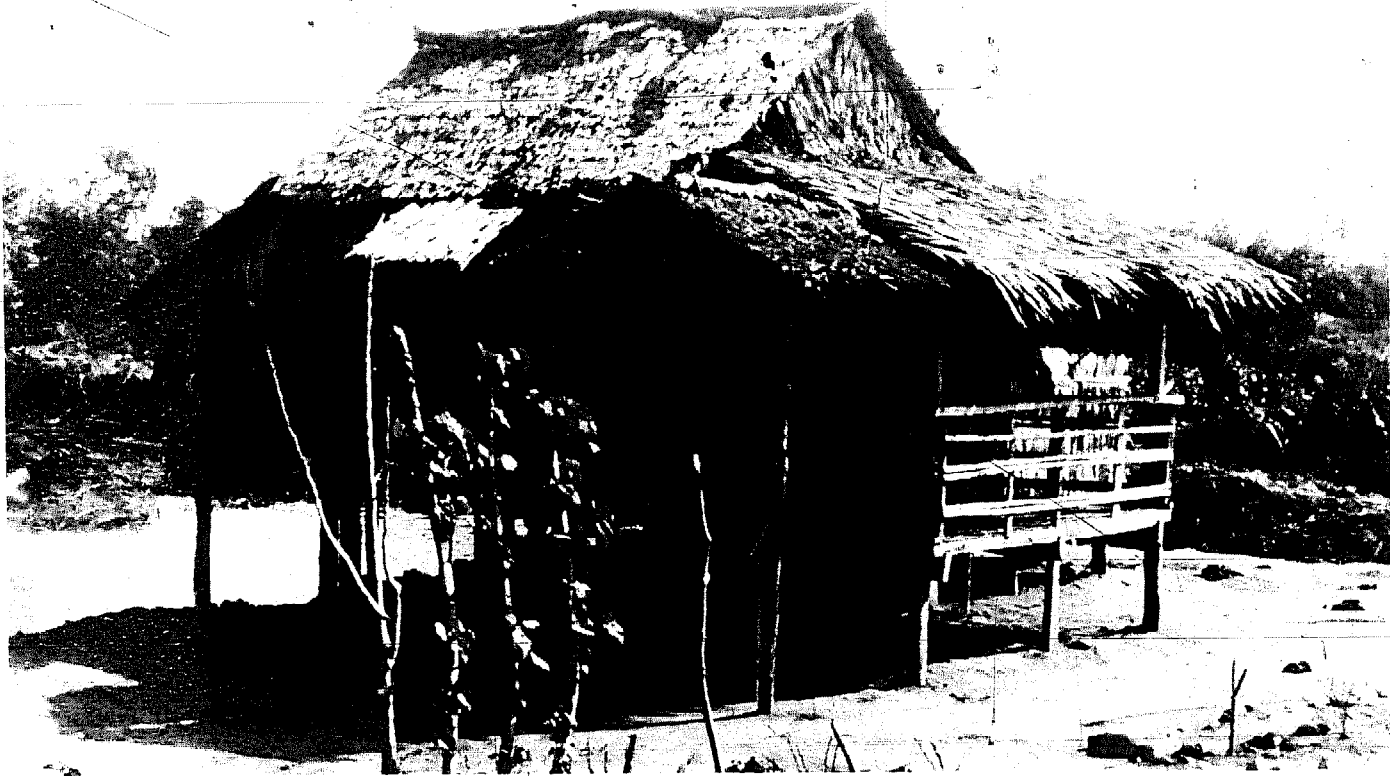
FIGURE 39 POLE-TYPE CONSTRUCTION.

- (1) Pole-type construction in which poles are set into the ground to serve as foundation and extend to the roof (fig. 39).

This type of construction is well suited to high wind areas because the major structural member, the pole, serves as the connecting link between all other structural members. If the poles are set 1.2 m (4 ft) or more into the ground, they serve as anchors for the building. For long life, all poles must be pressure treated for resistance to decay and insect attack.
